UCC28513 questions, Alex W., 11/17/2022

- The boost stage design is based on UCC28513. The PFC stage works well up to 200-220Vac input. Above this voltage range there are significant distortions at the points where sinusoidal input voltage reaches to its positive and negative peaks
- Output voltage is 385Vac
- Input voltage range is 85-264Vac; 50/60Hz
- The load on DC link output is 120W max
- Boost stage switching frequency is 277kHz
- Verified that the Vcc aux supply and Vref are stable
- Observed that the AC ripple on DC link goes up at around 200Vac but not sure it this is the reason or the result
- Observed that the duty cycle is about 70% at the peak sine wave at 85Vac but drops down to ~15% at the peaks of 220Vac at which point I start get distortions on the input current.
- The provided test results are at ~30W output power. It was observed that changing the load did not affect the behavior at around 220Vac.

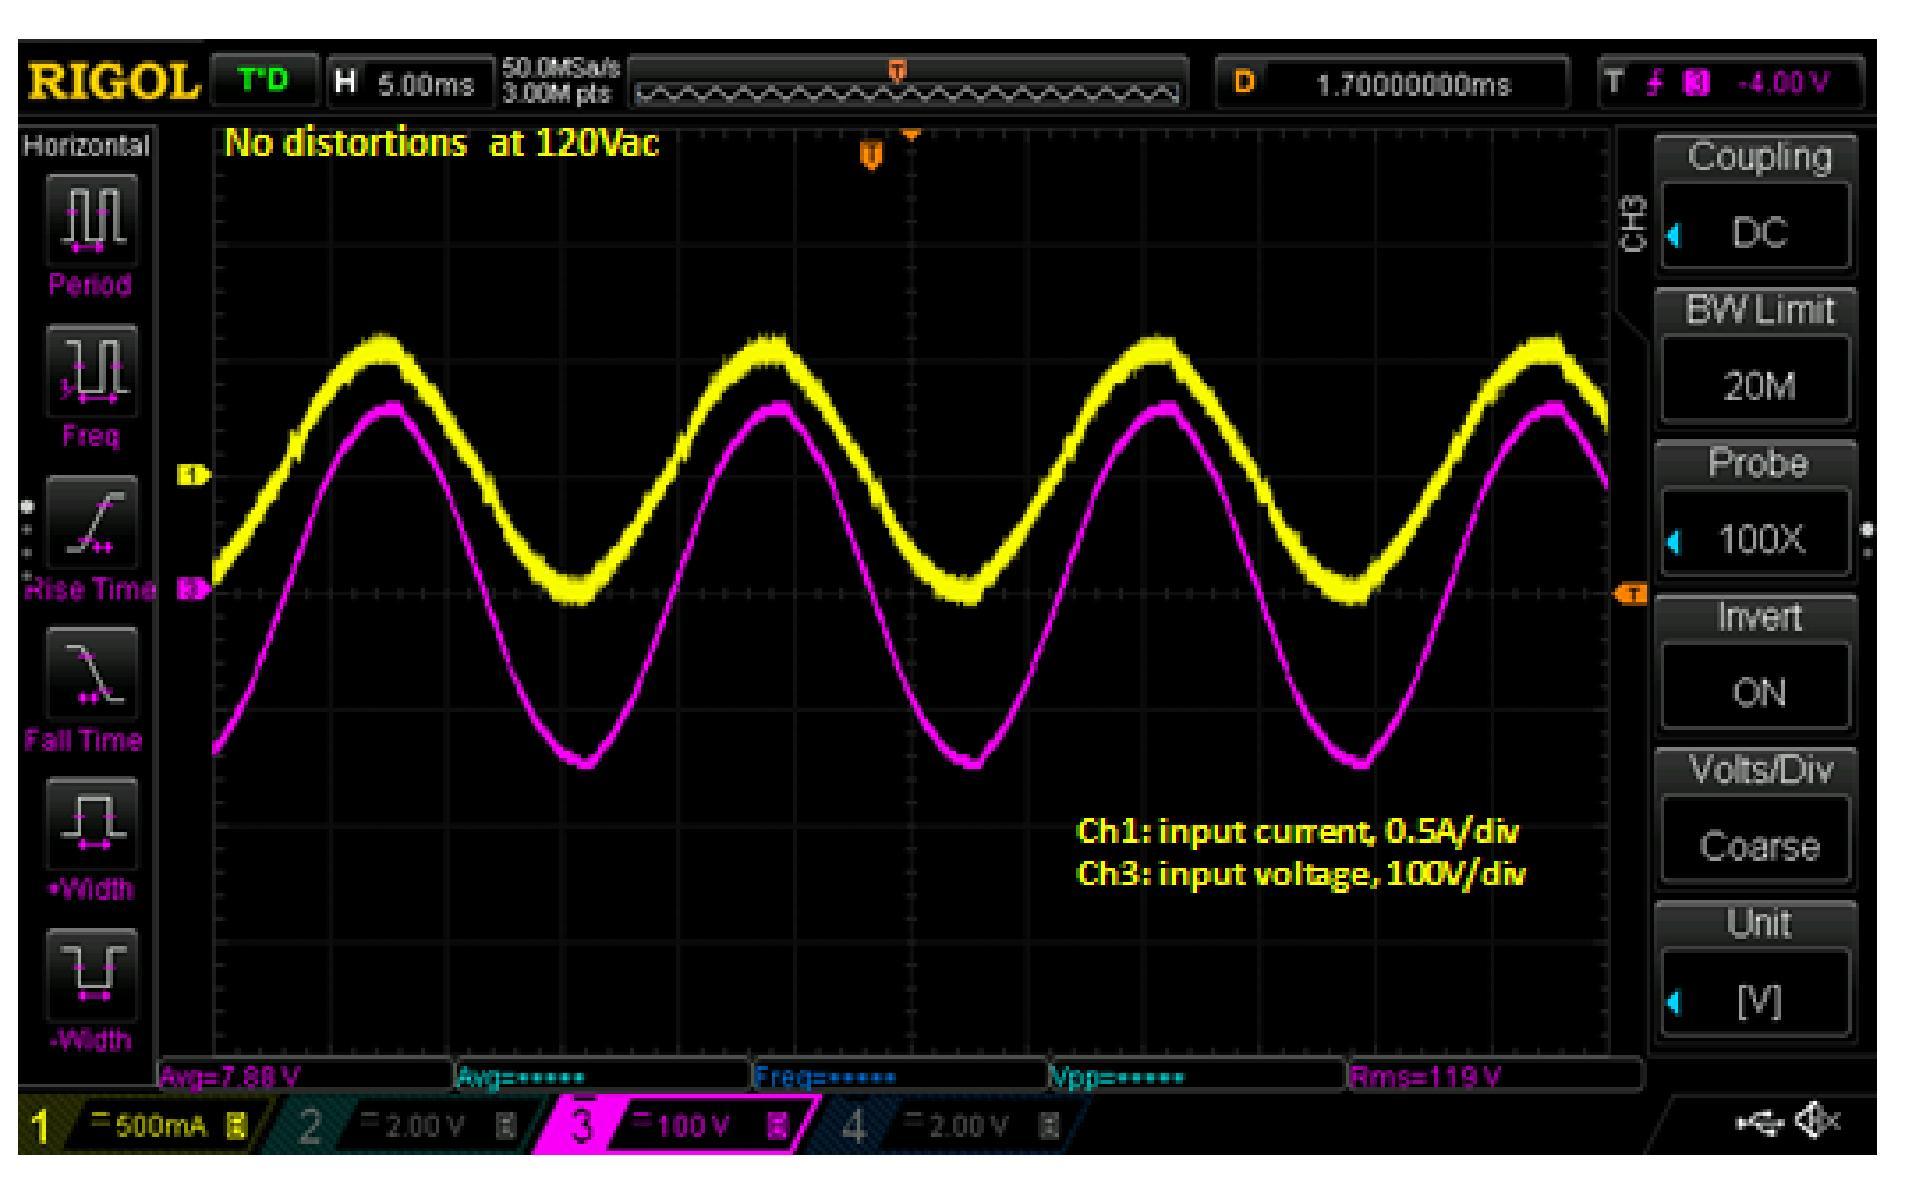
No distortions at 200Vac input, displacement between current and voltage is probably caused by the input capacitors on EMI filter

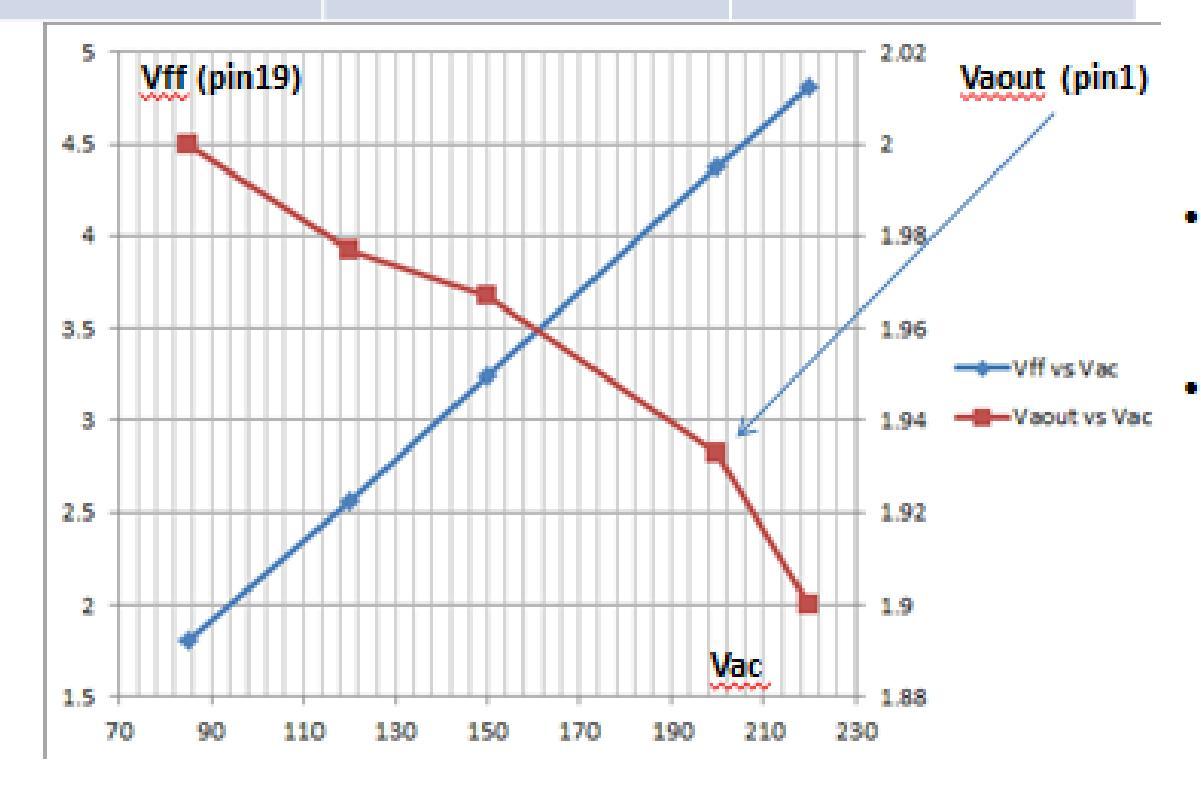
Input voltage (<u>Vrms</u>)	Vff on pin19 w/ DiffProbe (Vdc)	Vaout on pin1 w/ DVM (Vdc)	0 < i (t) < 500 A
85	1.80	2.000	$0 \leq T_{IAC}(t) \leq 500 \mu A,$
120	2.56	1.977	$0 \le V_{VAOUT}(t) \le 5 V,$
150	3.24	1.967	$1.4 \text{ V} \leq \text{V}_{\text{VEE}} \leq \text{V}_{\text{VEE}} - 1.4 \text{ V}$
200	4.38	1.933	VEF VICEF
220	4.81	1.900

- Vff increases proportionally and <u>Vaout</u> drops inversely as Vac increases.
- Vaout seems to start low at 2V and not varying within its full range of 0-5V

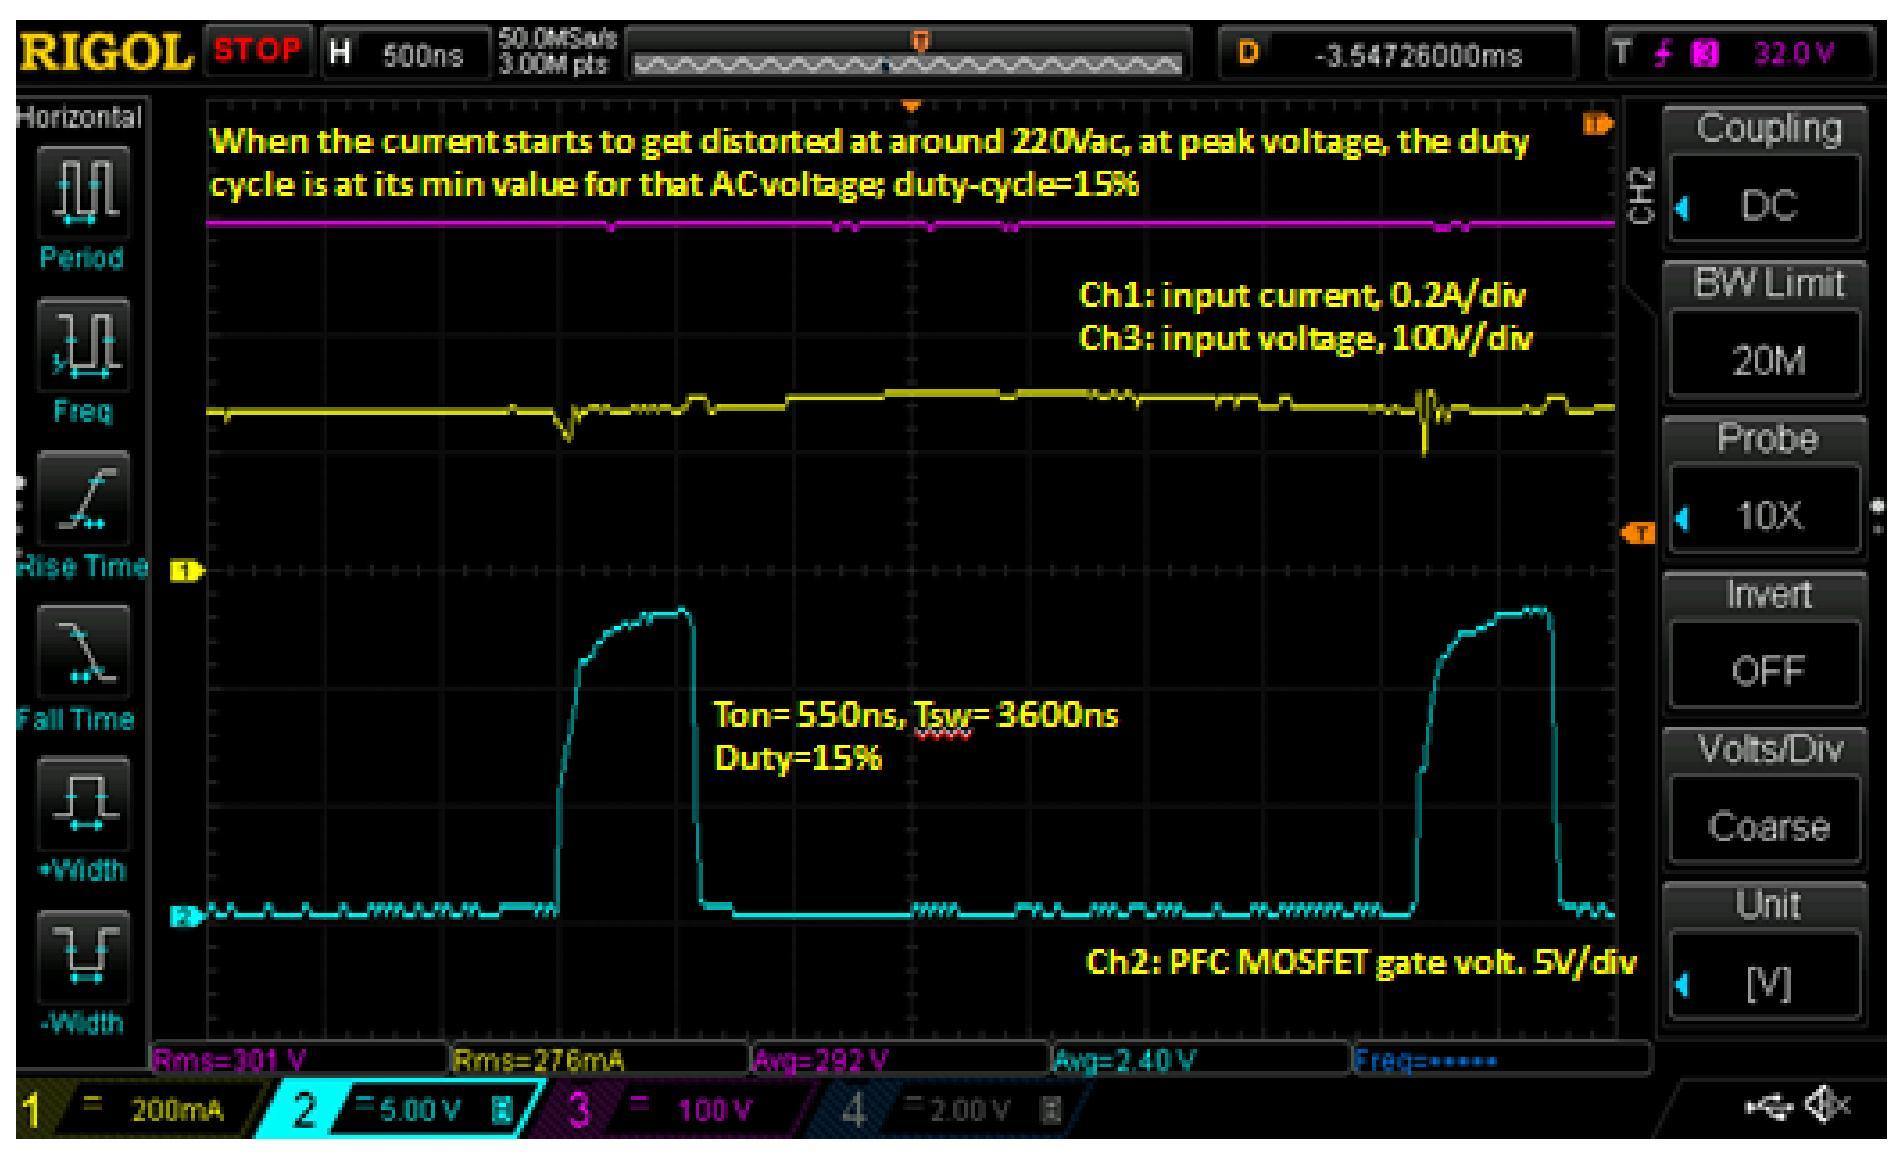
At the peak of sinewaves when distortion starts, the duty cycle of boost MOSFET is about 15%

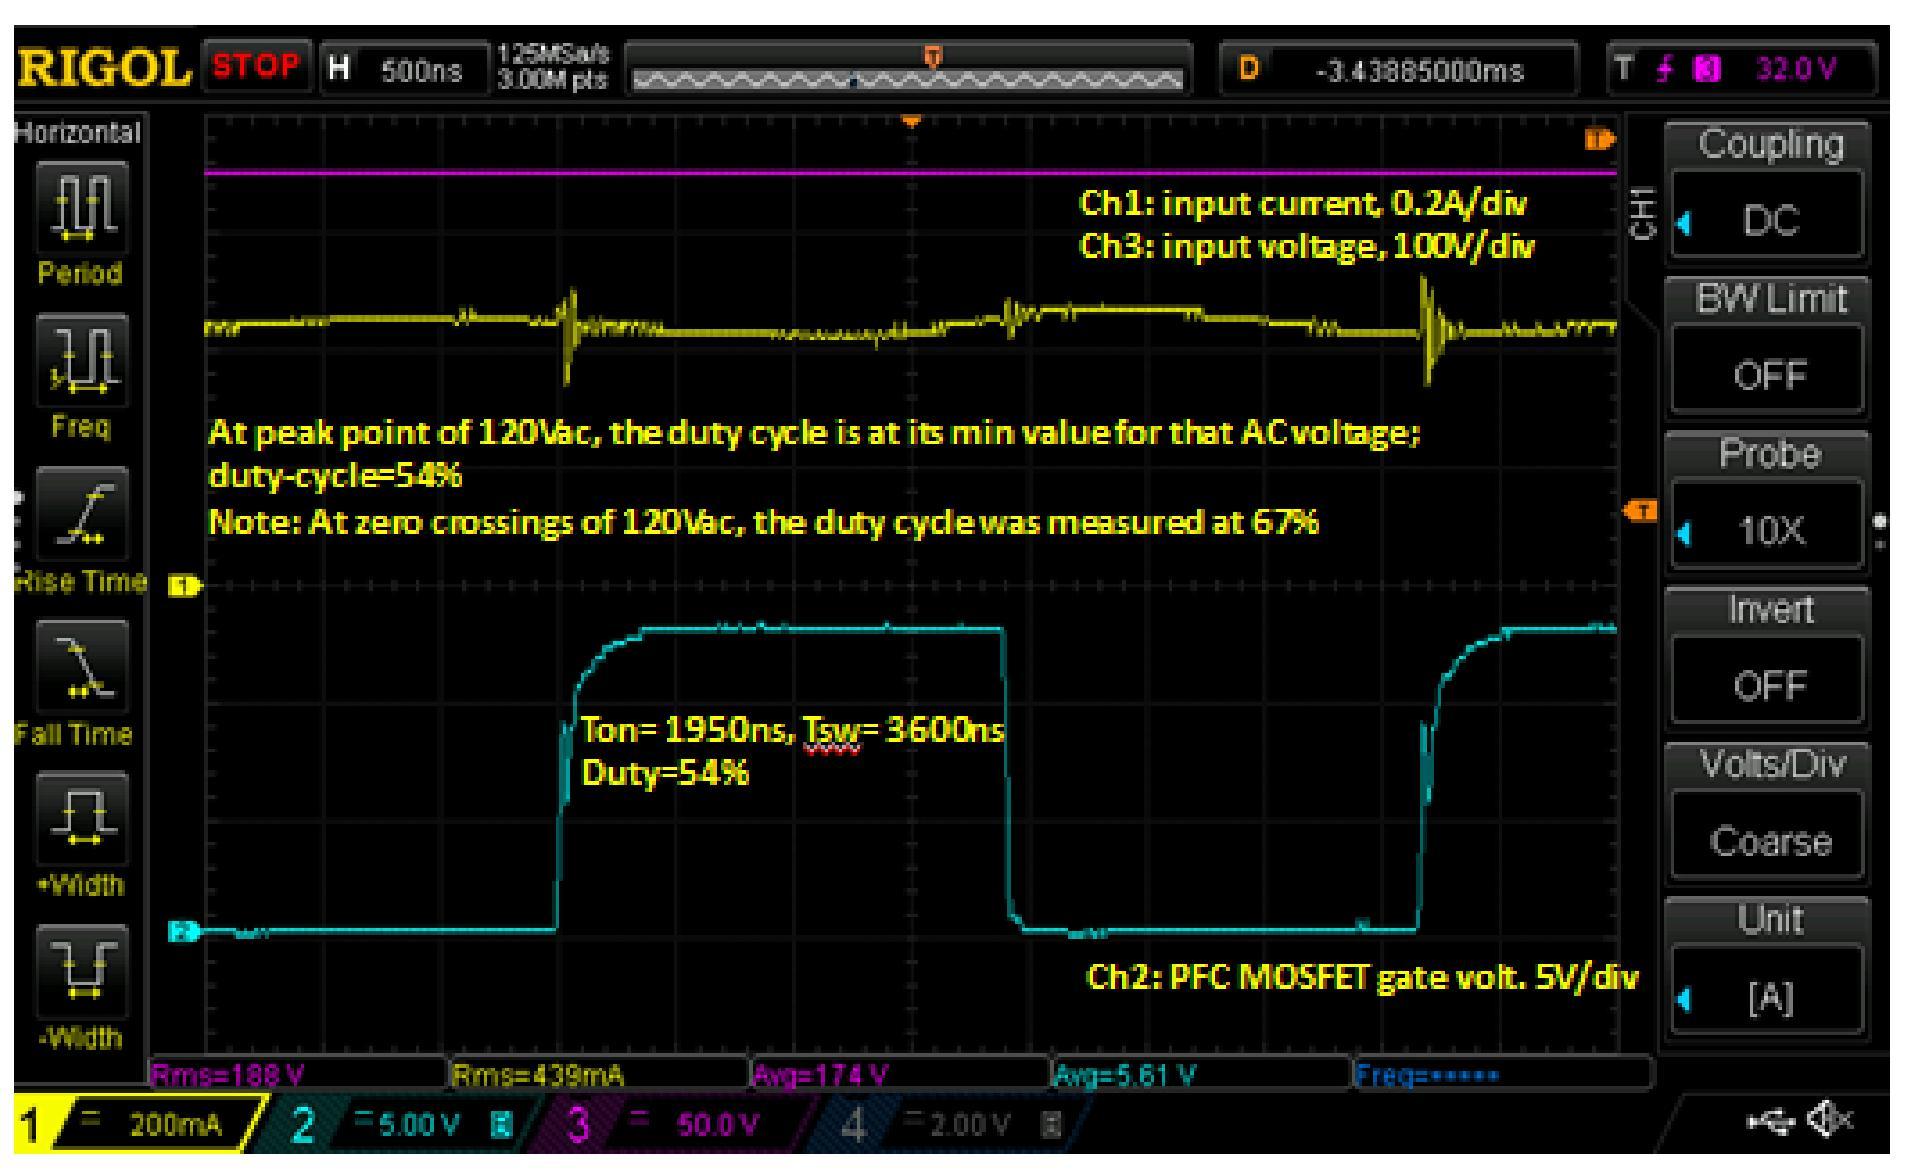
At the peak of sinewaves at 120Vac, the duty cycle of boost MOSFET is about 54%

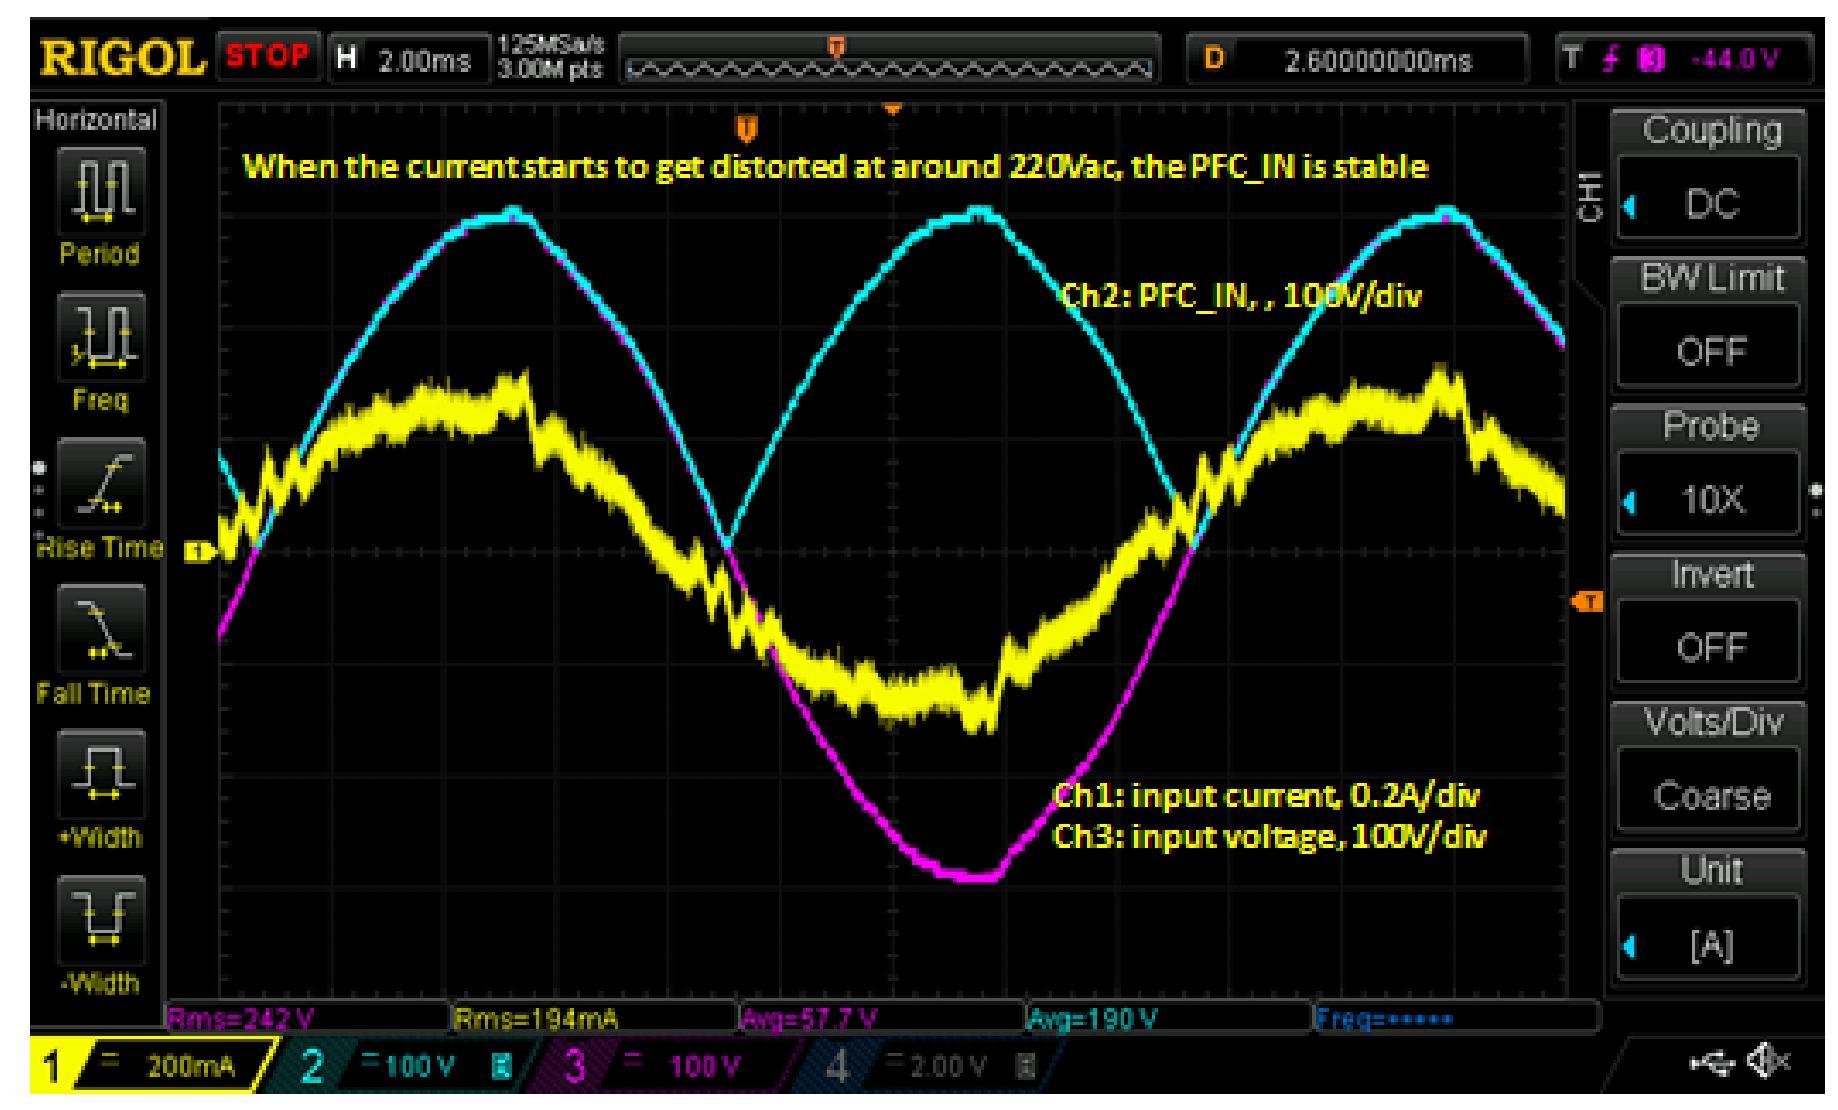
At 220Vac when distortions starts, the rectified input voltage (used for Vff) is shown below

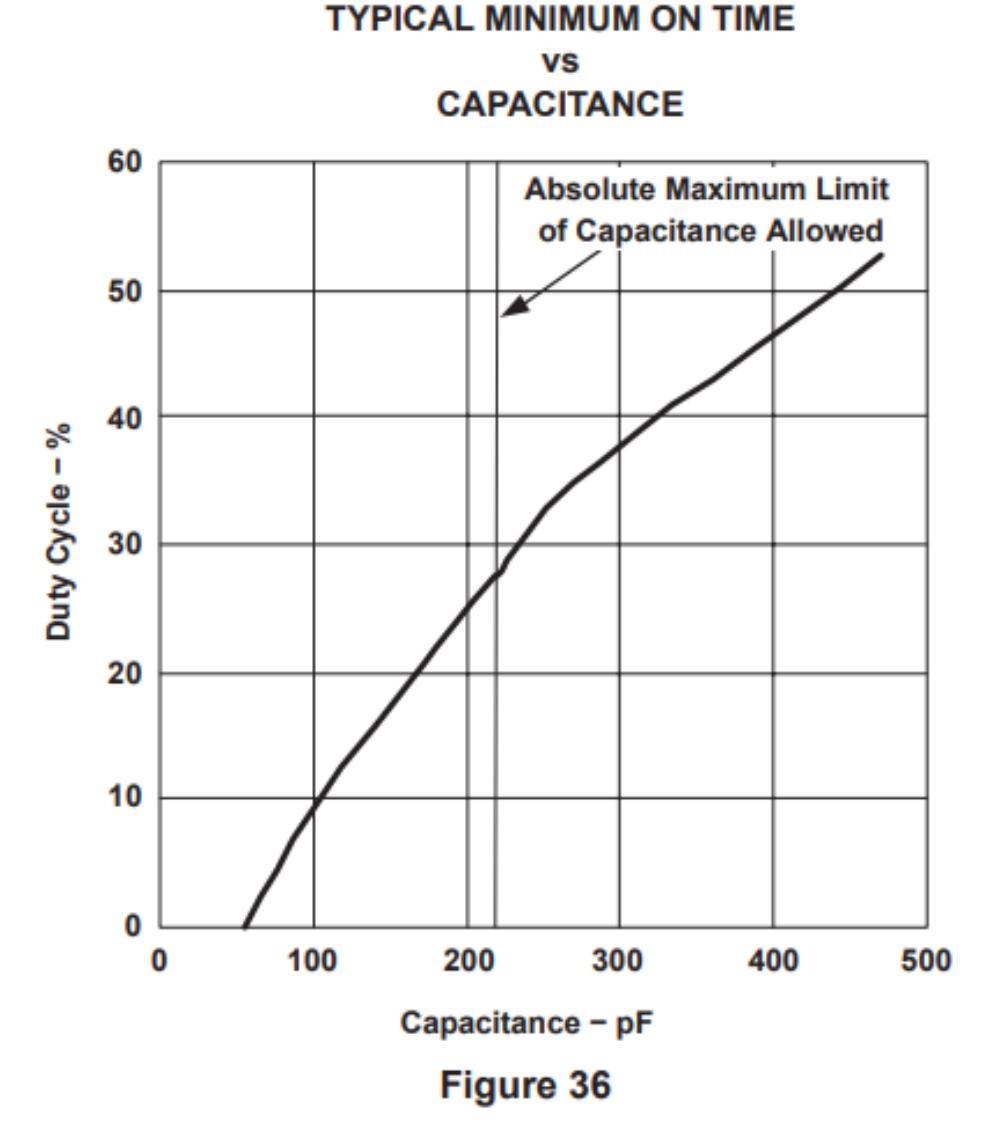
Referring to Fig 36 in the data sheet of UCC28513DW, what specific capacitor controls the min duty cycle?

Note: The capacitor on Isense2 affects the min duty cycle on GATE2 output, PFC is on GATE1 output

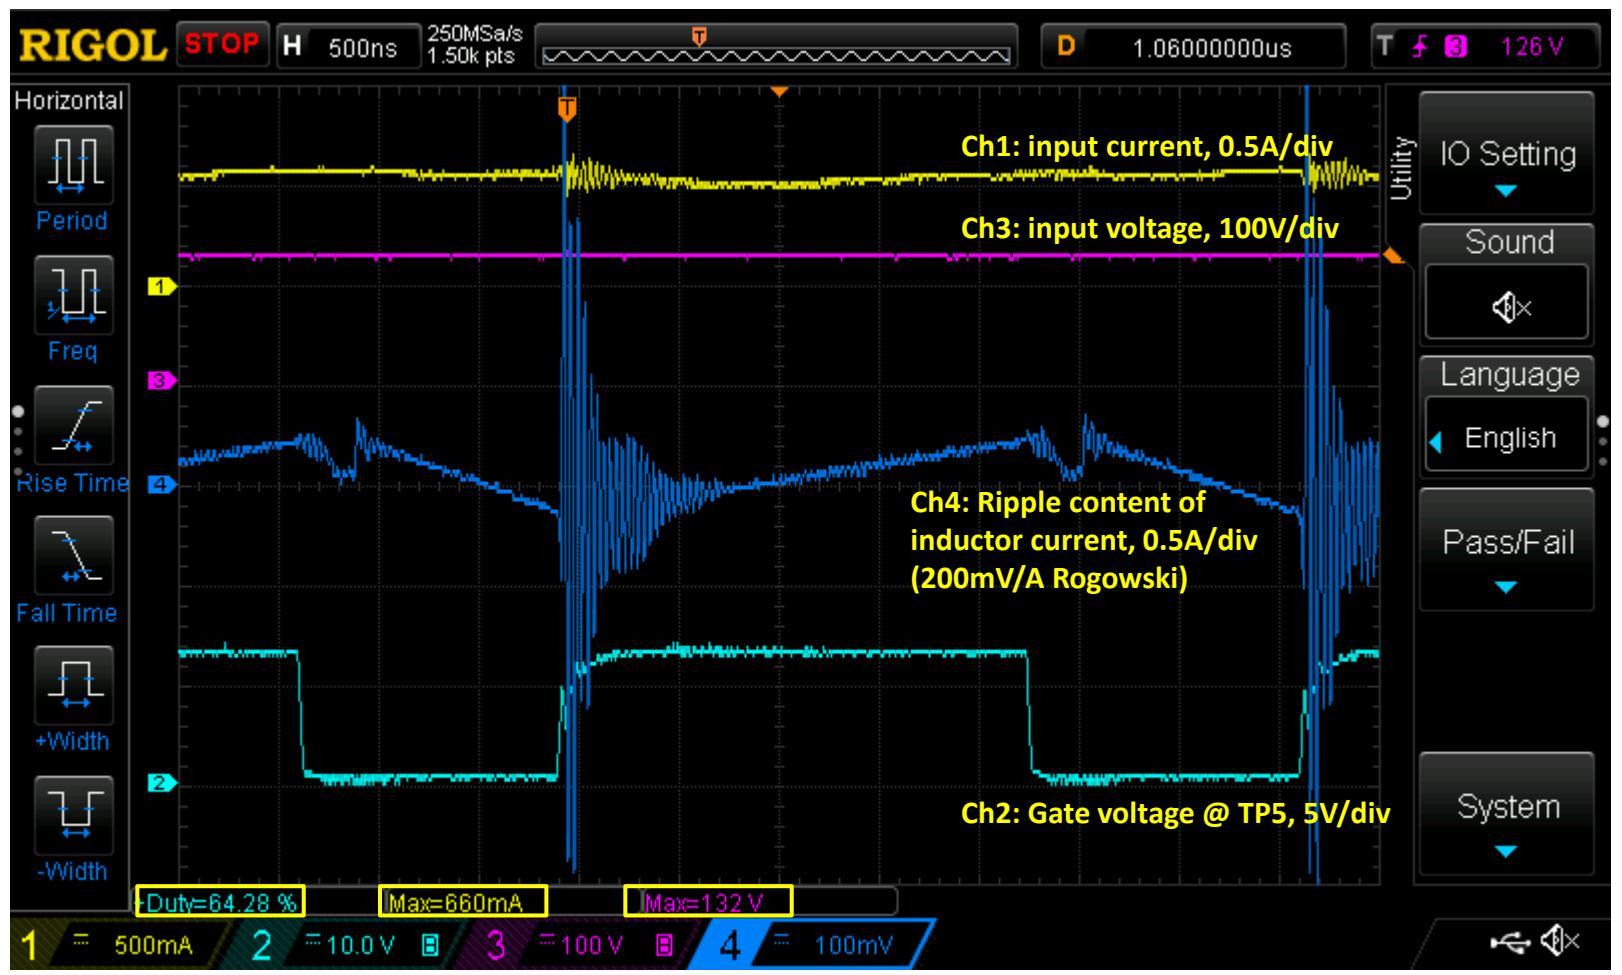
Ch1: Current probe is Fluke 80i-110S, which has limited bandwidth and is used to measure 60Hz input current

Ch4: Current probe is Rogowski CWTUM-015-B, which can measure high frequency only.

At the peak of 85Vac input voltage and ~25W external load, the instantaneous value of input voltage is 132V, peak input current is 660mA, duty cycle = 64.28%

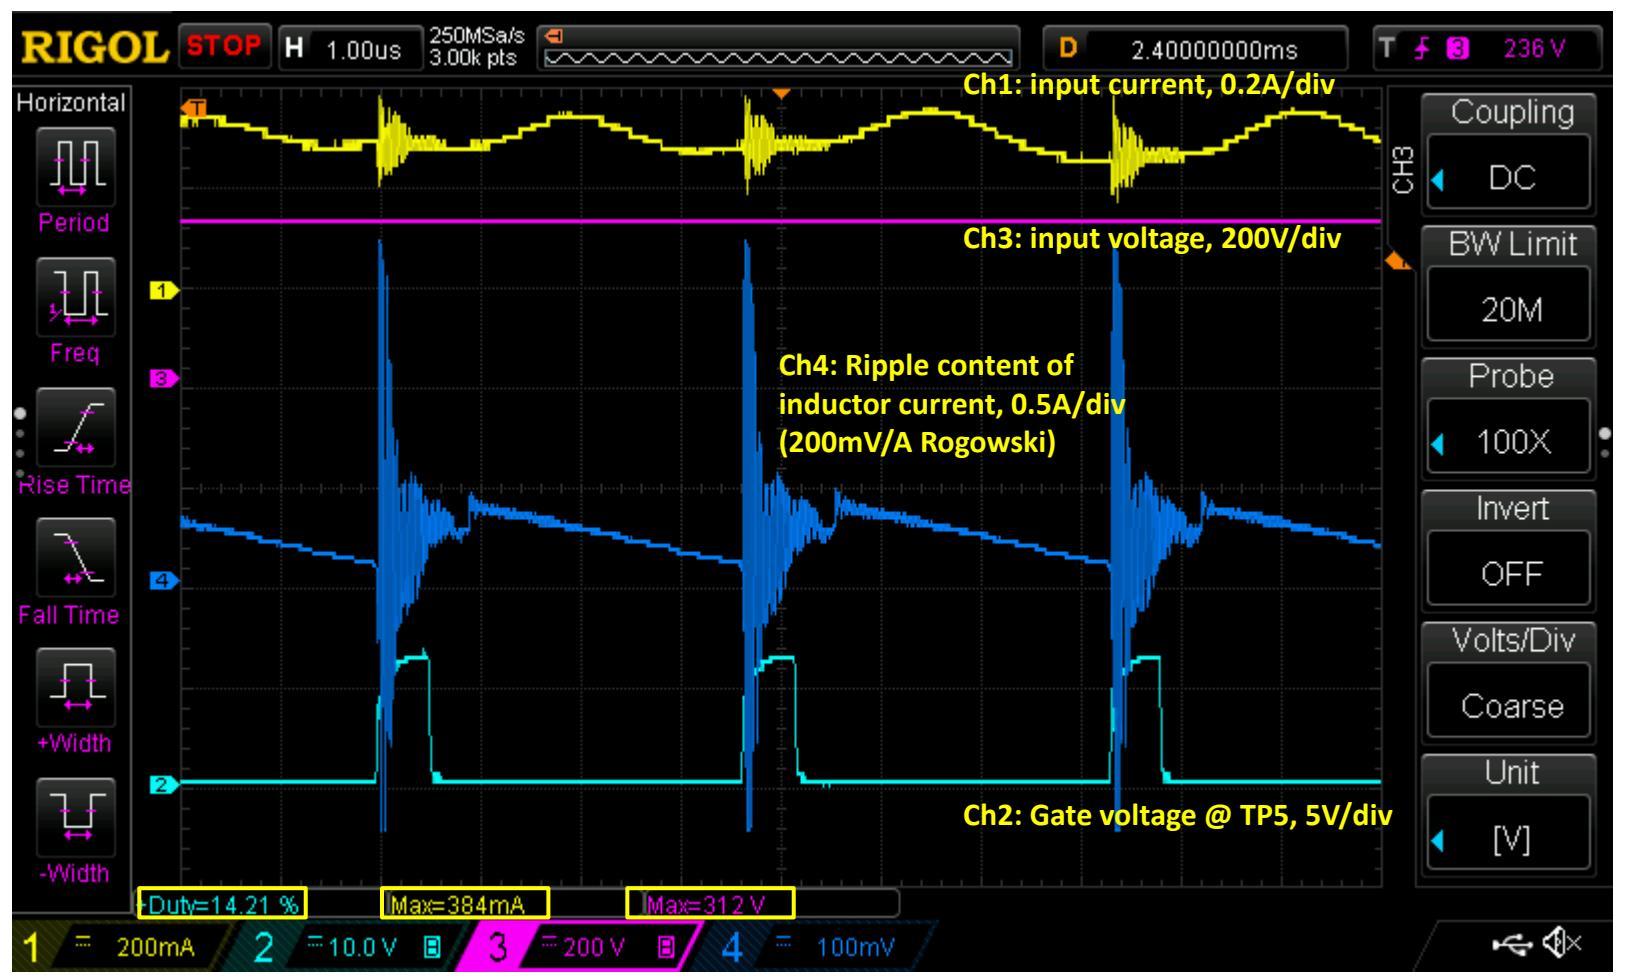
Ch1: Current probe is Fluke 80i-110S, which has limited bandwidth and is used to measure 60Hz input current

Ch4: Current probe is Rogowski CWTUM-015-B, which can measure high frequency only.

At the peak of 220Vac input voltage and ~25W external load, the instantaneous value of input voltage is 312V, peak input current is ~300mA (location B), duty cycle is about 14.2%

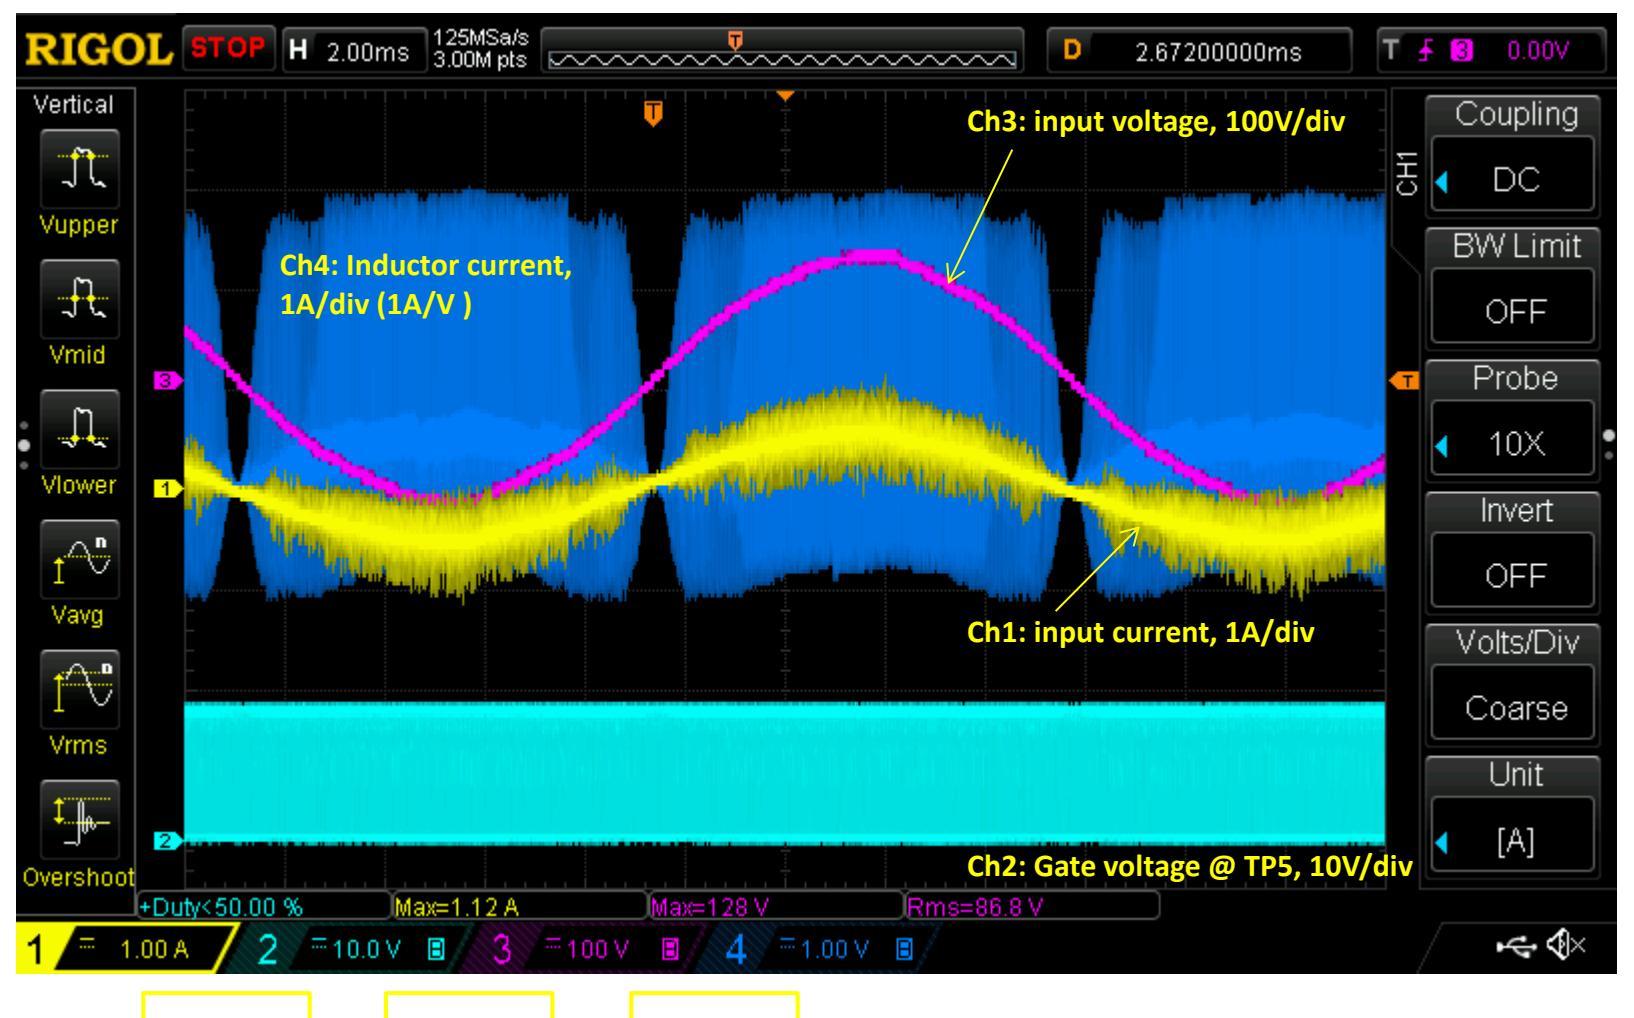
Measuring inductor current vs gate voltages, 12/25 Ch1: Fluke 80i-110S, which has limited bandwidth Ch4: Tek TCPA300 w/ TCP312 Current probe

At 85Vac input voltage and ~25W external load, no major distortions observed

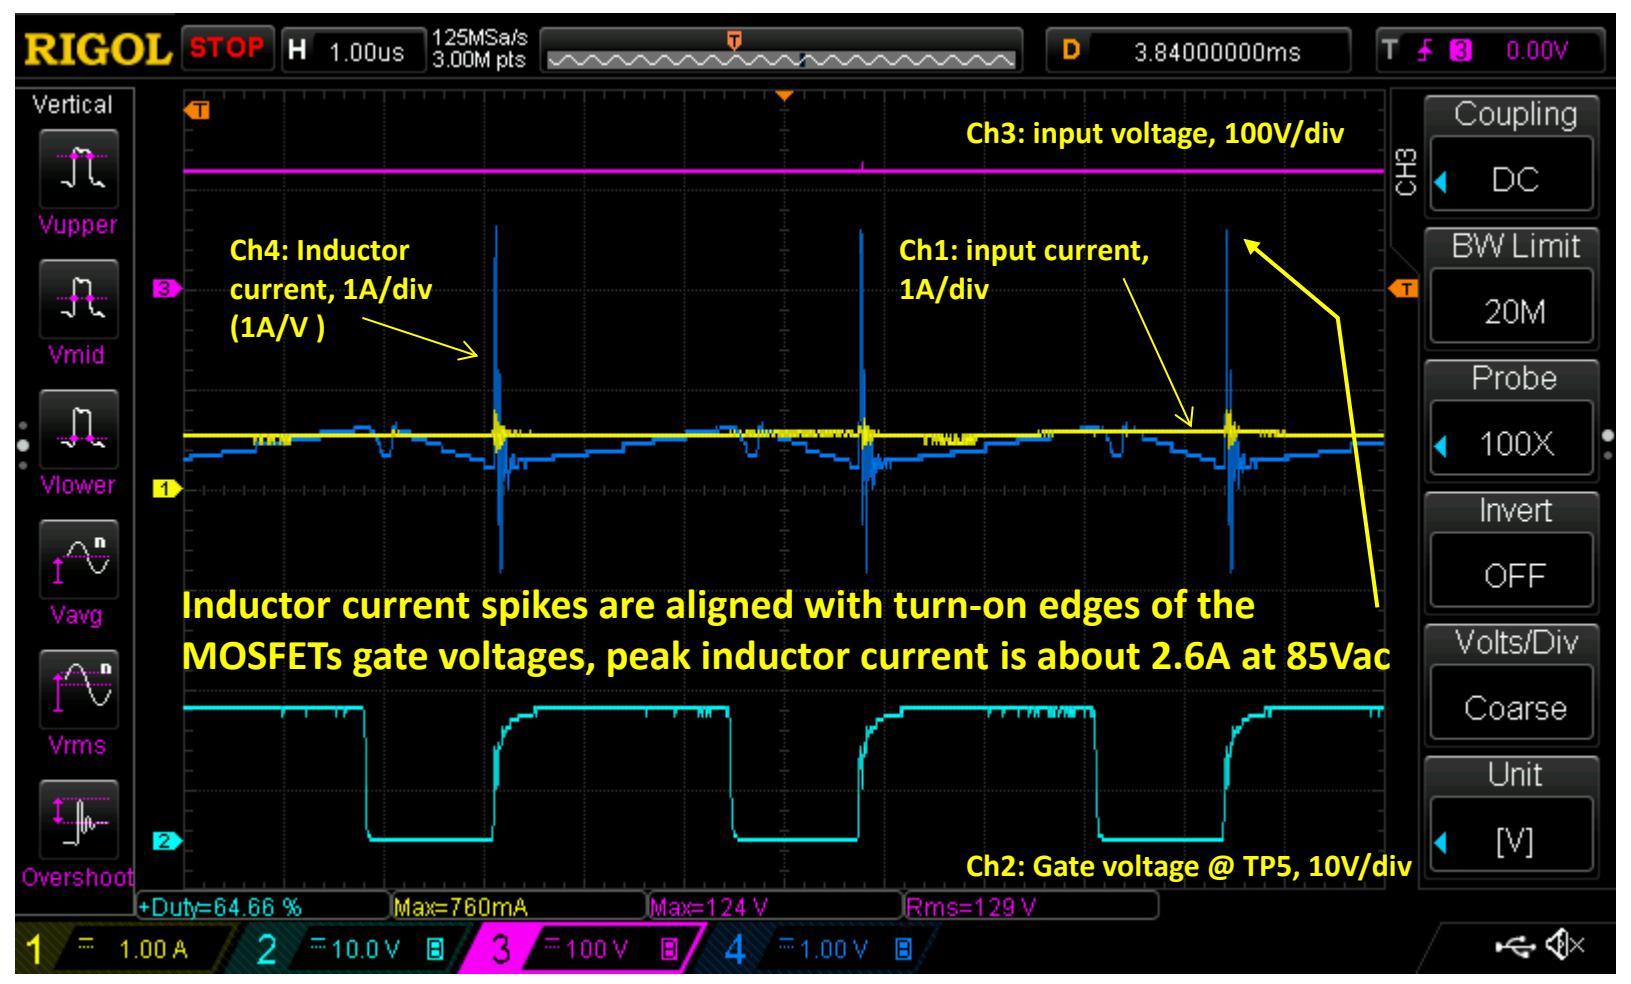
Measuring inductor current vs gate voltages, 12/25 Ch1: Fluke 80i-110S, which has limited bandwidth Ch4: Tek TCPA300 w/ TCP312 Current probe

At 85Vac input voltage and ~25W external load, no major distortions observed

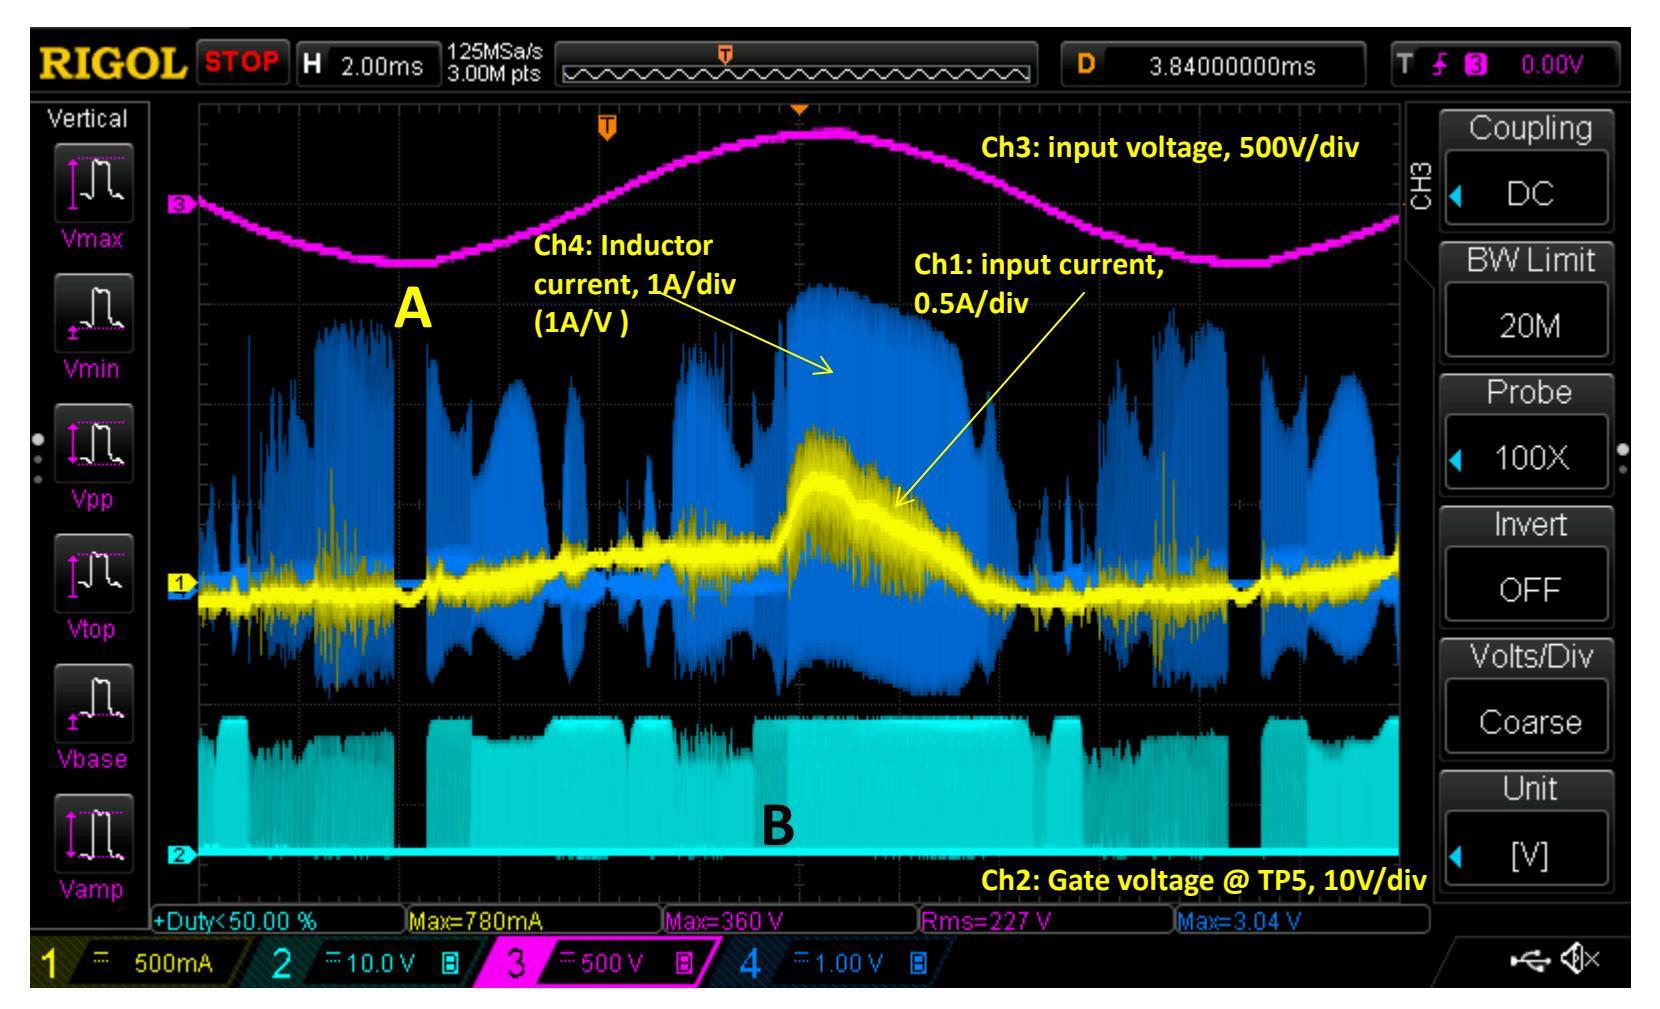
Ch1: Fluke 80i-110S, which has limited bandwidth Ch4: Tek TCPA300 w/ TCP312 Current probe

At ~230Vac input voltage and ~25W external load, distortions observed. See next slides for location A, B details

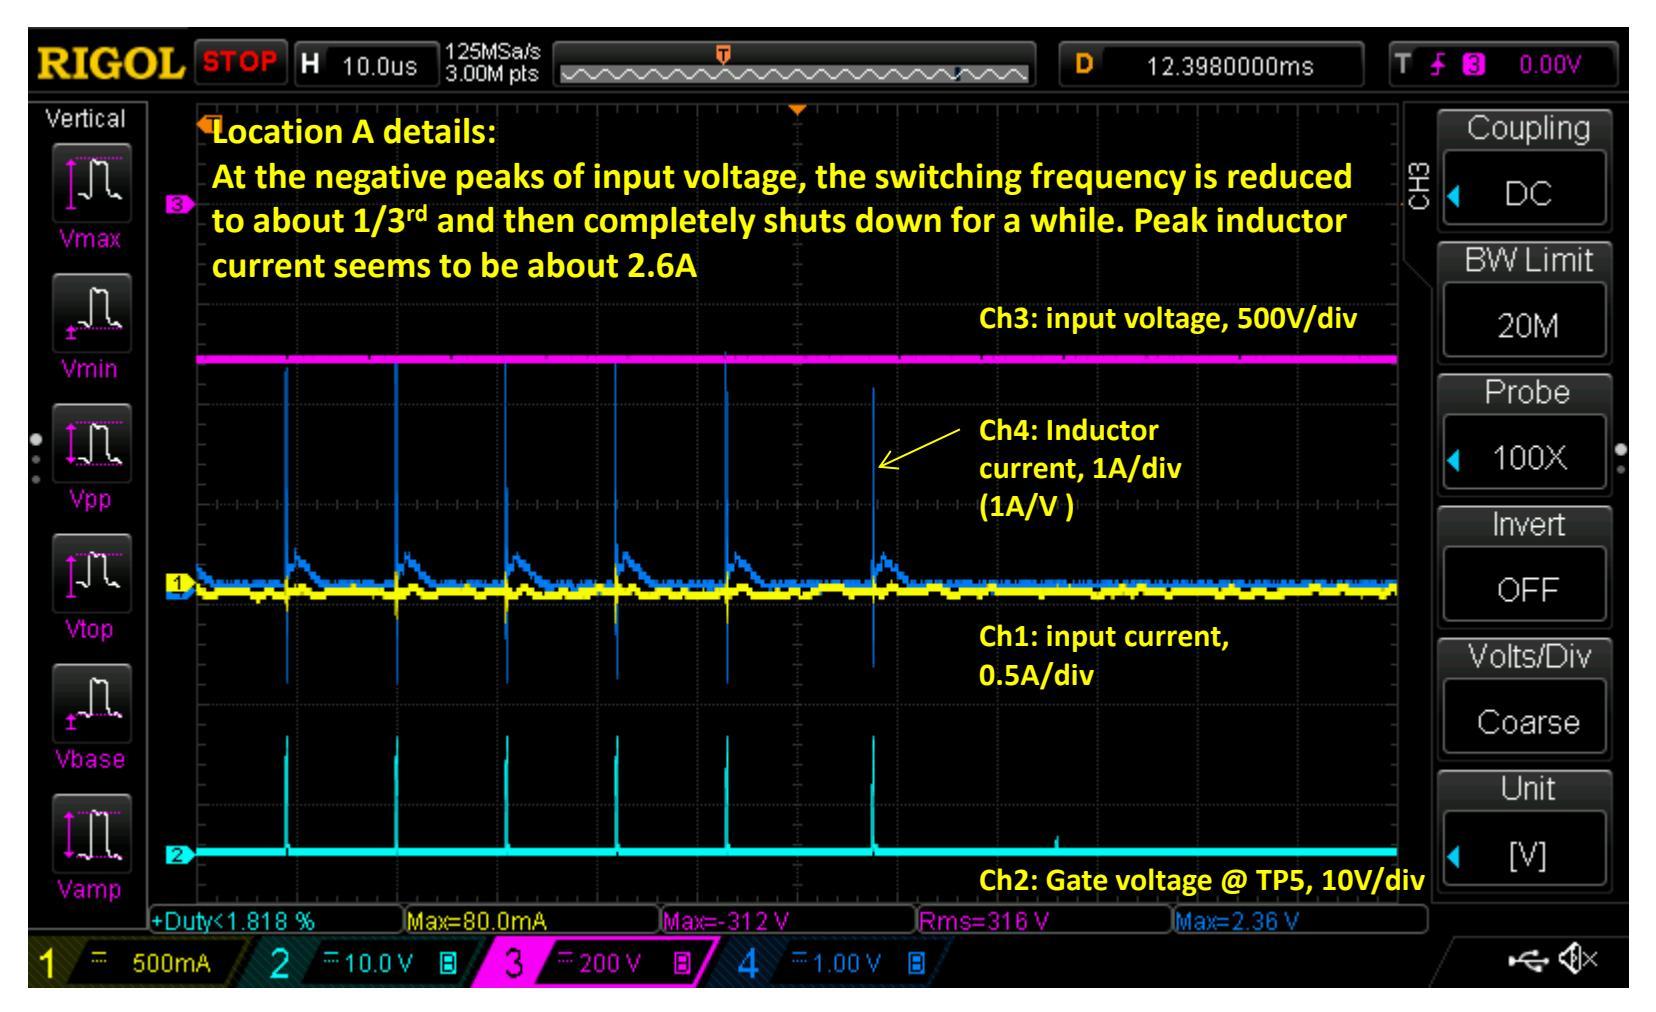
Ch1: Fluke 80i-110S, which has limited bandwidth Ch4: Tek TCPA300 w/ TCP312 Current probe

At ~230Vac input voltage and ~25W external load, distortions observed.
