UCC28513 questions, Alex W., 11/17/2022

- The boost stage design is based on UCC28513. The PFC stage works well up to 200-220Vac input. Above this voltage range there are significant distortions at the points where sinusoidal input voltage reaches to its positive and negative peaks
- Output voltage is 385Vac
- Input voltage range is 85-264Vac; 50/60Hz
- The load on DC link output is 120W max
- Boost stage switching frequency is 277kHz
- Verified that the Vcc aux supply and Vref are stable
- Observed that the AC ripple on DC link goes up at around 200Vac but not sure it this is the reason or the result
- Observed that the duty cycle is about 70% at the peak sine wave at 85Vac but drops down to ~15% at the peaks of 220Vac at which point I start get distortions on the input current.
- The provided test results are at ~30W output power. It was observed that changing the load did not affect the behavior at around 220Vac.

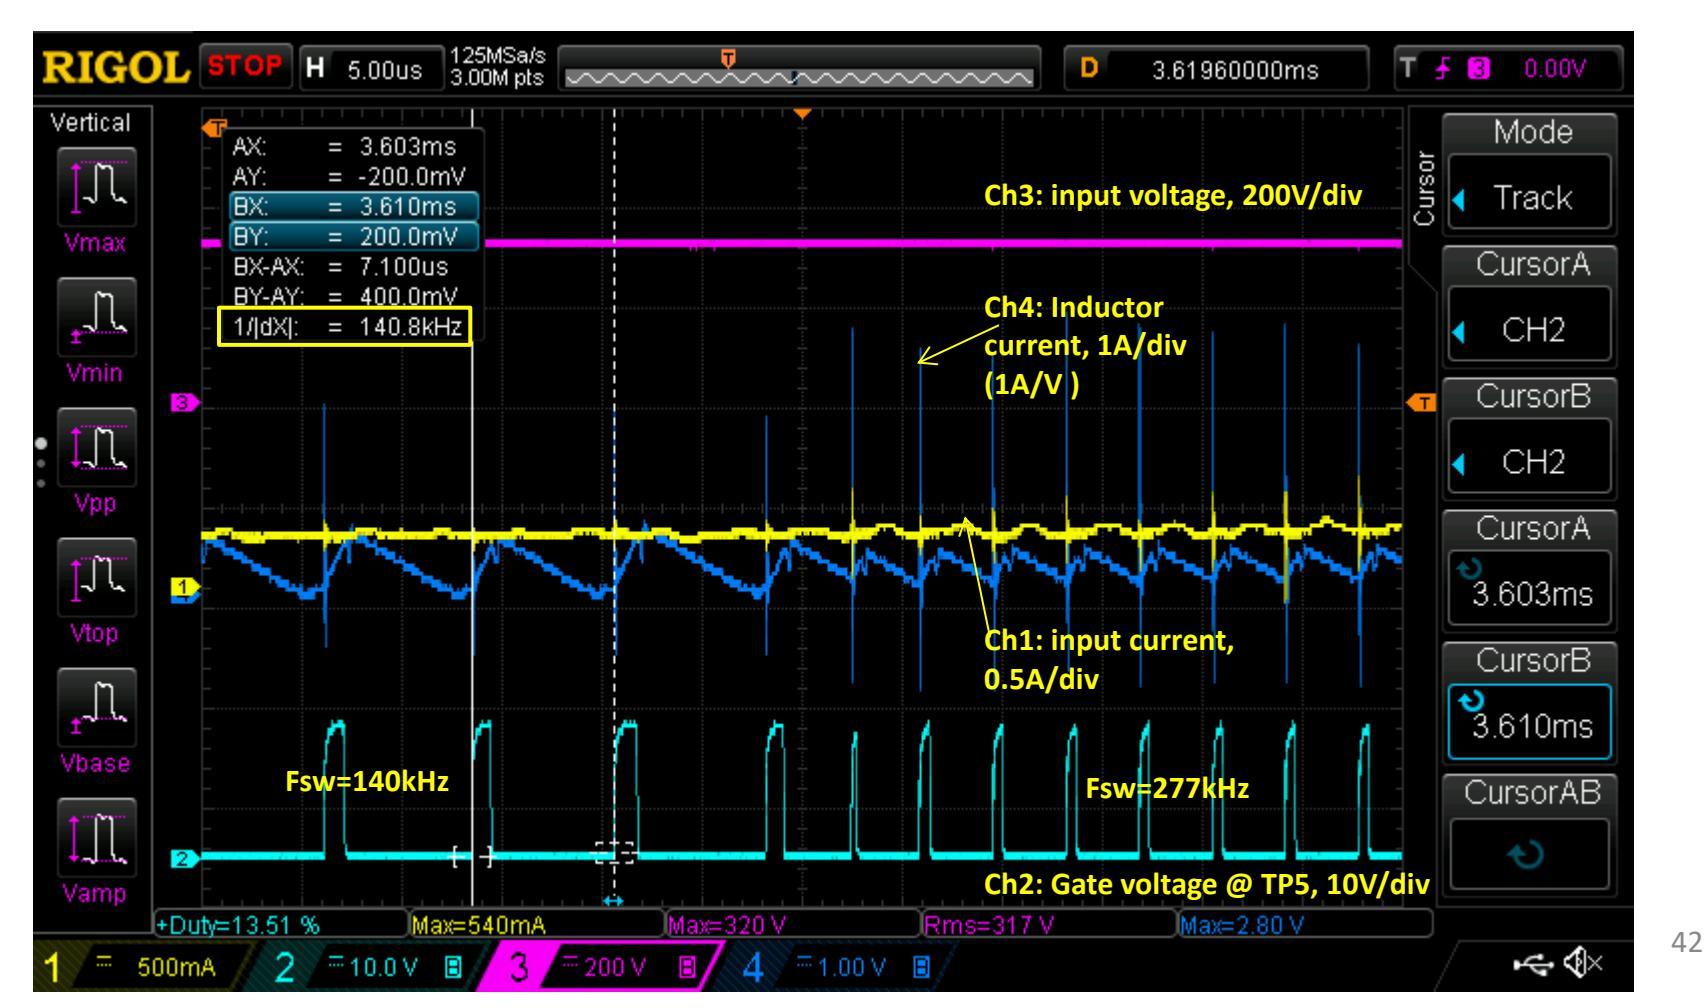
Location B details:

At the positive peaks of input voltage, the switching frequency is reduced to about ½ and this results in "flat top" on the current waveform. After that the switching frequency is raised and around that time the current surge is observed

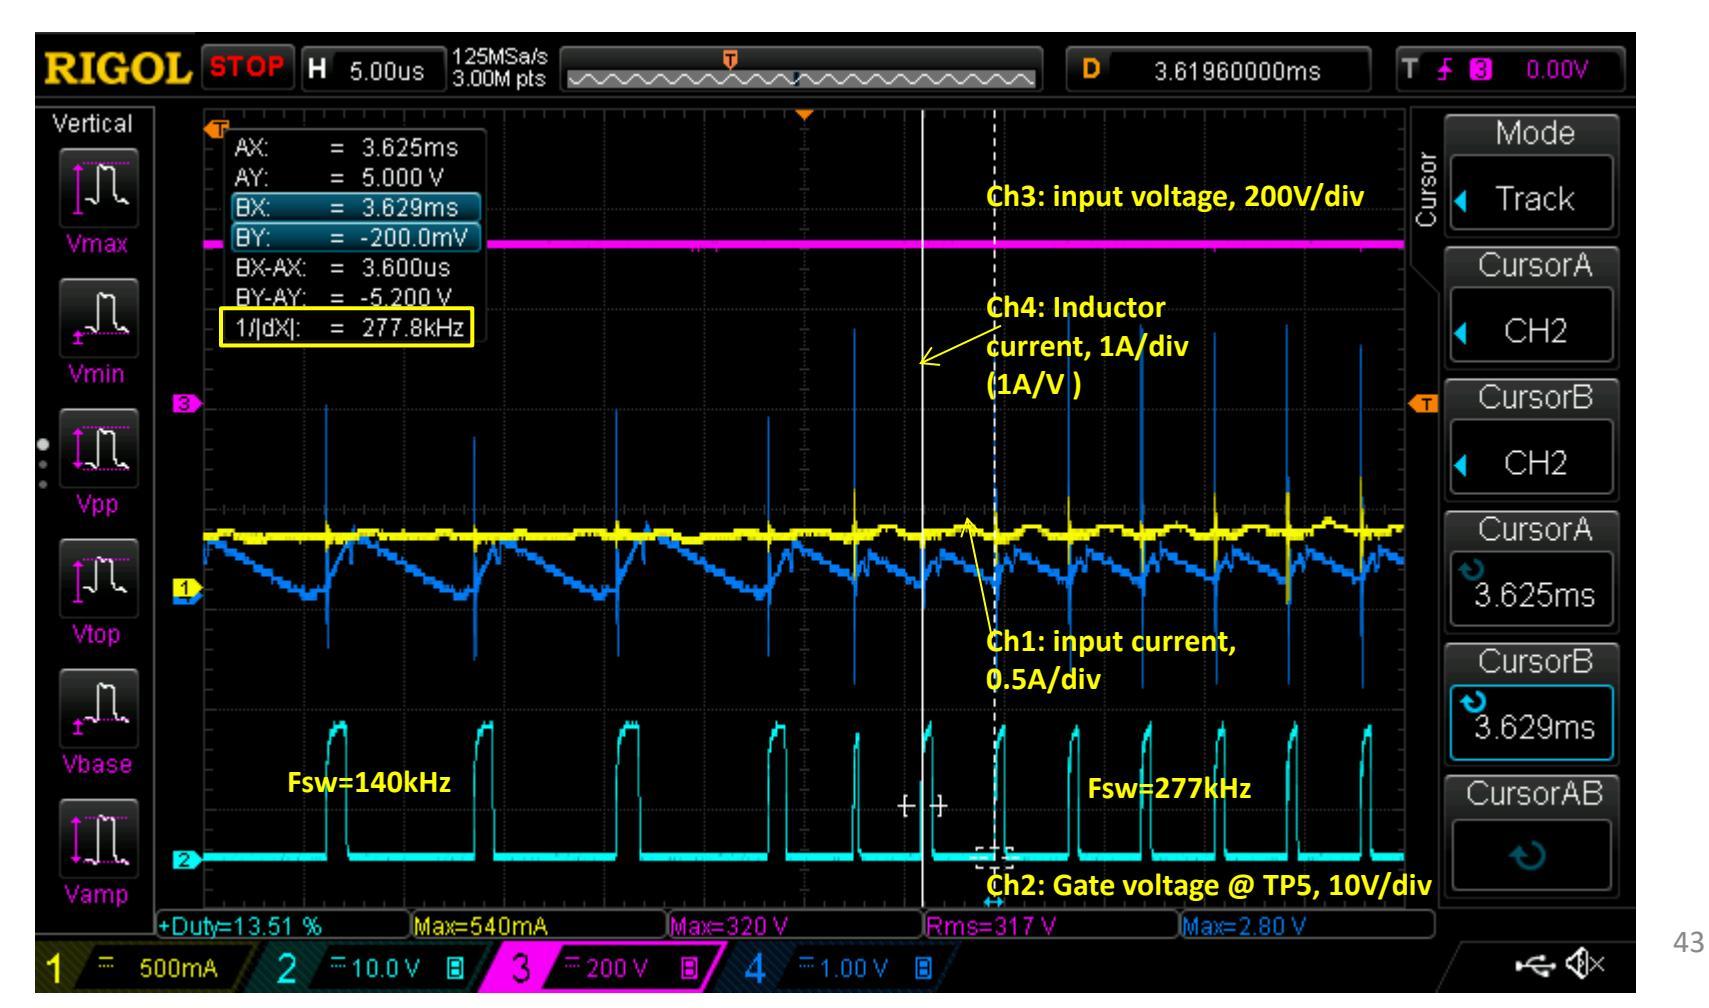
Location B details:

At the positive peaks of input voltage, the switching frequency is reduced to about ½ and this results in "flat top" on the current waveform. After that the switching frequency is raised and around that time the current surge is observed

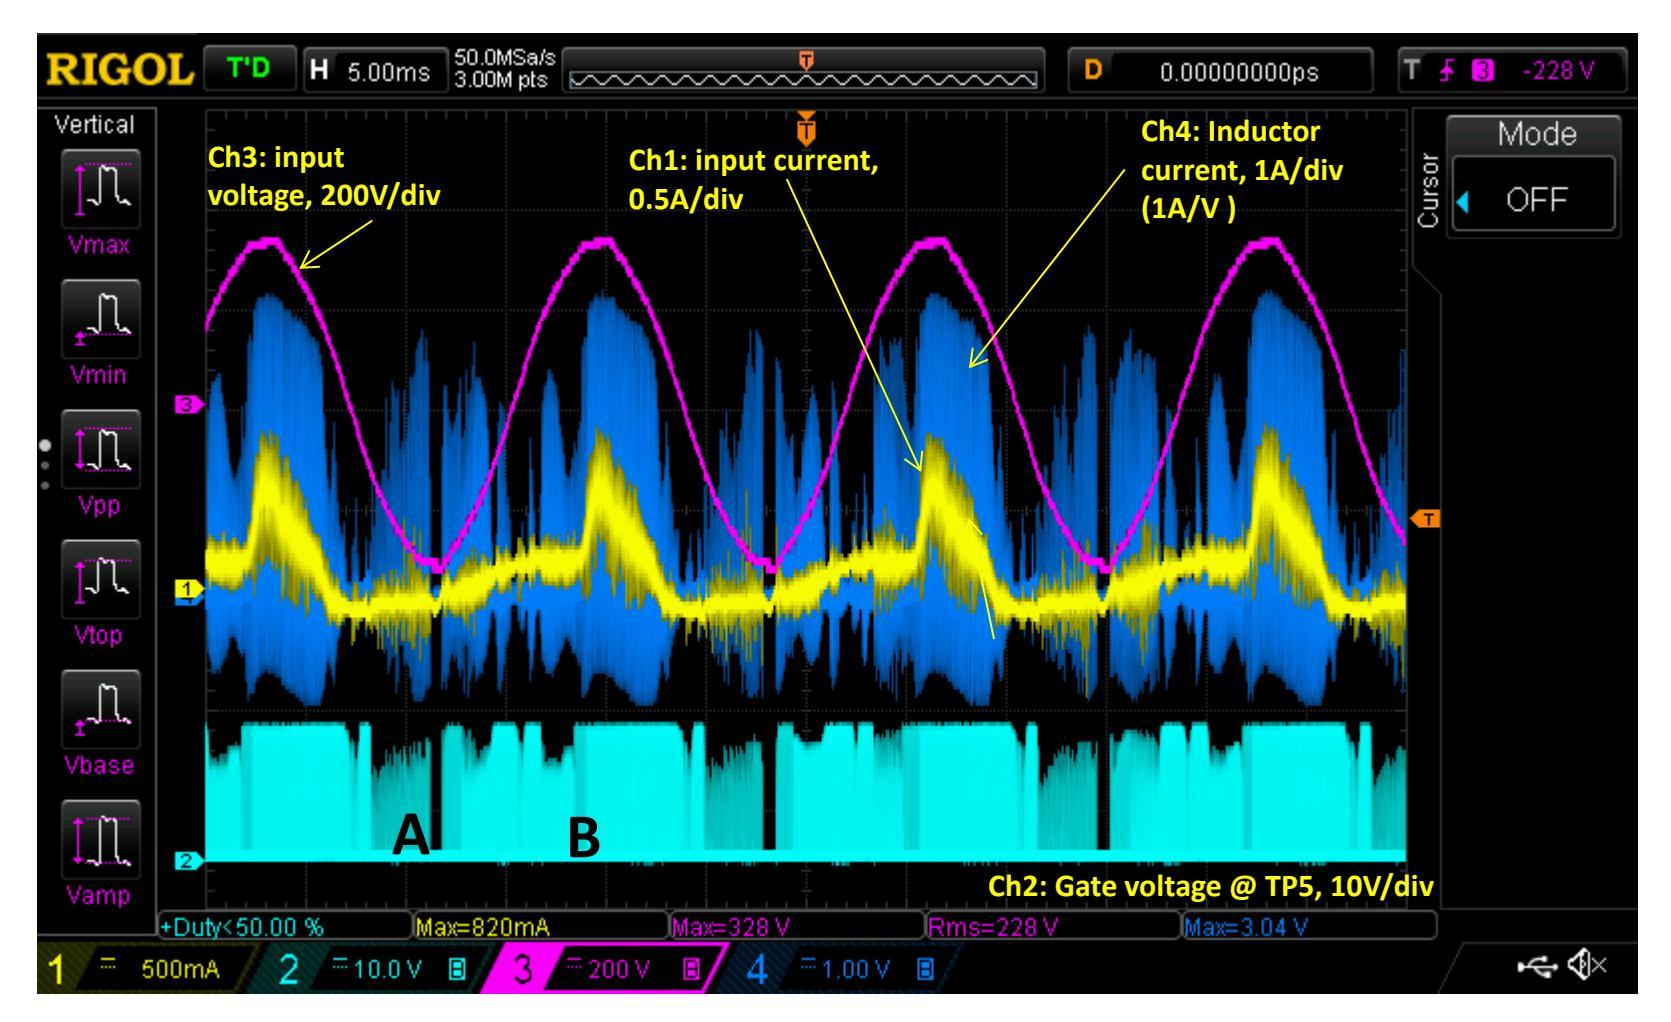
At 230Vac input, 25W external load, the view of locations A (negative peak) and location B (positive peak)

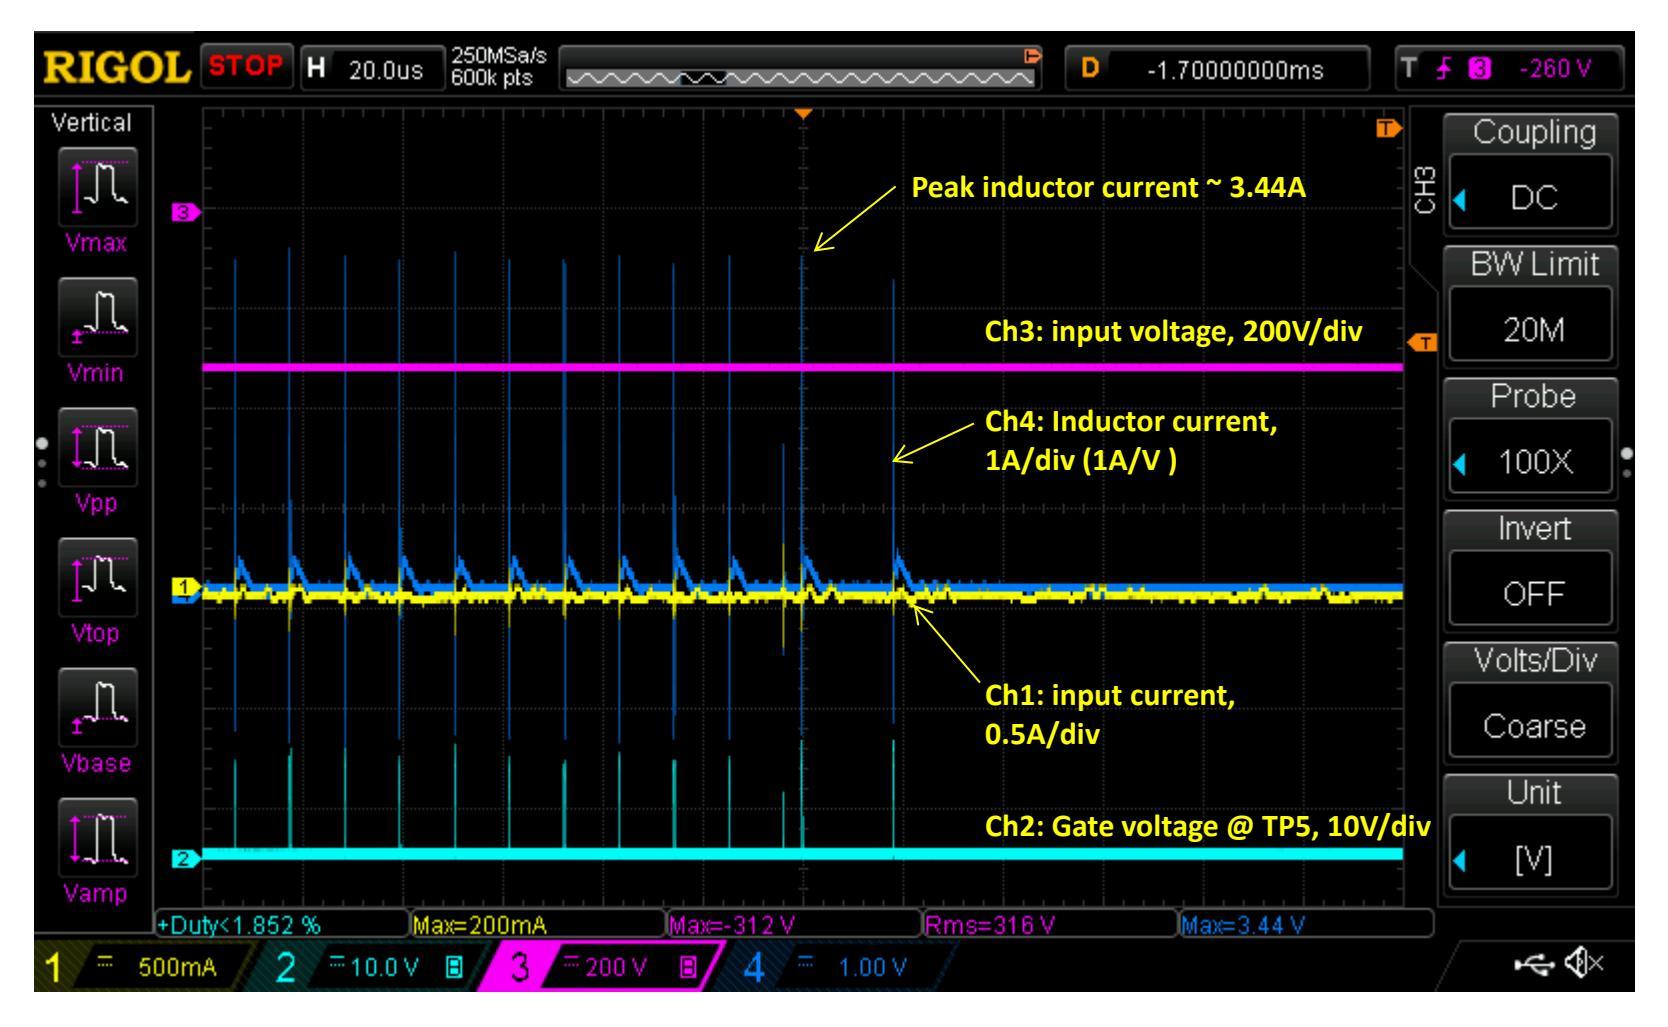
At ~230Vac input voltage and ~25W external load, distortions observed.

Location A: Current probe on Ch1 has low BW and is used to measure input current only.

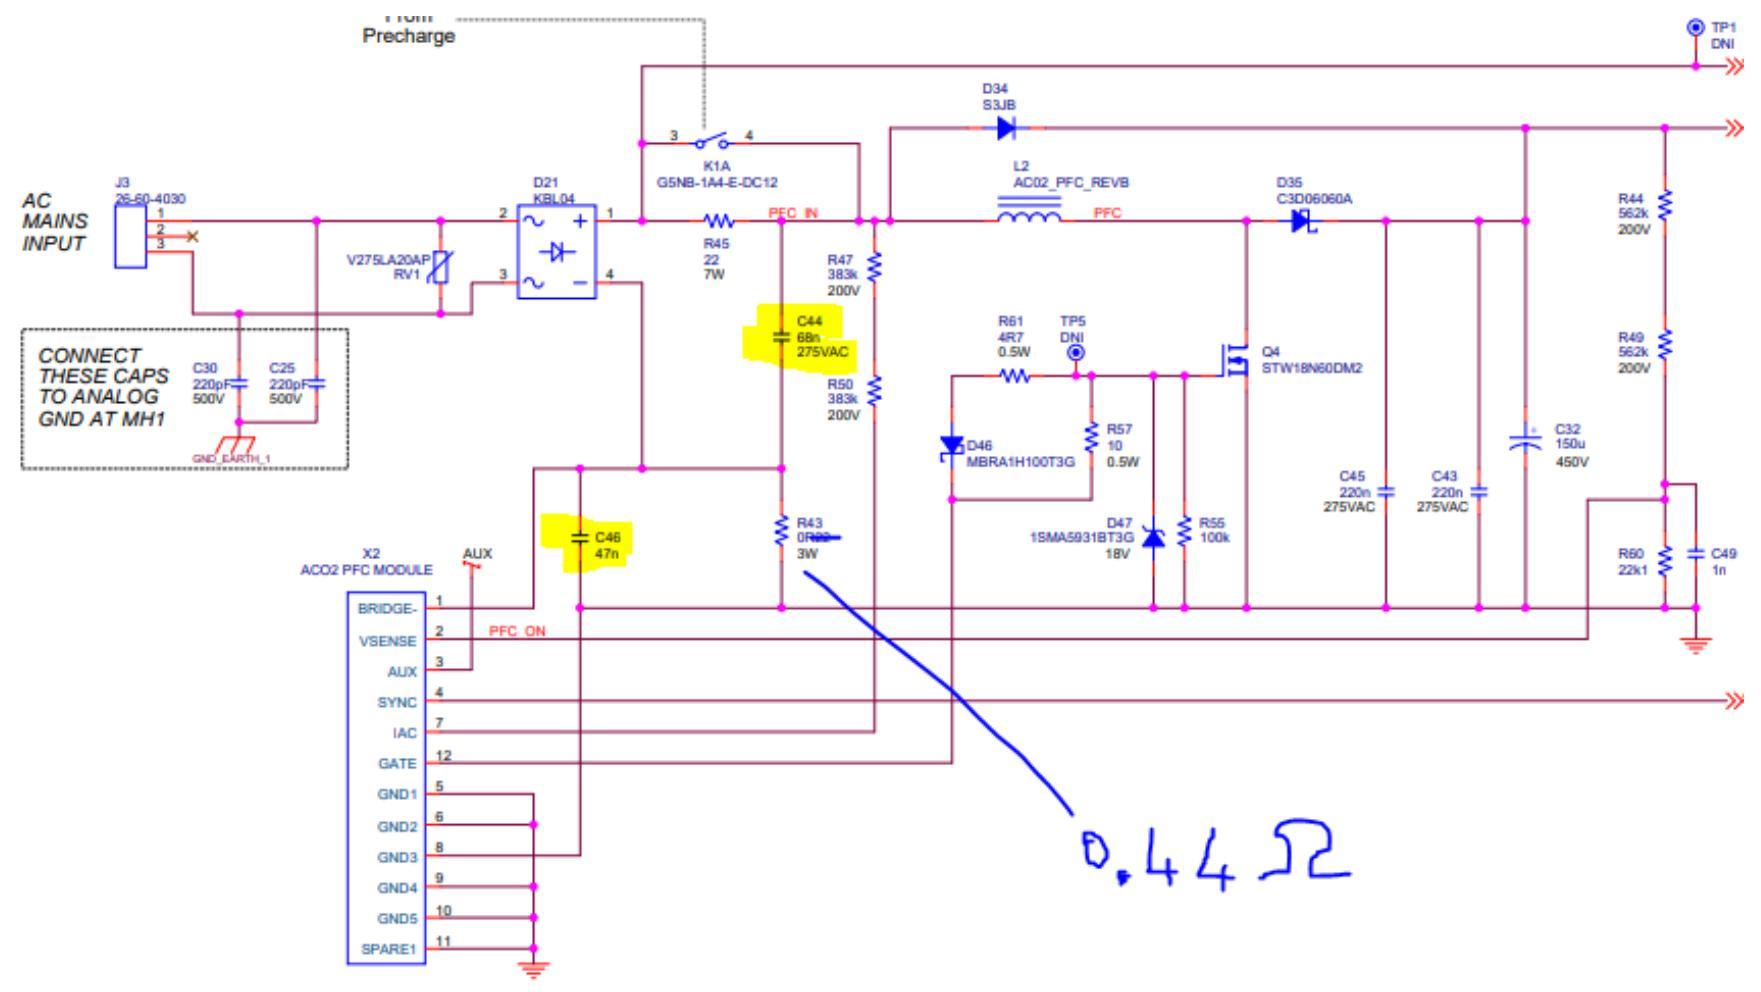
At ~230Vac input voltage and ~25W external load, distortions observed.

There is a 68nF cap after the rectifier. It is increased to 2x68=136nF, did not observe any improvements

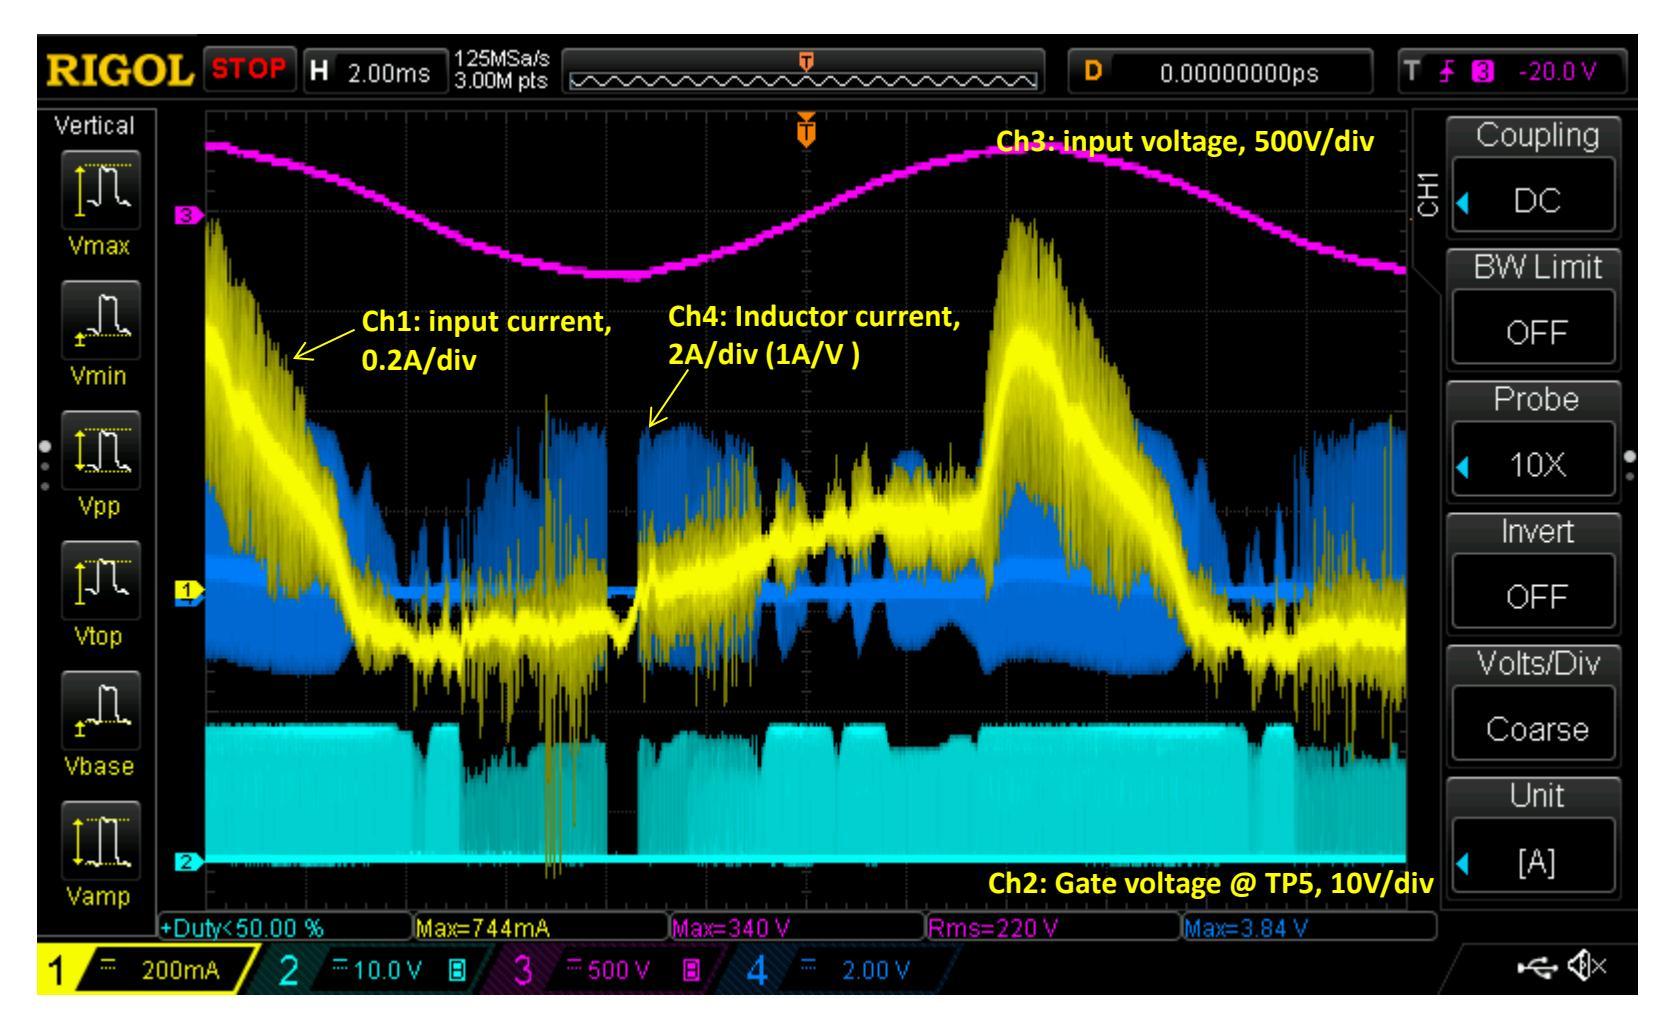
At ~230Vac input voltage and ~25W external load, distortions observed.

There is a 68nF cap after the rectifier. It is increased to 2x68=136nF, did not observe any improvements

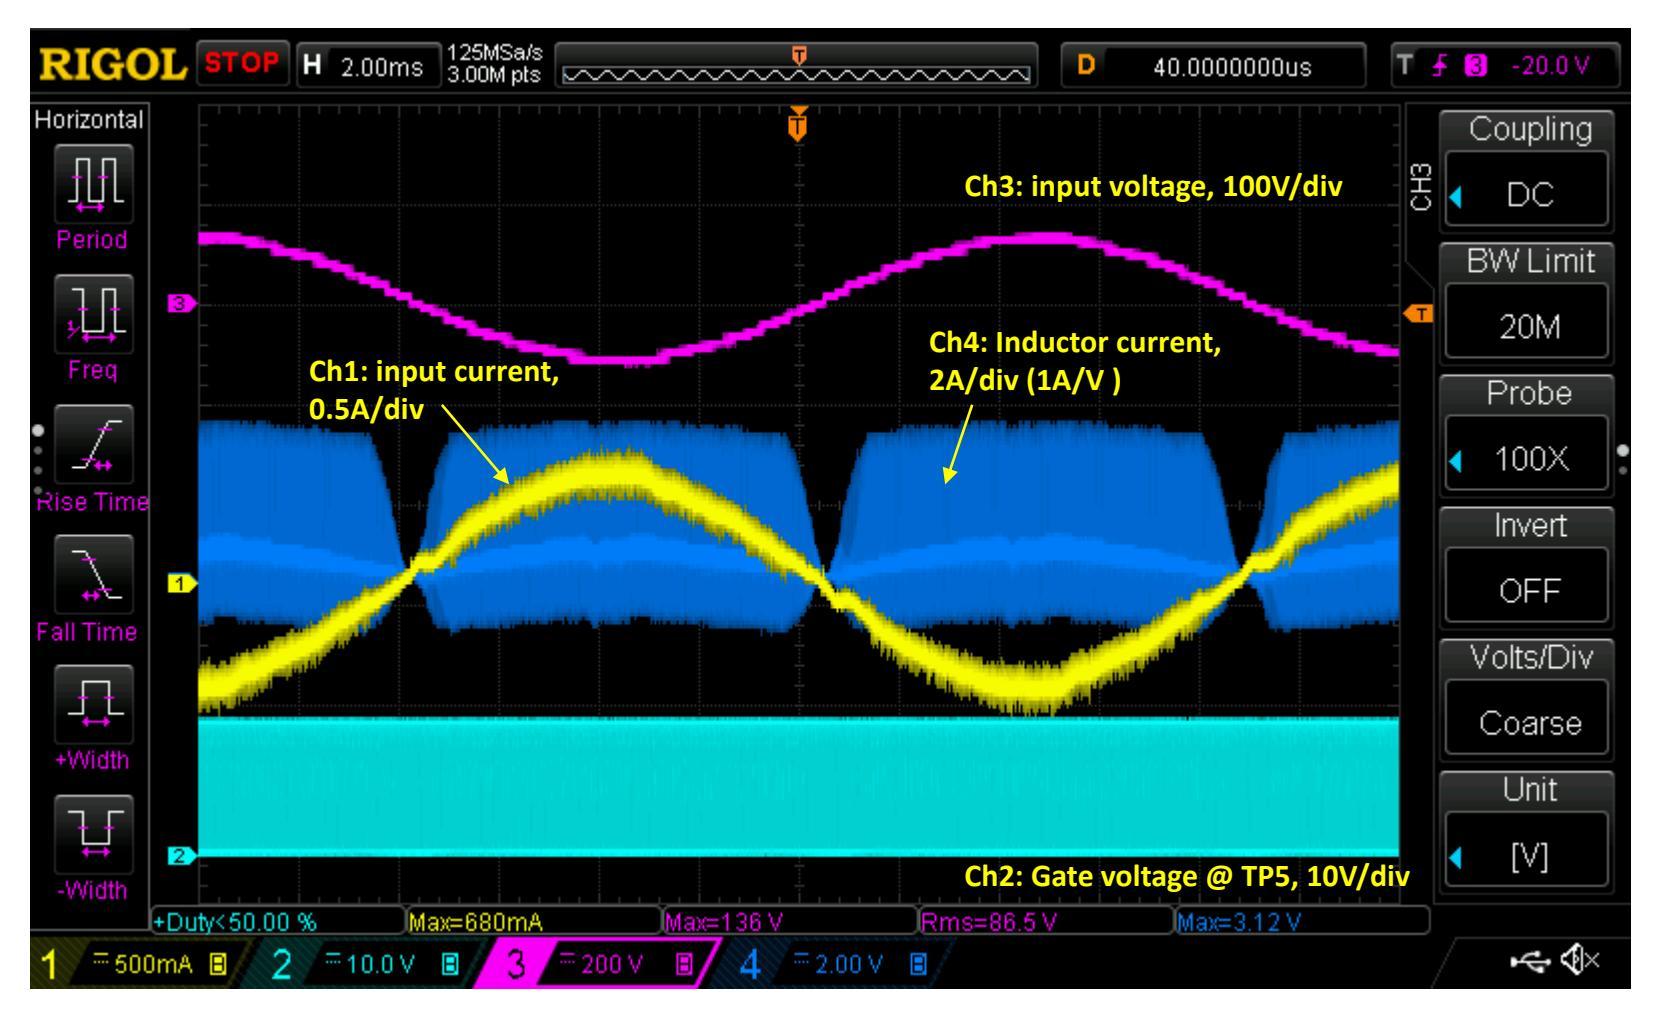
Per changes listed on page 55

At ~85Vac input voltage and ~25W external load, no major distortions observed

РСВ	RefDes on datasheet	RefDes in design	12/11/2022 Fci=44kHz, Gci=5.6	12/25/2022 Fci=11kHz, Gci=1.6
PSB- 04	R1	R47, R50	383K	383K
	R2	R43	0.44	0.44
	L1	L2	660uH	660uH
PFC- 03	R8, R12	R4, R9	2.74K	2.74К
	R13	R10	15.8K	4.7К
	C6	C6	233pF (200p//33p)	3.3n
	С7	C8	33pF	150pF
	R15	R11	30.1K	30.1K
	C8	C9	4.7uF	4.7uF
	C10	C1	1.5uF	1.5uF
	C11	C2	150nF	150nF
	R21	R1	48.7K	48.7K
	R14	R13	10K	10K
	R7	R5	1.50K (3.3K//2.74K) +100pF	1.50K (3.3K//2.74K) + 100pF
	С9	C4	1uF	1uF

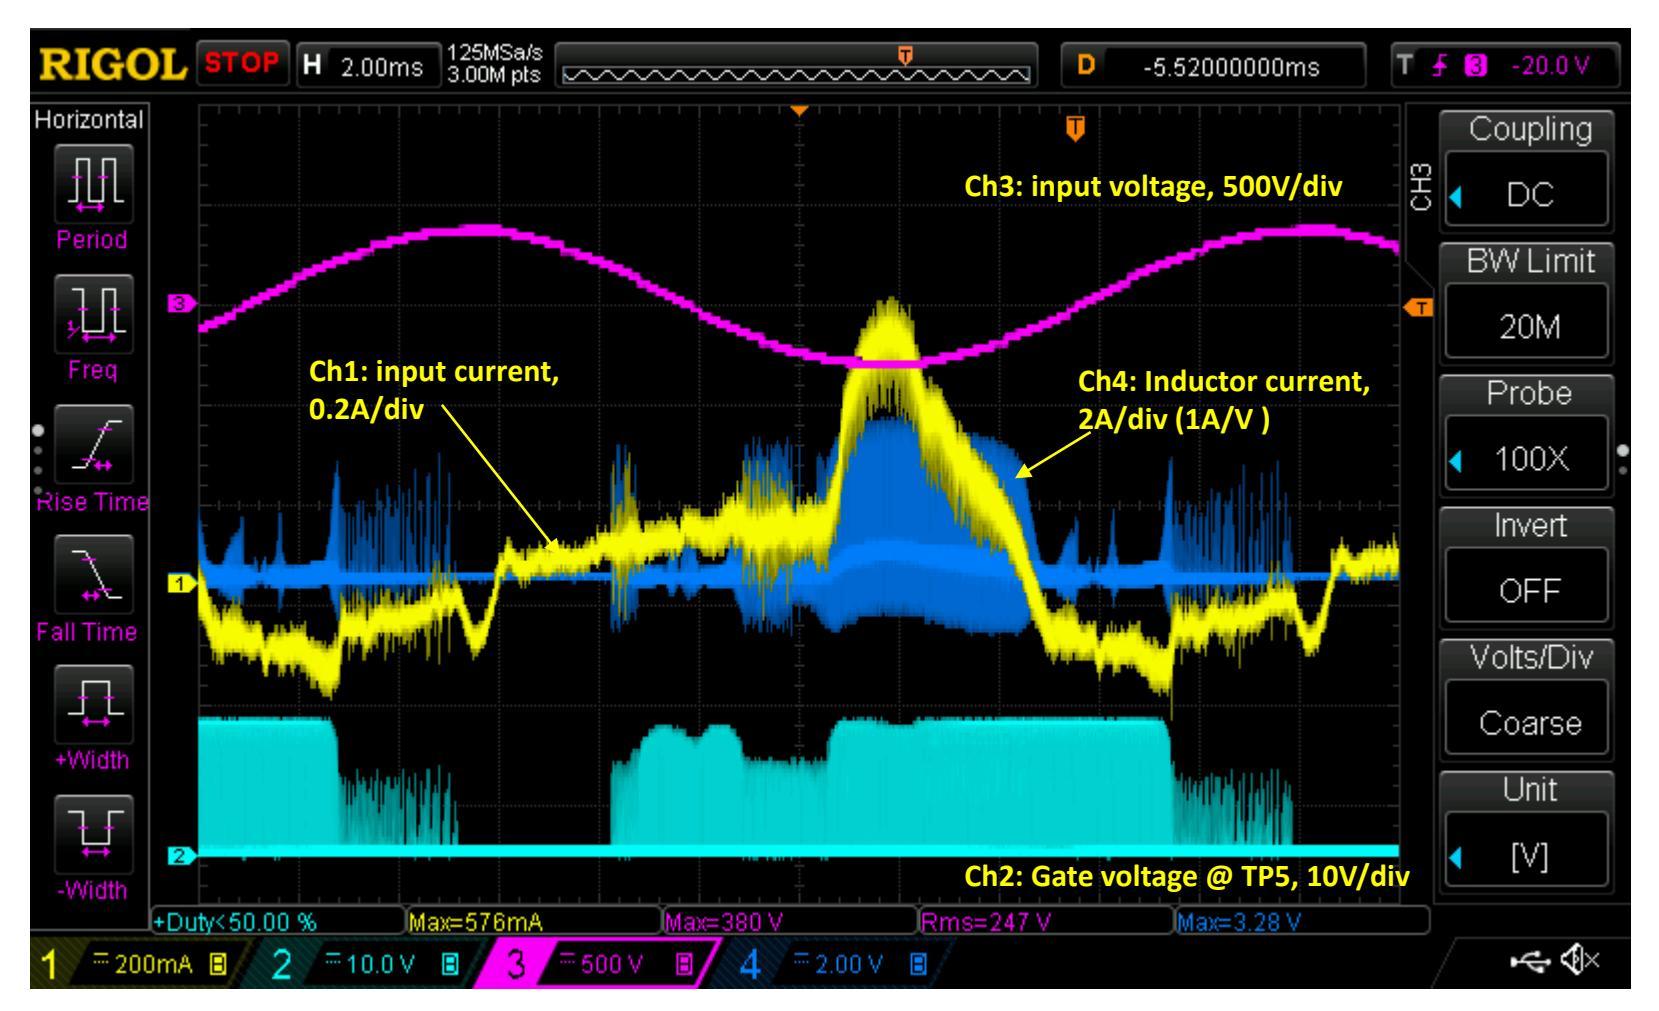
Per changes listed on page 55

At ~230Vac input voltage and ~25W external load, major distortions observed
