TAS2562HYFPR – Debug Update

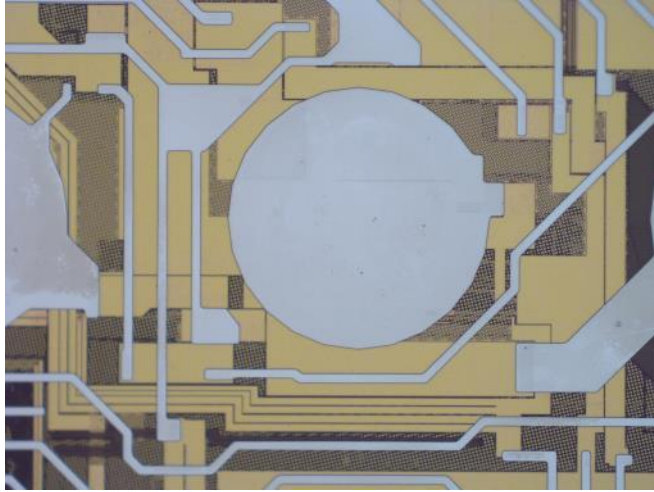
For GREG OC issue, FA performed on the Good unit and NG unit for comparison, it is confirmed no physical difference & defect, no contamination, as further evidence to support no long term reliability risk which proved by early technical explanation and bench test results

Top metal

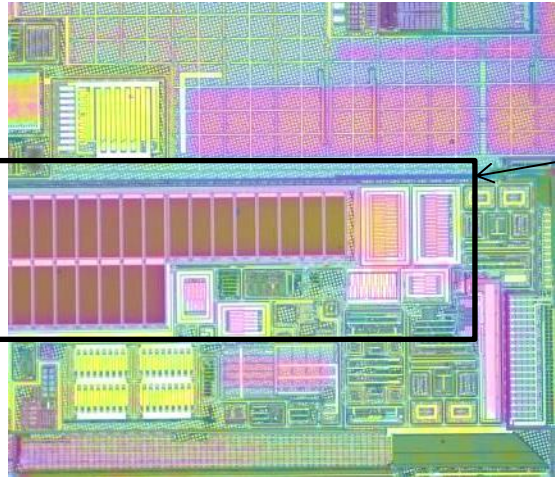
Good unit

Inner Metal layer

GREG
Circuit

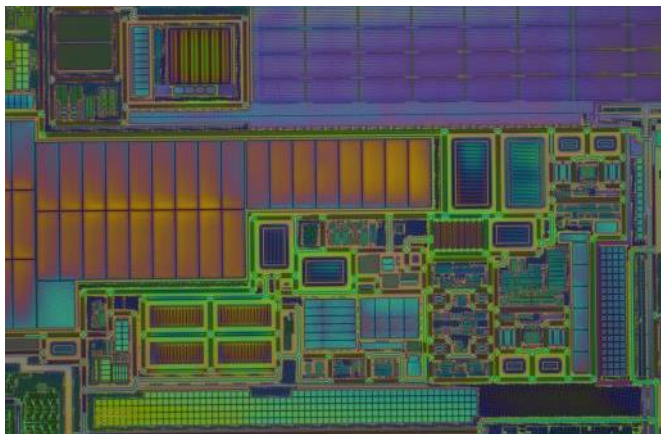
Good unit

Poly
