Scope Screen shots.

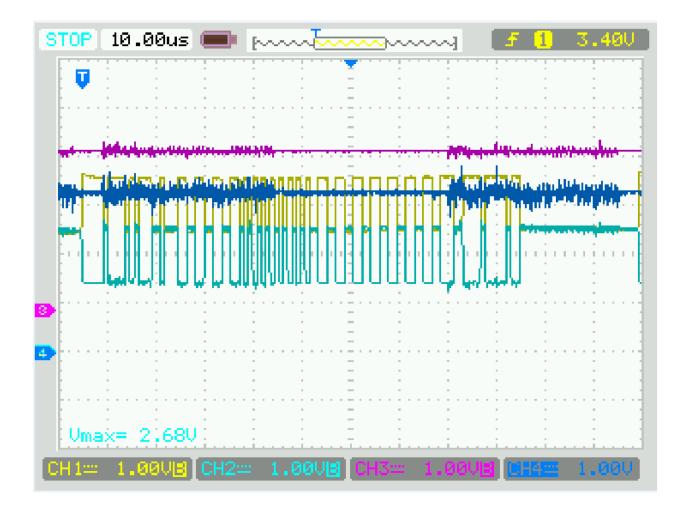
All transmission after the first 3 look like the following graph. You can see when comparing the 1^{st} graph to the 2^{nd} that the end of the transmissions look different.
