Before modification (VDD11→VDD33)

After correction (VDD33→VDD11)

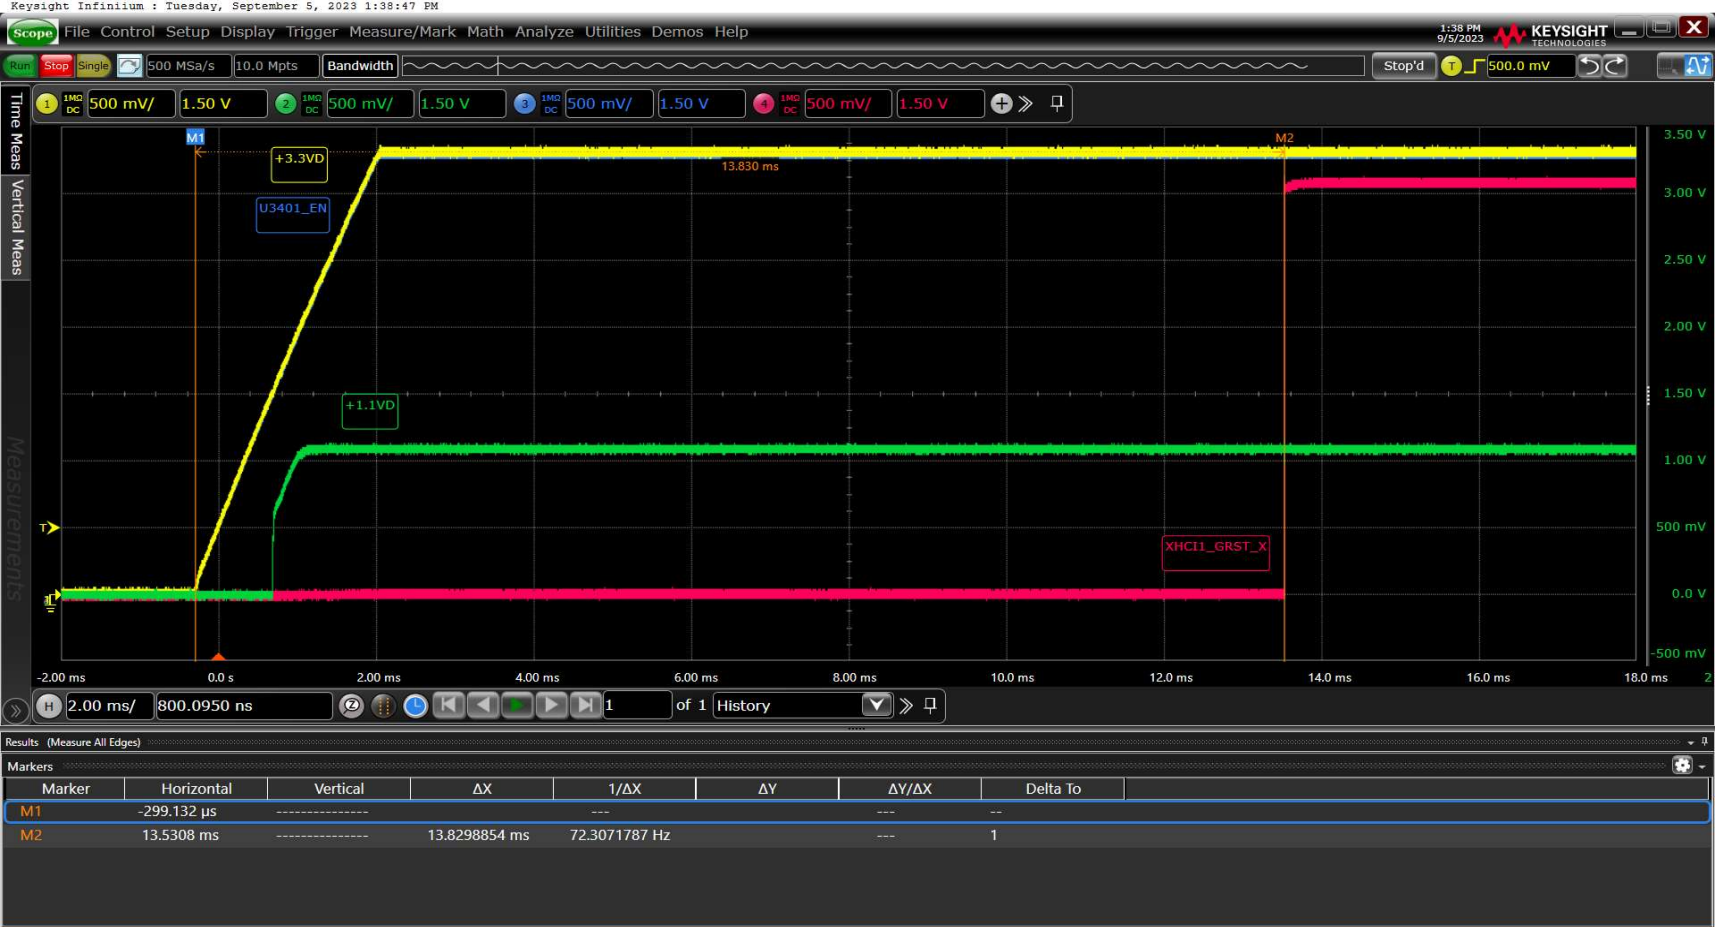
CH1 : VDD33 (+3.3VD)

Power supply input to VDD33 pin of TUSB7320.

CH2 : VDD11 (+1.1VD\_U1)

Power supply input to VDD11 pin of TUSB7320.

CH4 : XHCI1\_GRST\_X

Signal input to the GRST pin of the TUSB7320.

Regarding XHCI1\_GRST\_1, it seems that the power supply of VDD33 input to the TUSB7320 is circulating.

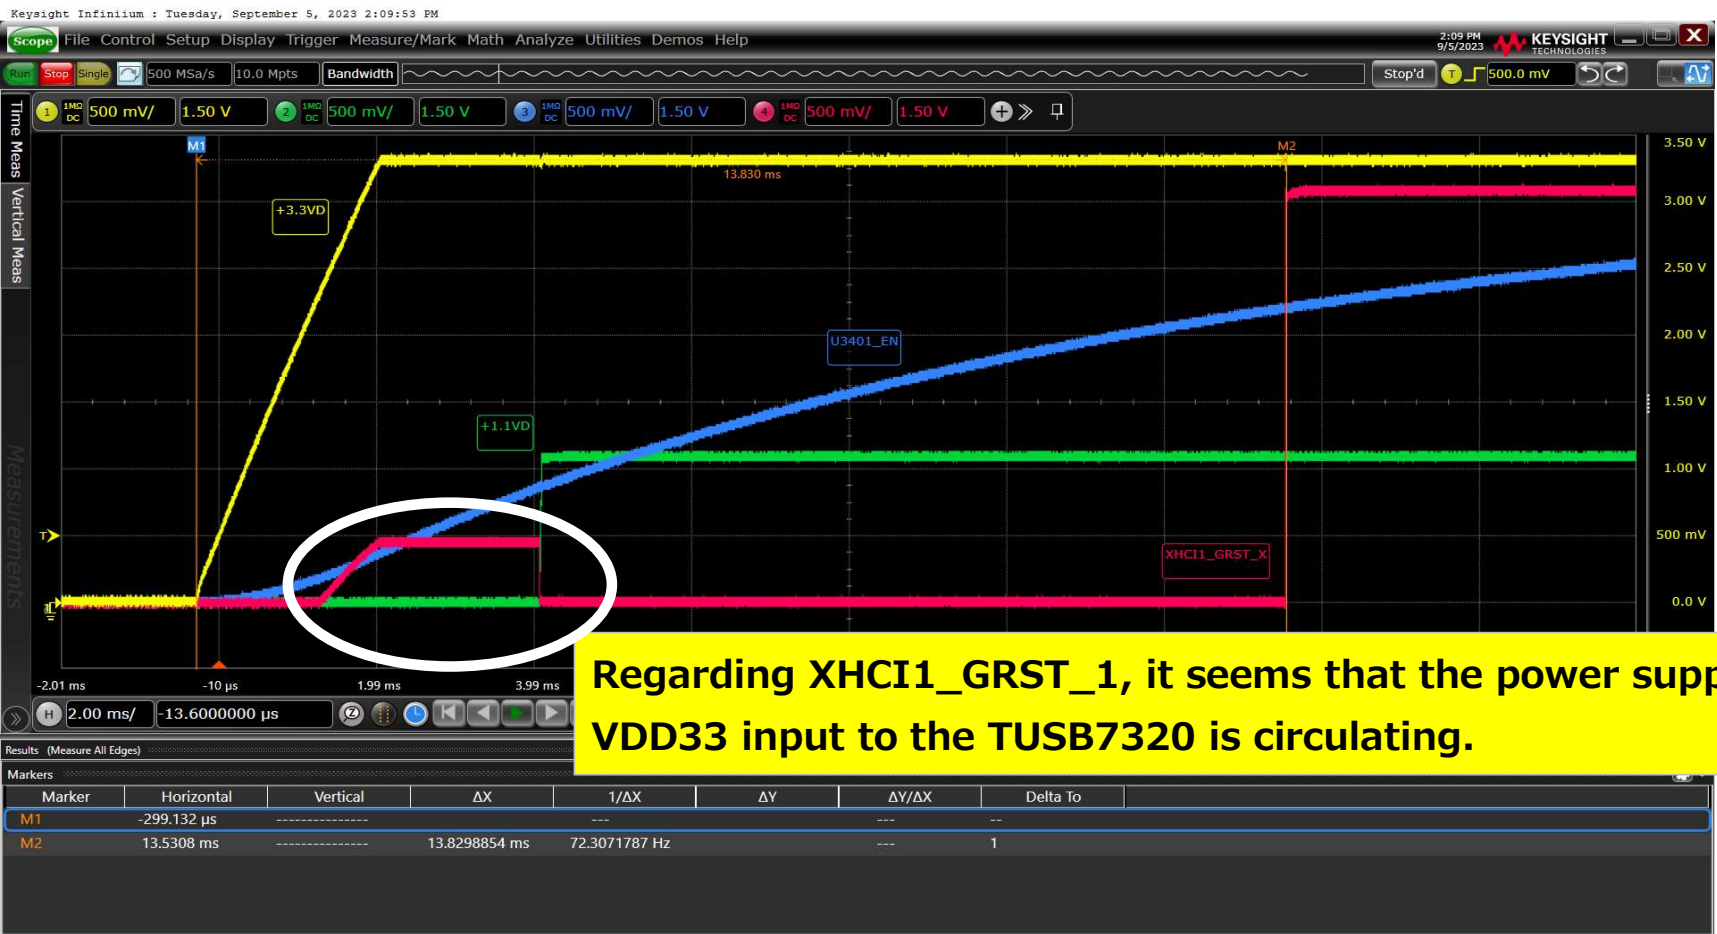
CH1 : VDD33 (+3.3VD)

Power supply input to VDD33 pin of TUSB7320.

CH2 : VDD11 (+1.1VD\_U1)

Power supply input to VDD11 pin of TUSB7320.

CH4 : XHCI1\_GRST\_X

Signal input to the GRST pin of the TUSB7320.
