Waveform of TPS2552

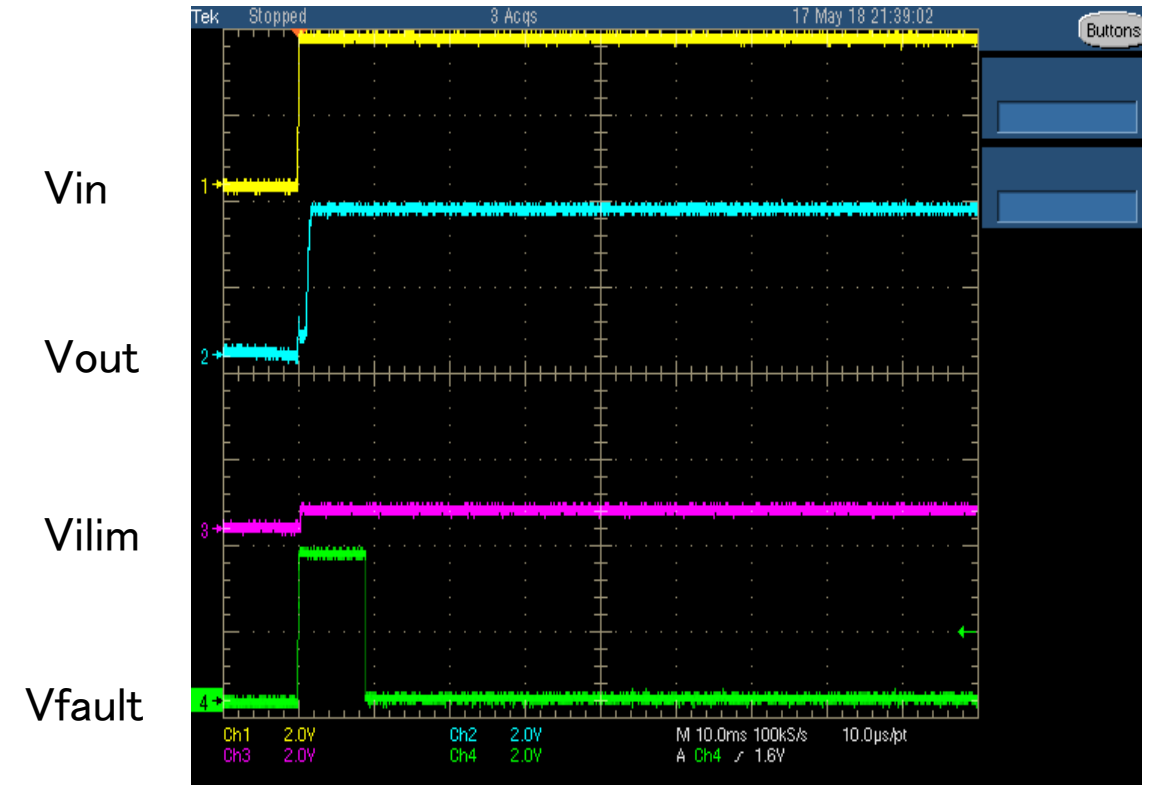
In the problem IC, V_{fault} pin falls to L.

I do not know the cause.

Even if it is verified with TPS2552DRV1EVM - 364, it also becomes the waveform of the problem.

As a result of verification with ATE, it becomes a good product.
