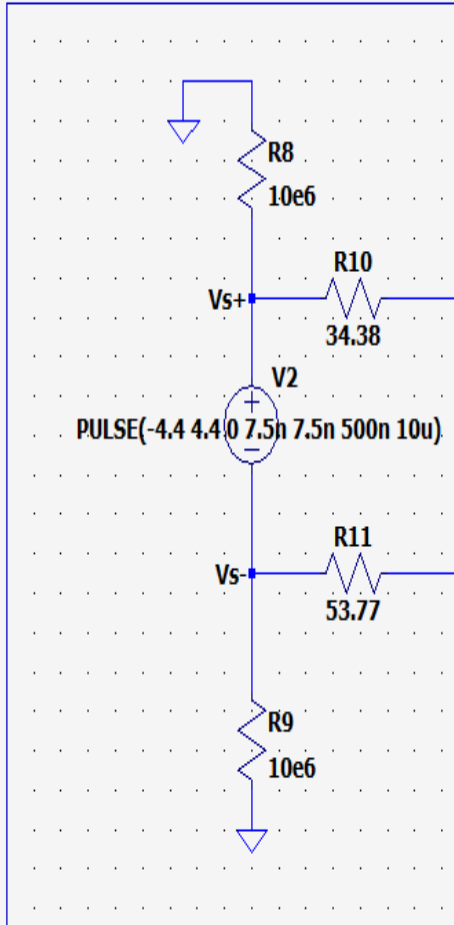
Configuration - 2

Transmitter

Removed

.tran 0 200e-6 0 0.5e-9

U2
CDSOT23-SM712

Td=50n Z0=120

V1
5
R2
556
VR+
R1
135
VR-
R3
556

Receiver

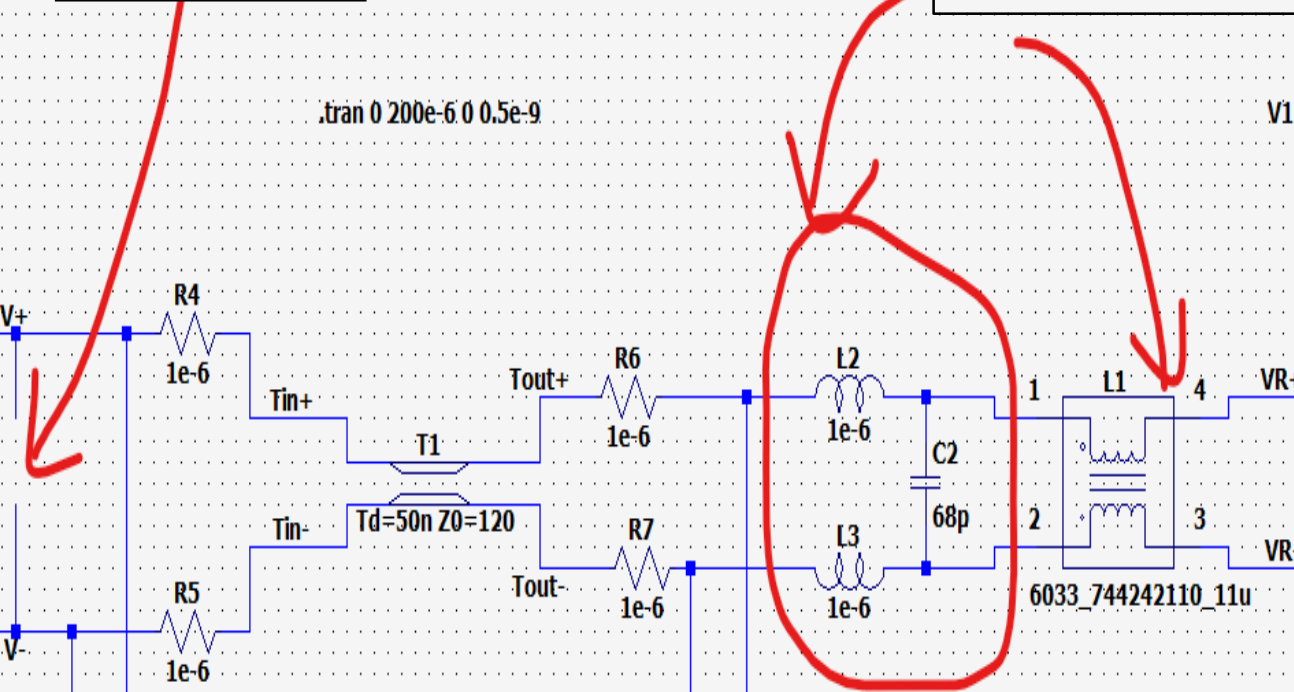
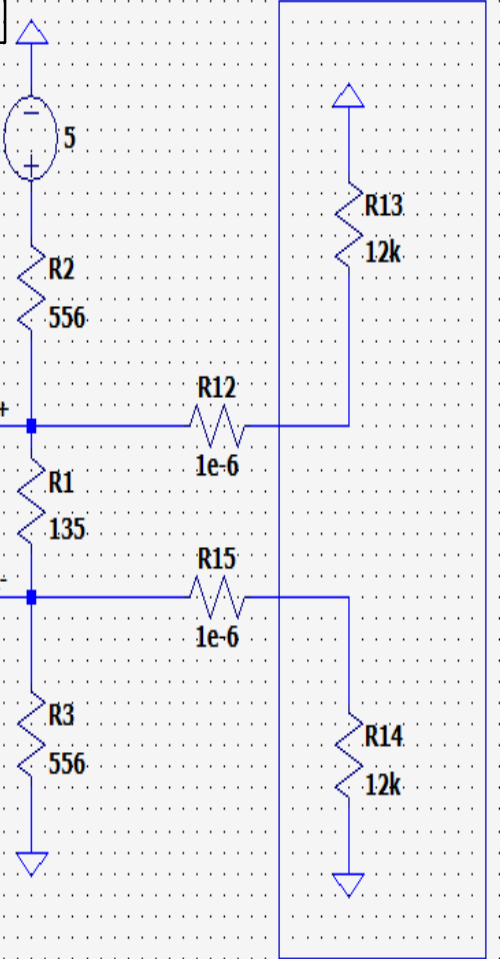
Configuration - 7

Transmitter

Removed

Position Interchanged Compared to Configuration-1

Receiver
