# SN74LV123A circuit 1ch

# SN74LV123A circuit 2ch

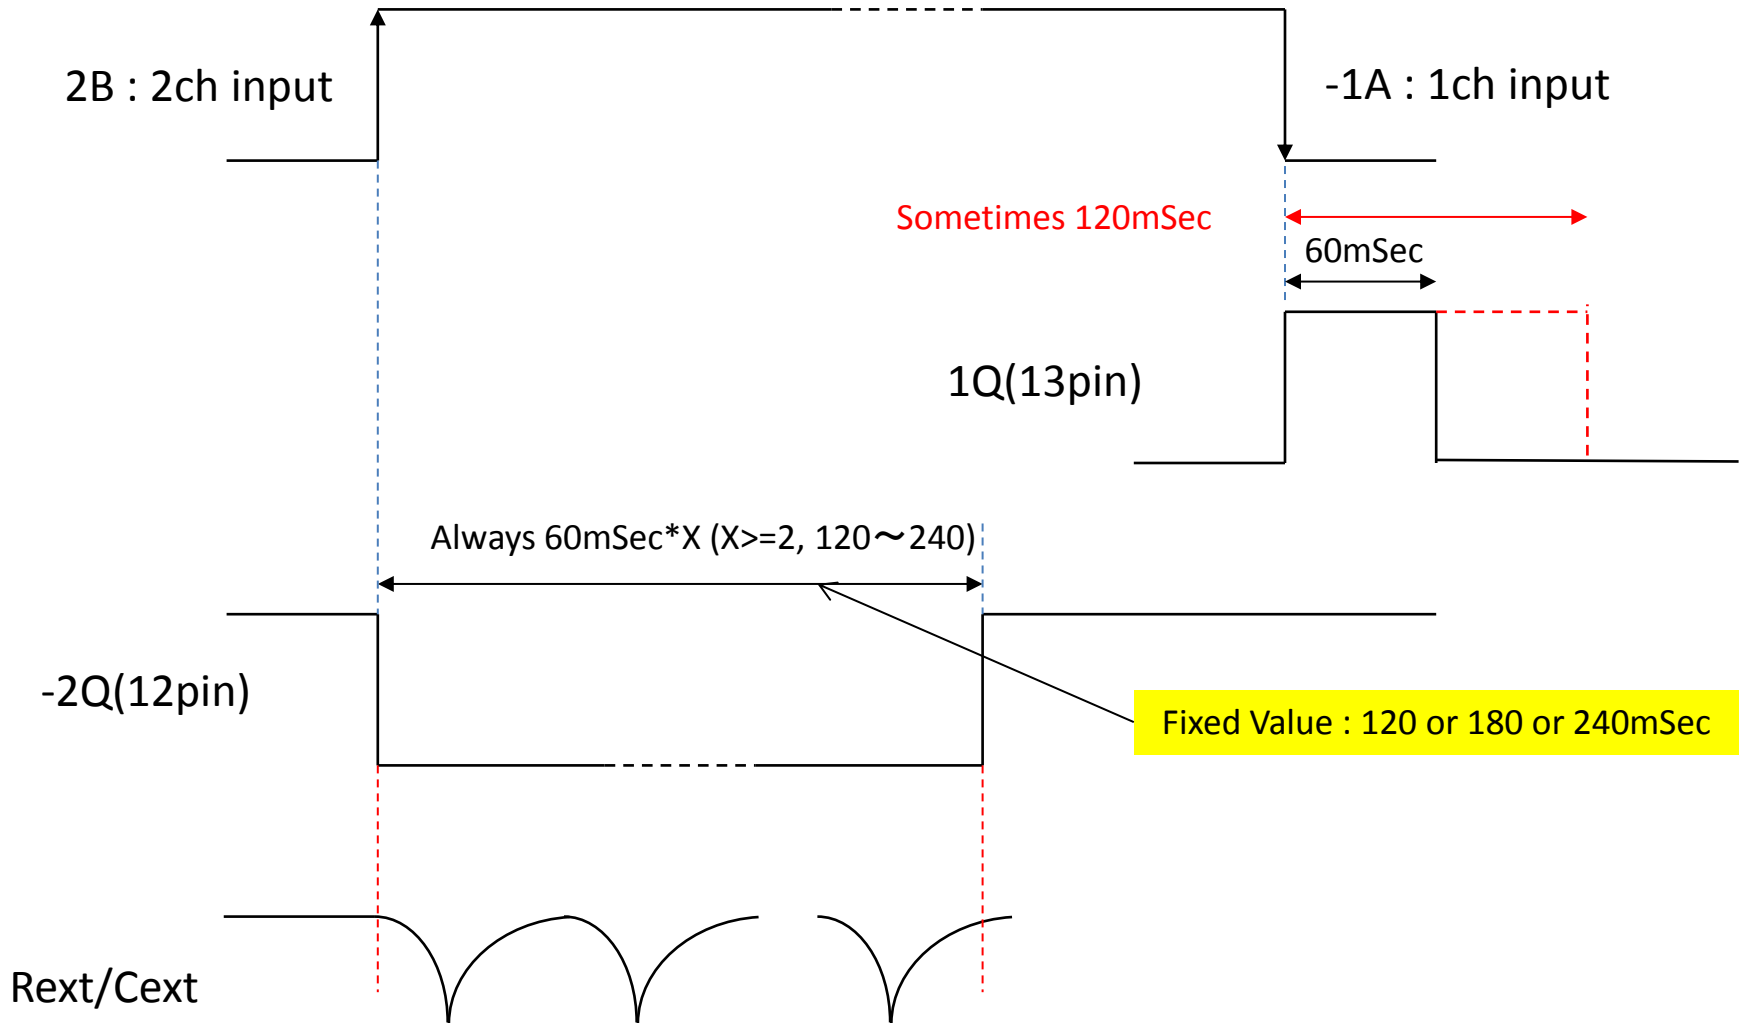
# In case of Pulse width 60mSec ( $R_t = 620K$ , $C_t = 0.1\mu\text{Sec}$ )

Irregular behavior happened

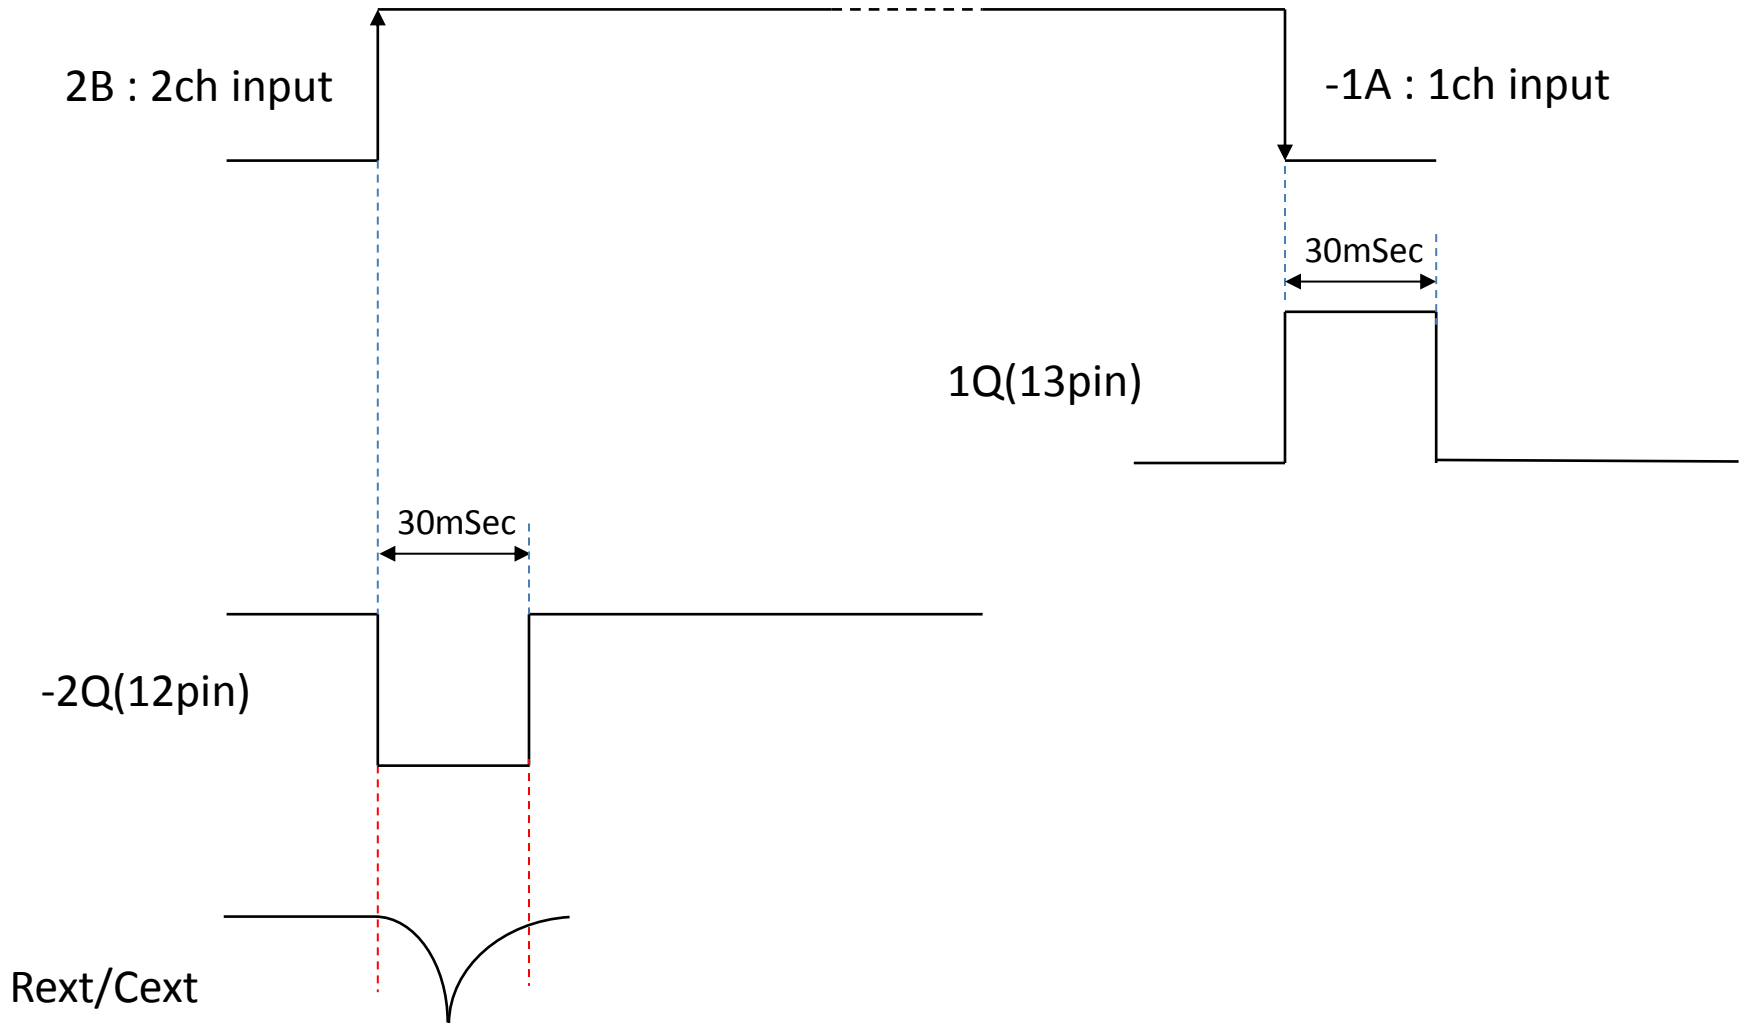
# In case of Pulse width 30mSec ( $R_t = 310K$ , $C_t = 0.1\mu\text{Sec}$ )

Normal behavior happened
