# ◆ LM5180: About correct measurement point at switching current

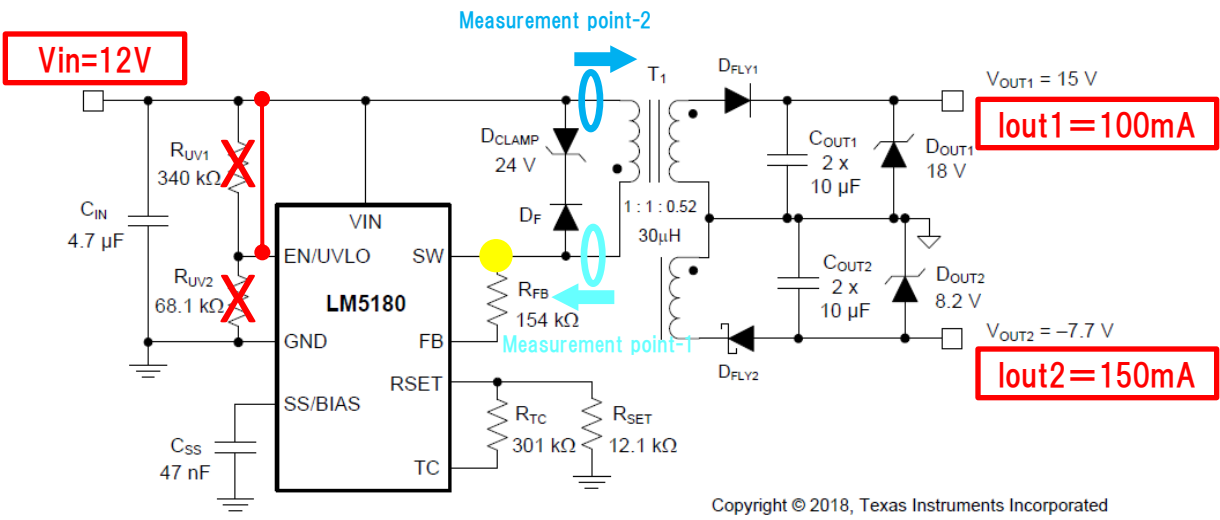
Measurement point-2: Lift this terminal of the transformer, connect the lead wire, and measure the current with a current probe

Measurement point-1: Lift this terminal of the transformer, connect the lead wire, and measure the current with a current probe

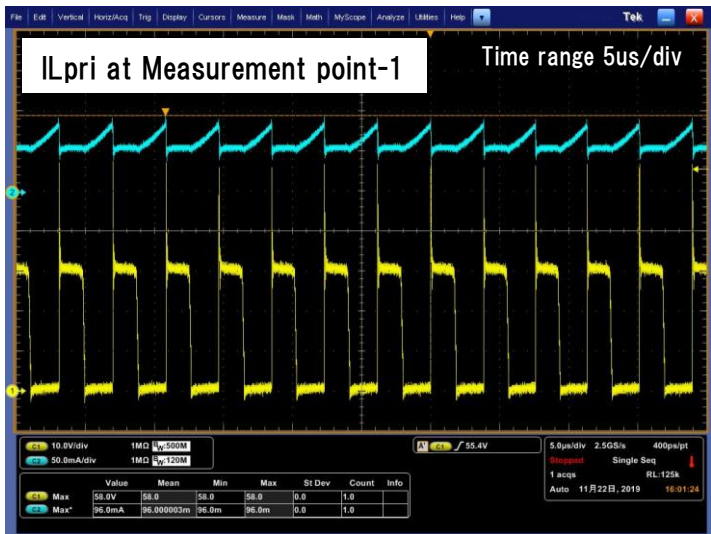
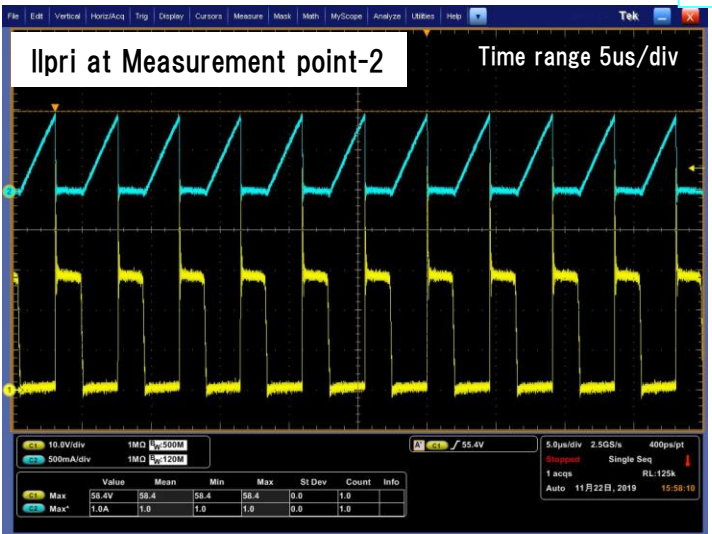
Even when the current waveform on the primary side is confirmed at measurement points 1 and 2 in the target condition of evm, the waveforms are different from each other.the different current waveforms were confirmed.

Why is the cause of the different current?(The waveform seems to be correct switching current waveform at primary side of transformer.)
