Customer circuit

Customer charging profile with thermal regulation image

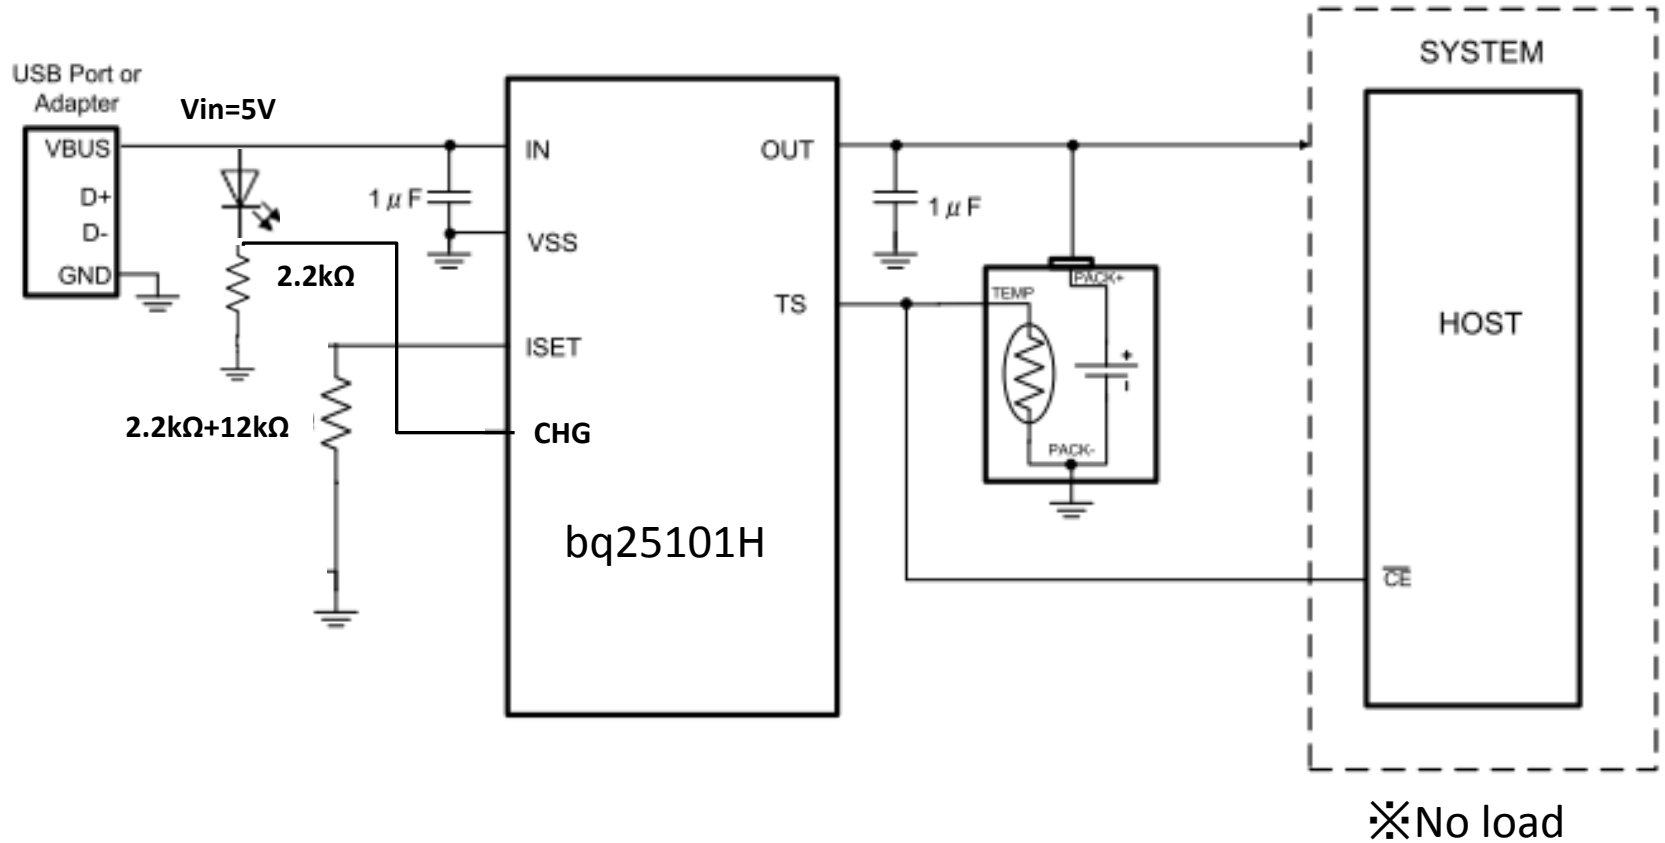
※1 Does not occur this issue by bq25101 in same circuit.(bq25101H only)

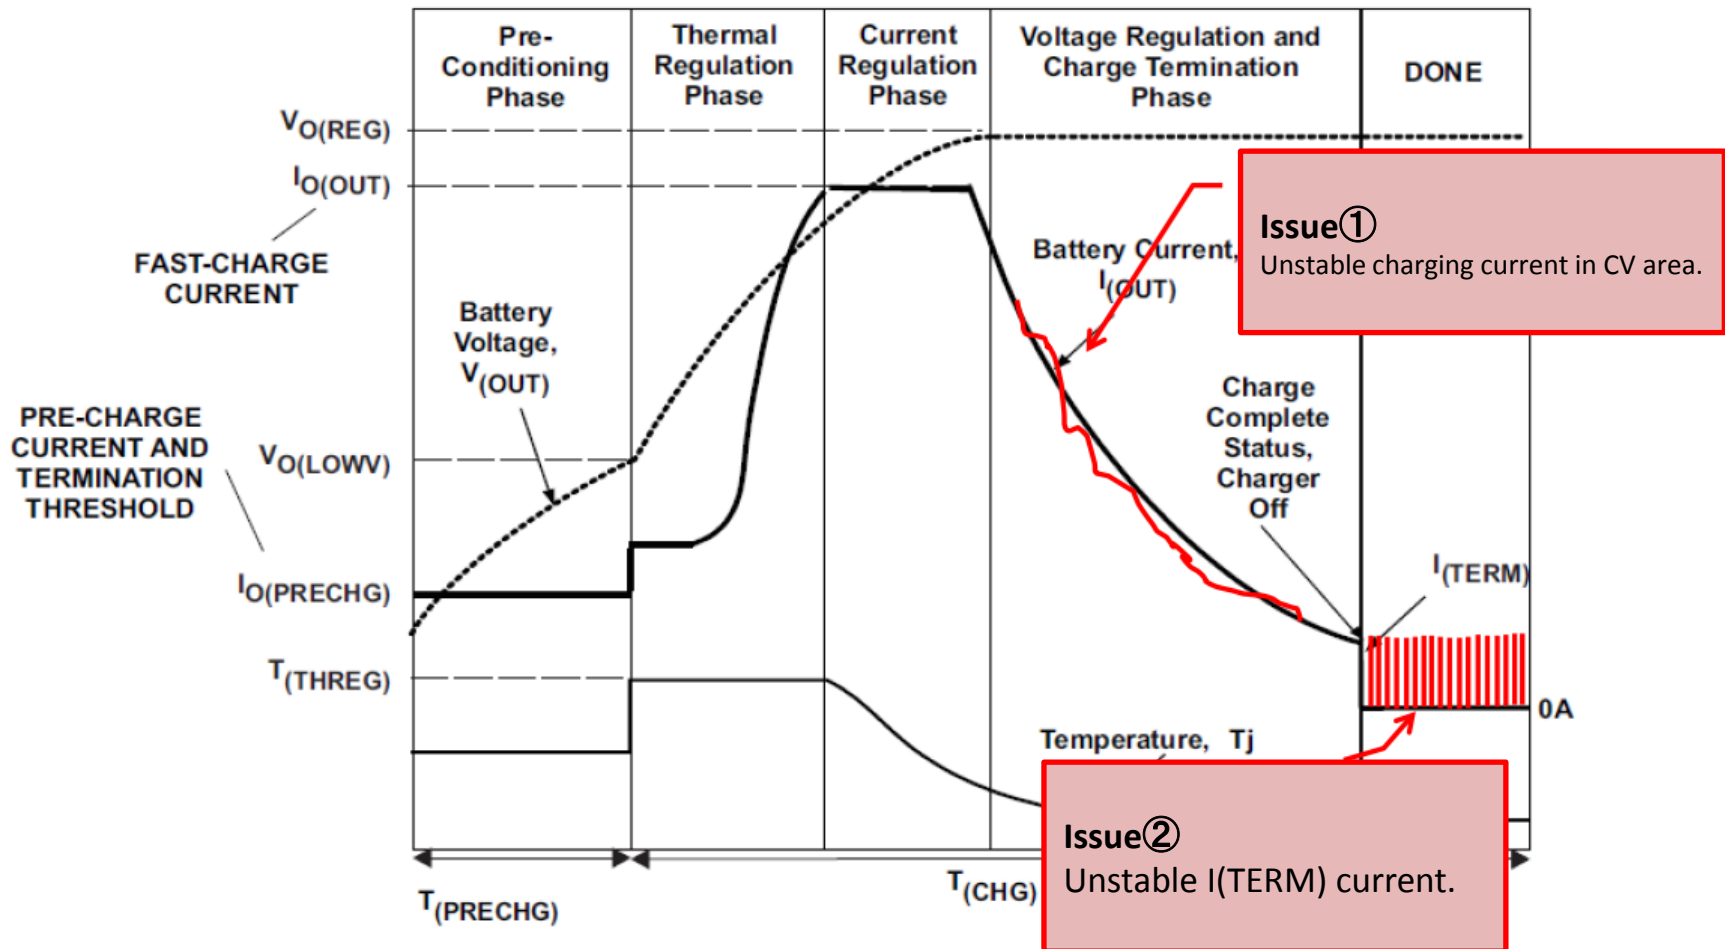
◇ Please tell me the cause of the issue ①, ②.

※2 charge current is 9.5m - 14mA
