[SL]Vout is existed even EN pin is connected to ground. No matter load is removed or not.

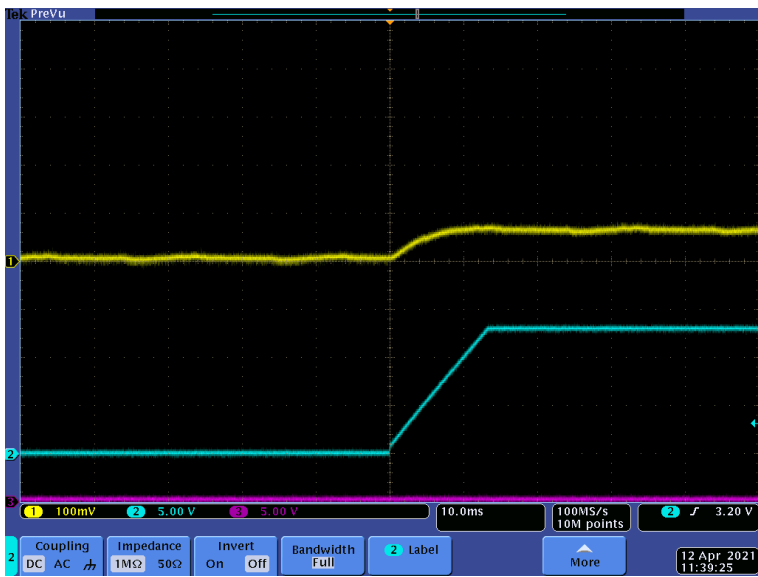
Fig20

yellow:EN

blue:Vin

purple:Vout

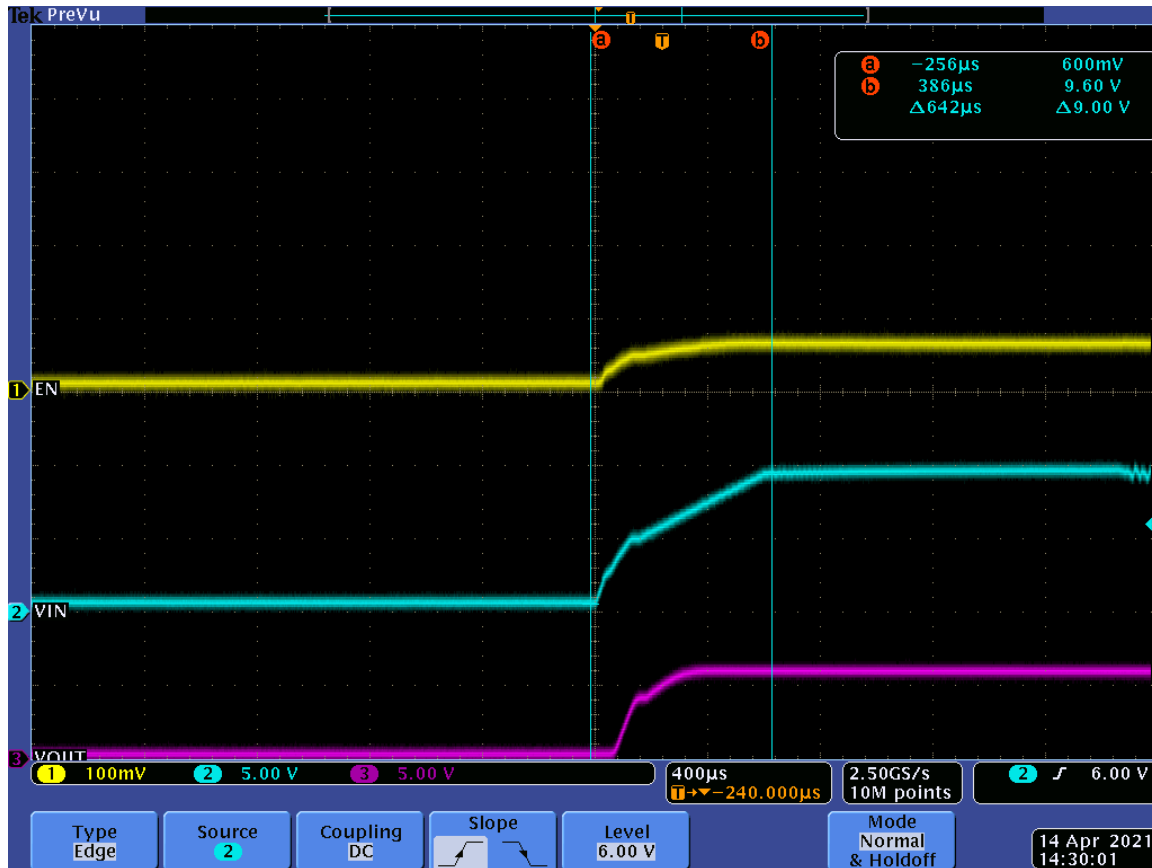
EN pin	board source V/T setup	Vin rising (ms)	Vout existed before enabled?
original	10V/5A	0.64	Existed 6V, see left figure
directly to ground	10V/5A	0.64	Existed 5V, see right figure
