Charger (top) Orca at external case connection (bottom) Start of a byte request:

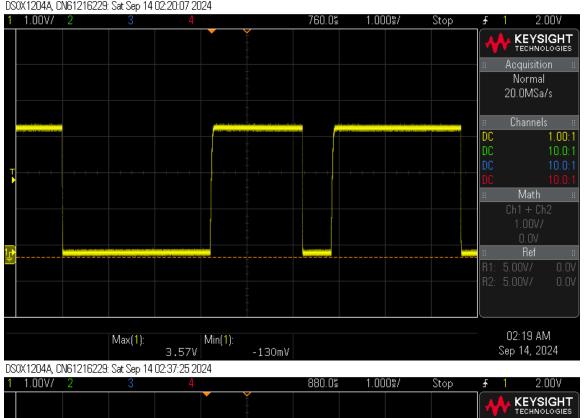
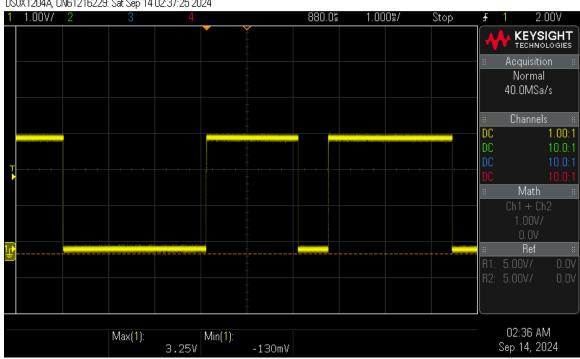
BREAK pulse (3ms MIN, no MAX) followed by break recovery (1ms MIN, no MAX)

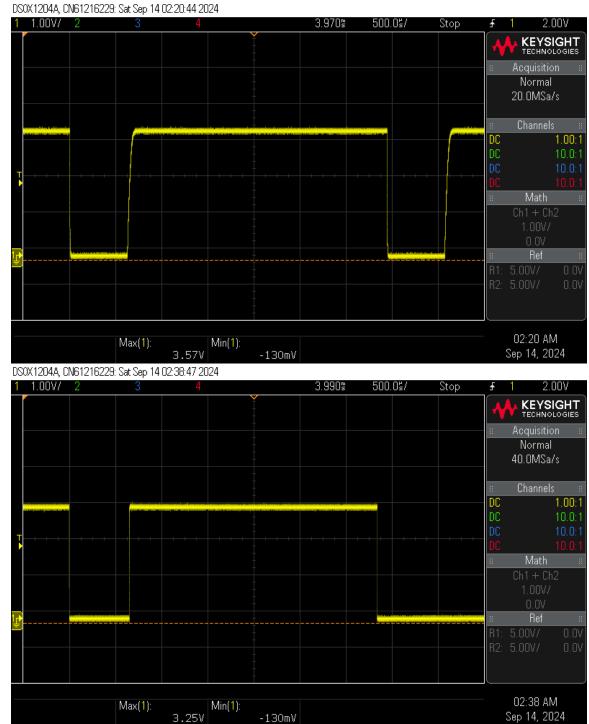
Byte transmit:

1-bit (5ns MIN, 750us MAX) total bit time (until next HIGH-LOW xition) 2.95ms MIN no MAX

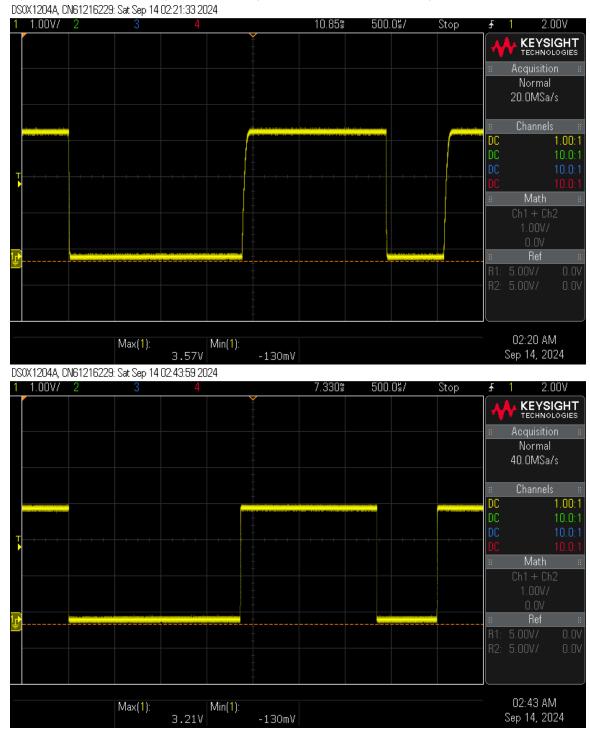
Byte transmit:

0-bit (1ms MIN, 2.25ms MAX) total bit time (until next HIGH-LOW xition) 2.95ms MIN no MAX

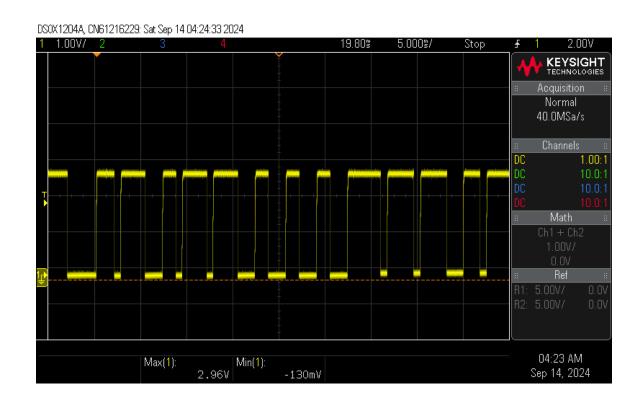
Received reply from battery "A"

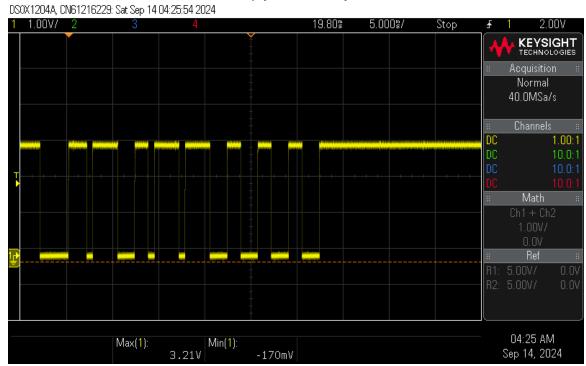
No reply from battery "B"
