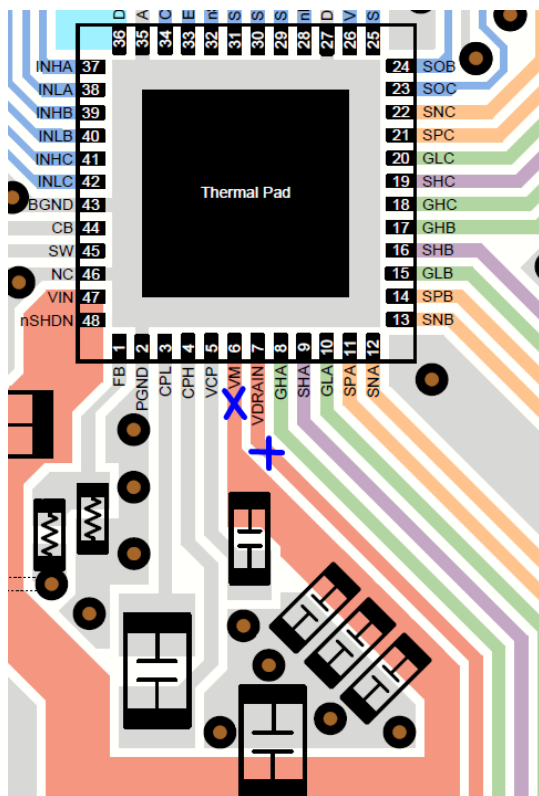
Figure 1: Blue marked wires blown up.

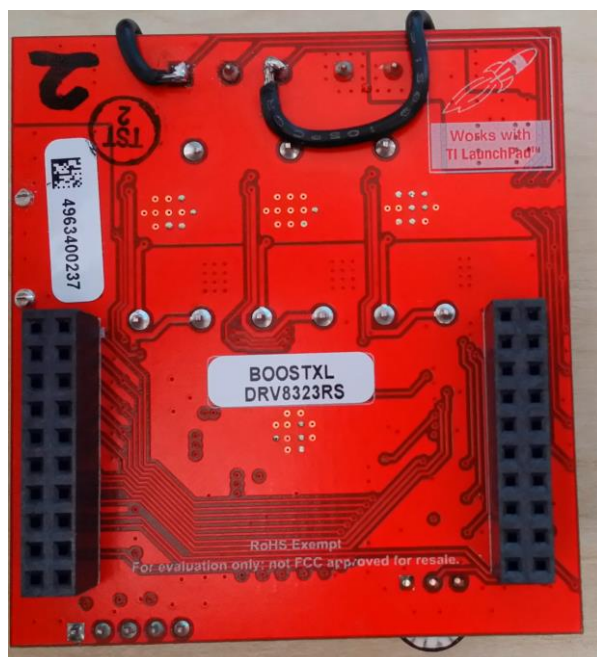
Figure 2: Board 1 bottom side

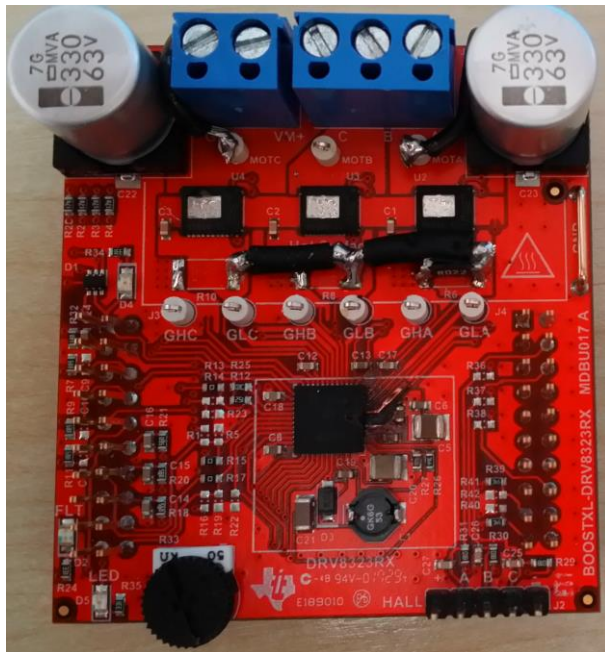
Figure 3: Board 1 top side

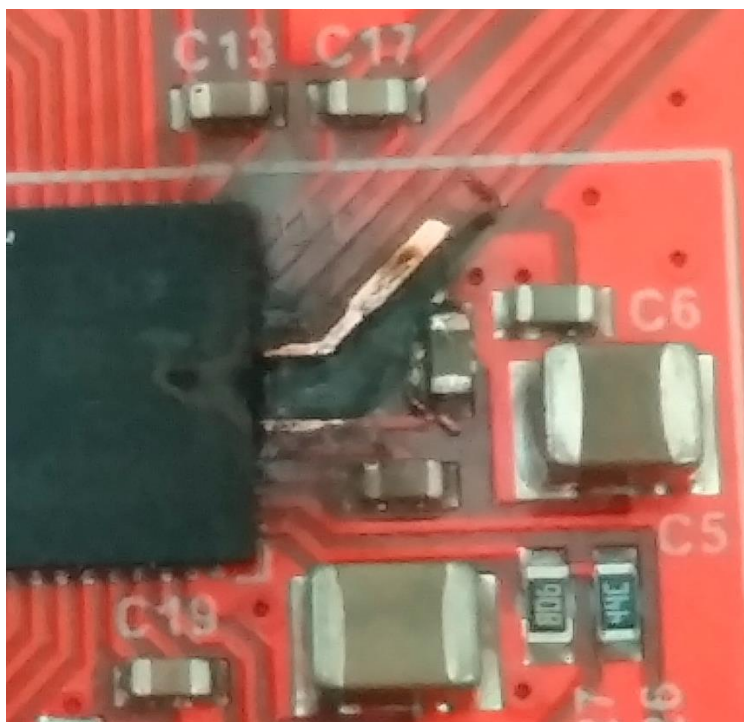
Figure 4: Board 1 top side, burned wires and burned package of DRV8323SR

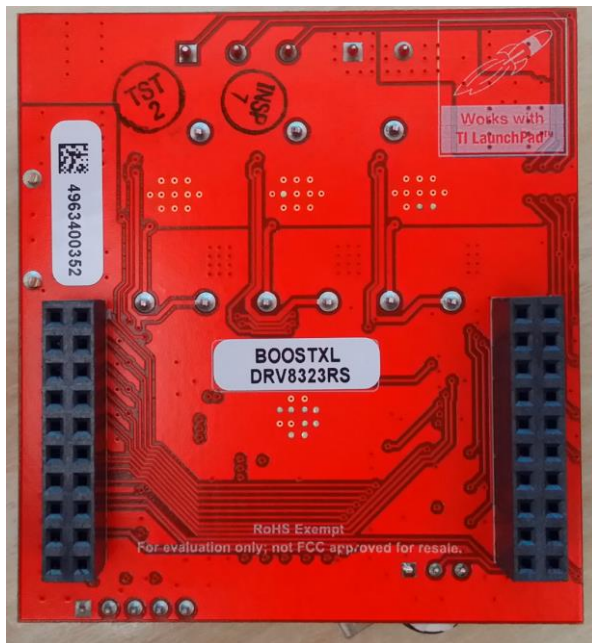
Figure 5: Board 2, bottom side

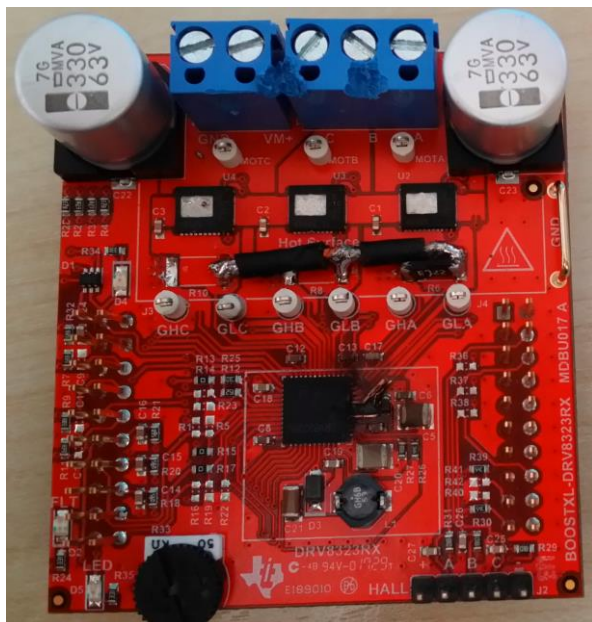
Figure 6: Board 2, top side

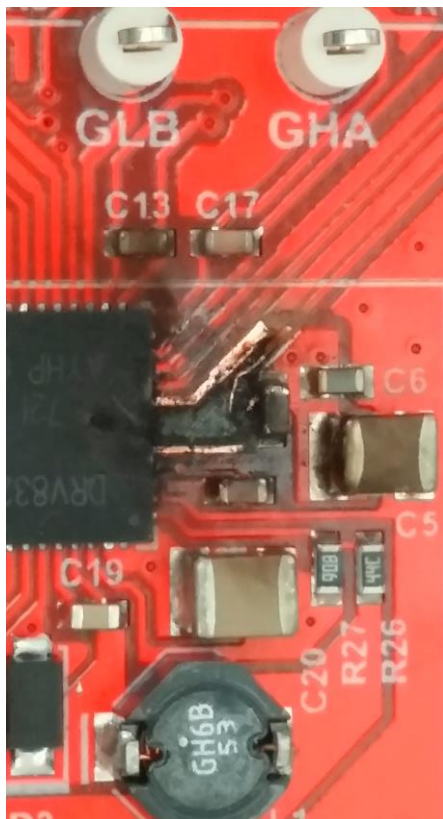
Figure 7: Board 2, top side, burned wires and burned package of DRV8323SR
