## Comparison report of Both the IC TI35AHGYM CD4066BM & IC TI55C8S3K CD4066BM

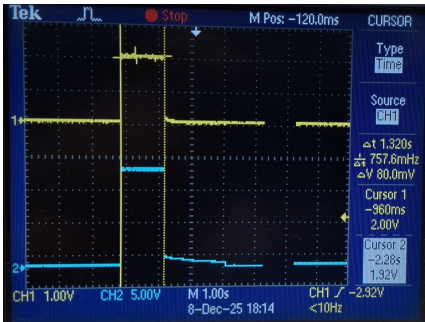
Sr. No.	Card Pulse 19 with IC TI35AHGYM CD4066BM at location U7	Card Pulse 19 with IC TI55C8S3K CD4066BM at location U7	Remarks
1.	Wave form of Control Signal at Pin no 13 and the wave form of output signal at pin No. 2 is same in case of IC TI35AHGYM CD4066BM at location U7 as shown in below image	Wave form of Control Signal at Pin no 13 and the wave form of output signal at pin No. 2 is not same in case of IC TI55C8S3K CD4066BM at location U7as shown in below image	<b>Not same</b>

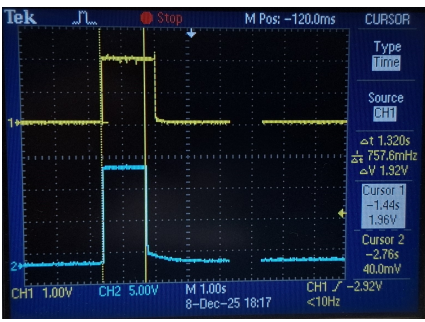
**Conclusion:** - The time of control signal and the time of output signal is not same.
