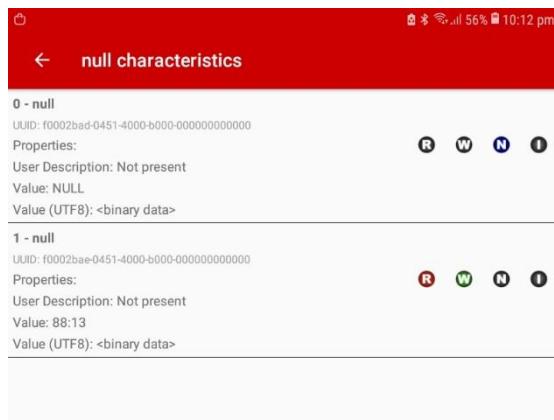
1. First, I am clicking on null service on ti simple link starter app after connecting with the launchpad and get the following value.

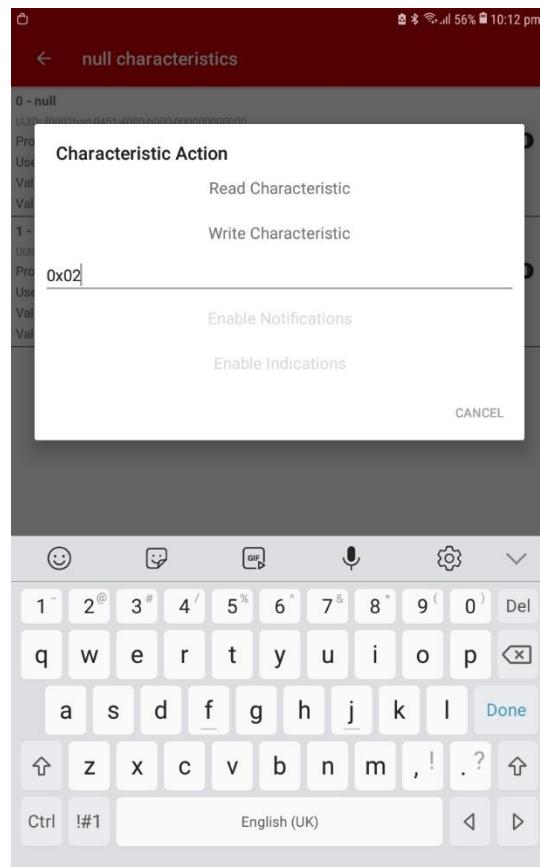
2. Afterwards, I click w and I write a particular value in my case I have written 0x02 as shown in the image below.

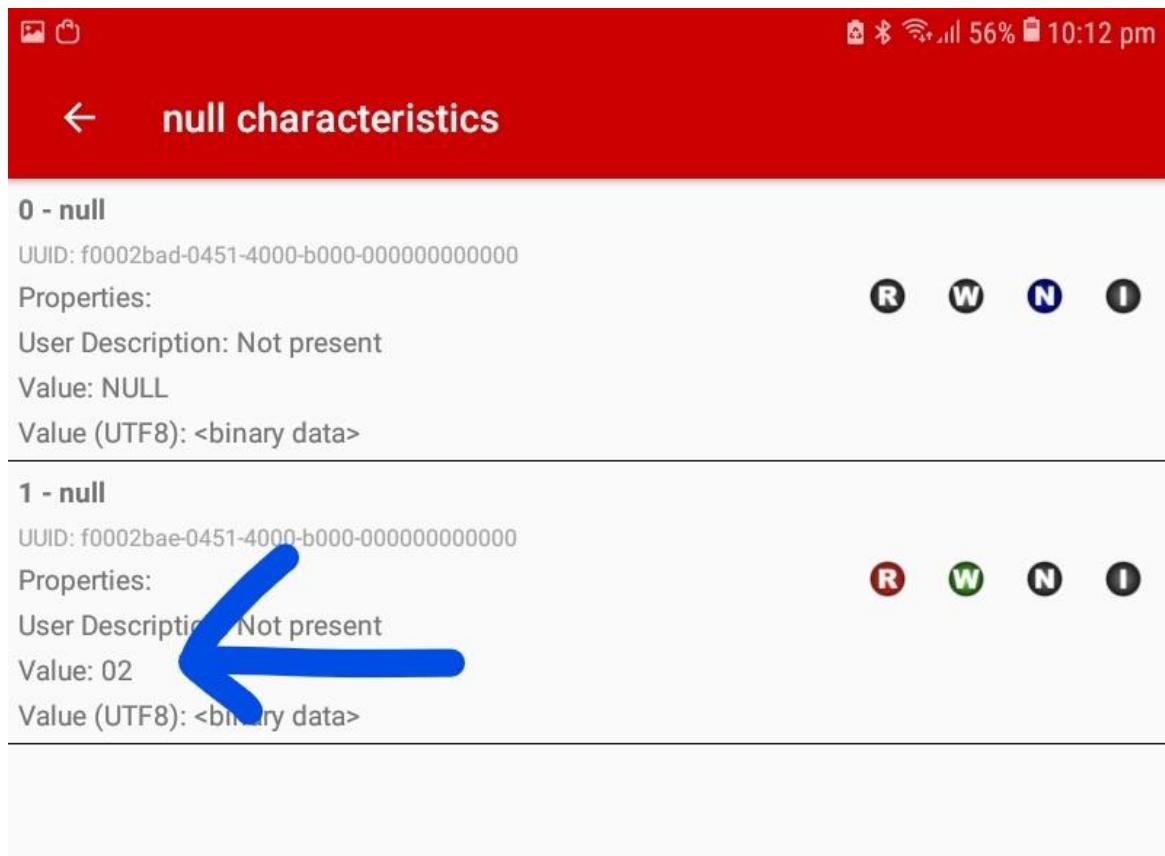
3. Now when I press left button on launchpad I am getting the initial value as shown below.

4. Finally, when I am again pressing the button, the value should update as per the custom profile tutorial, but it is not getting updated. It remains at initial value. Although I have added following code in handle button press in the application task as shown below.

```
SunlightService_SetParameter(SUNLIGHTSERVICE_SUNLIGHTVALUE_ID,  
                            SUNLIGHTSERVICE_SUNLIGHTVALUE_LEN,  
                            &myVar);  
myVar++;
```
