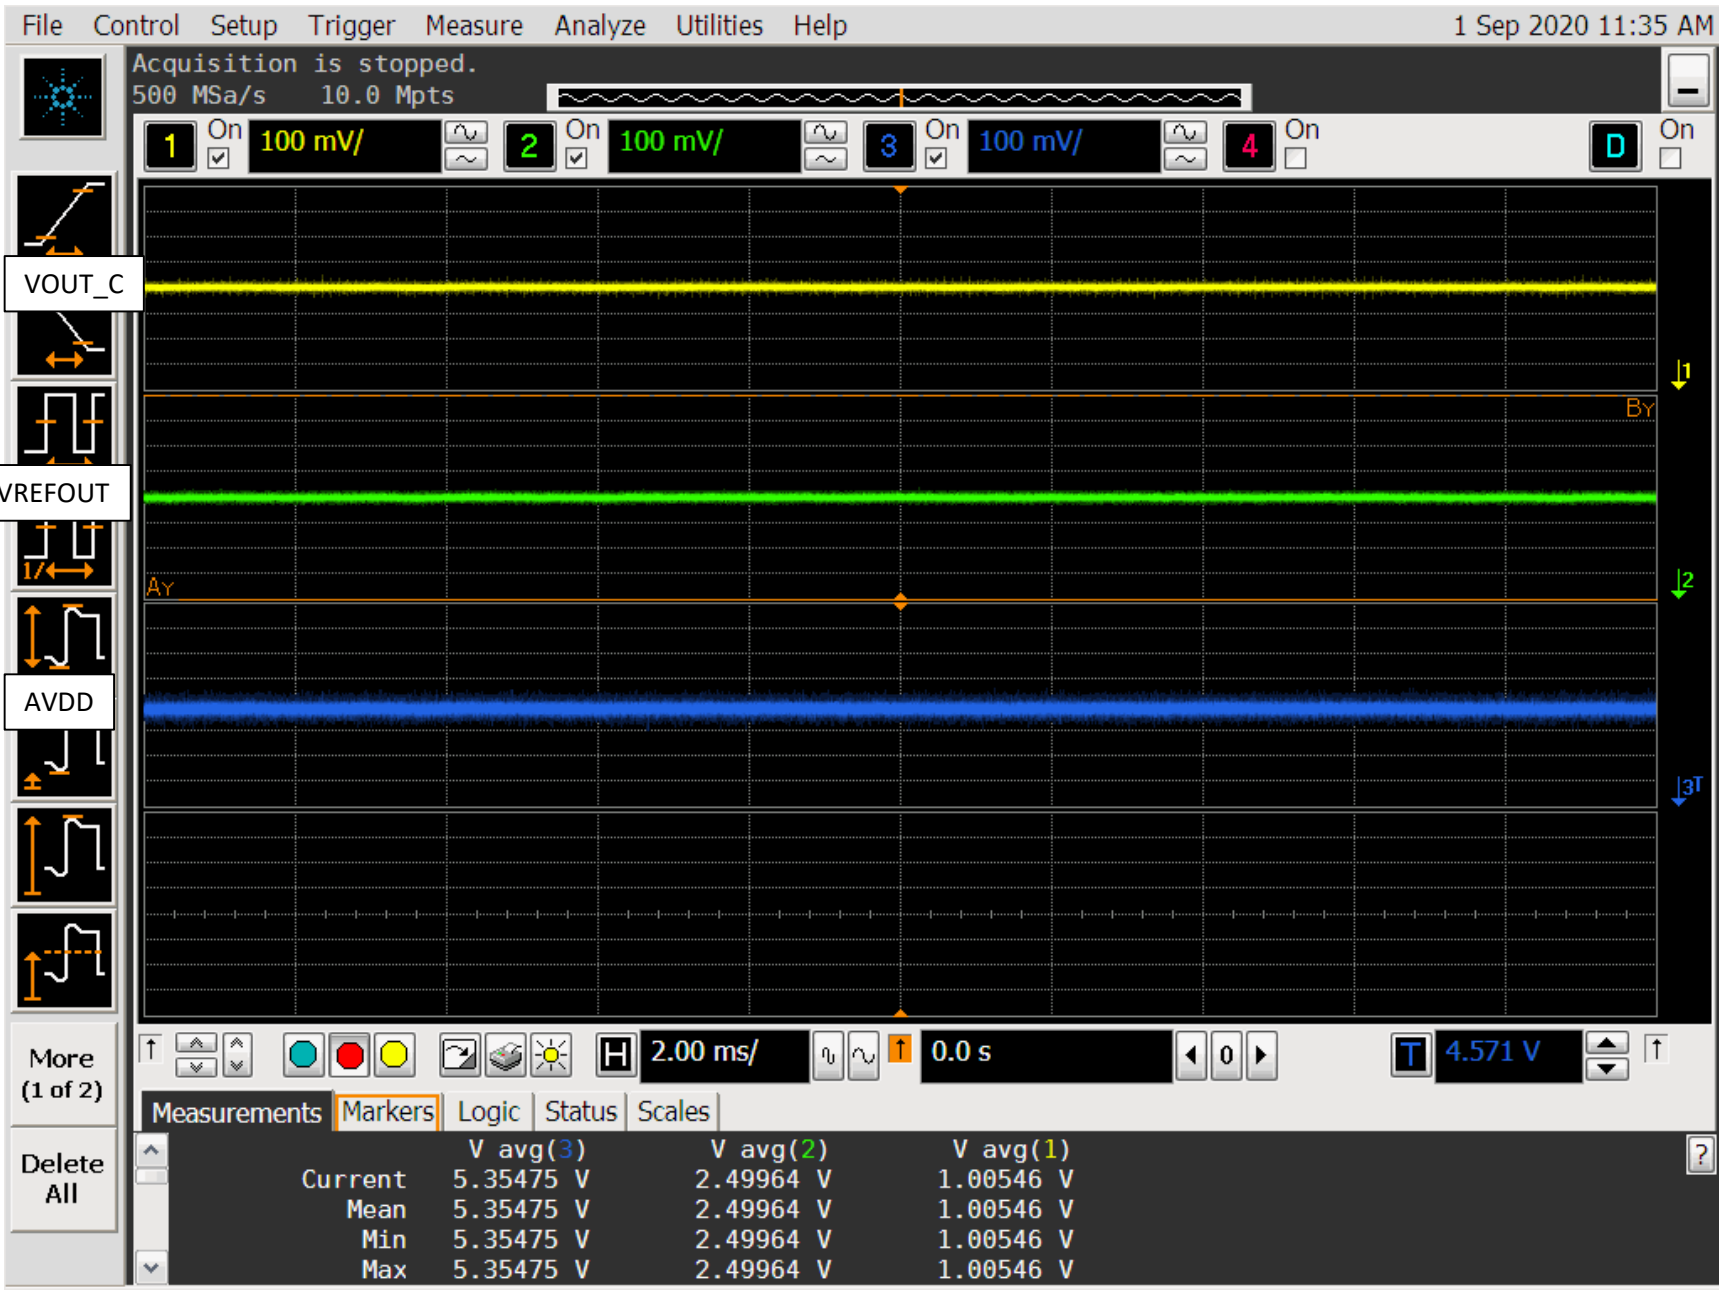
# Before applying Noise

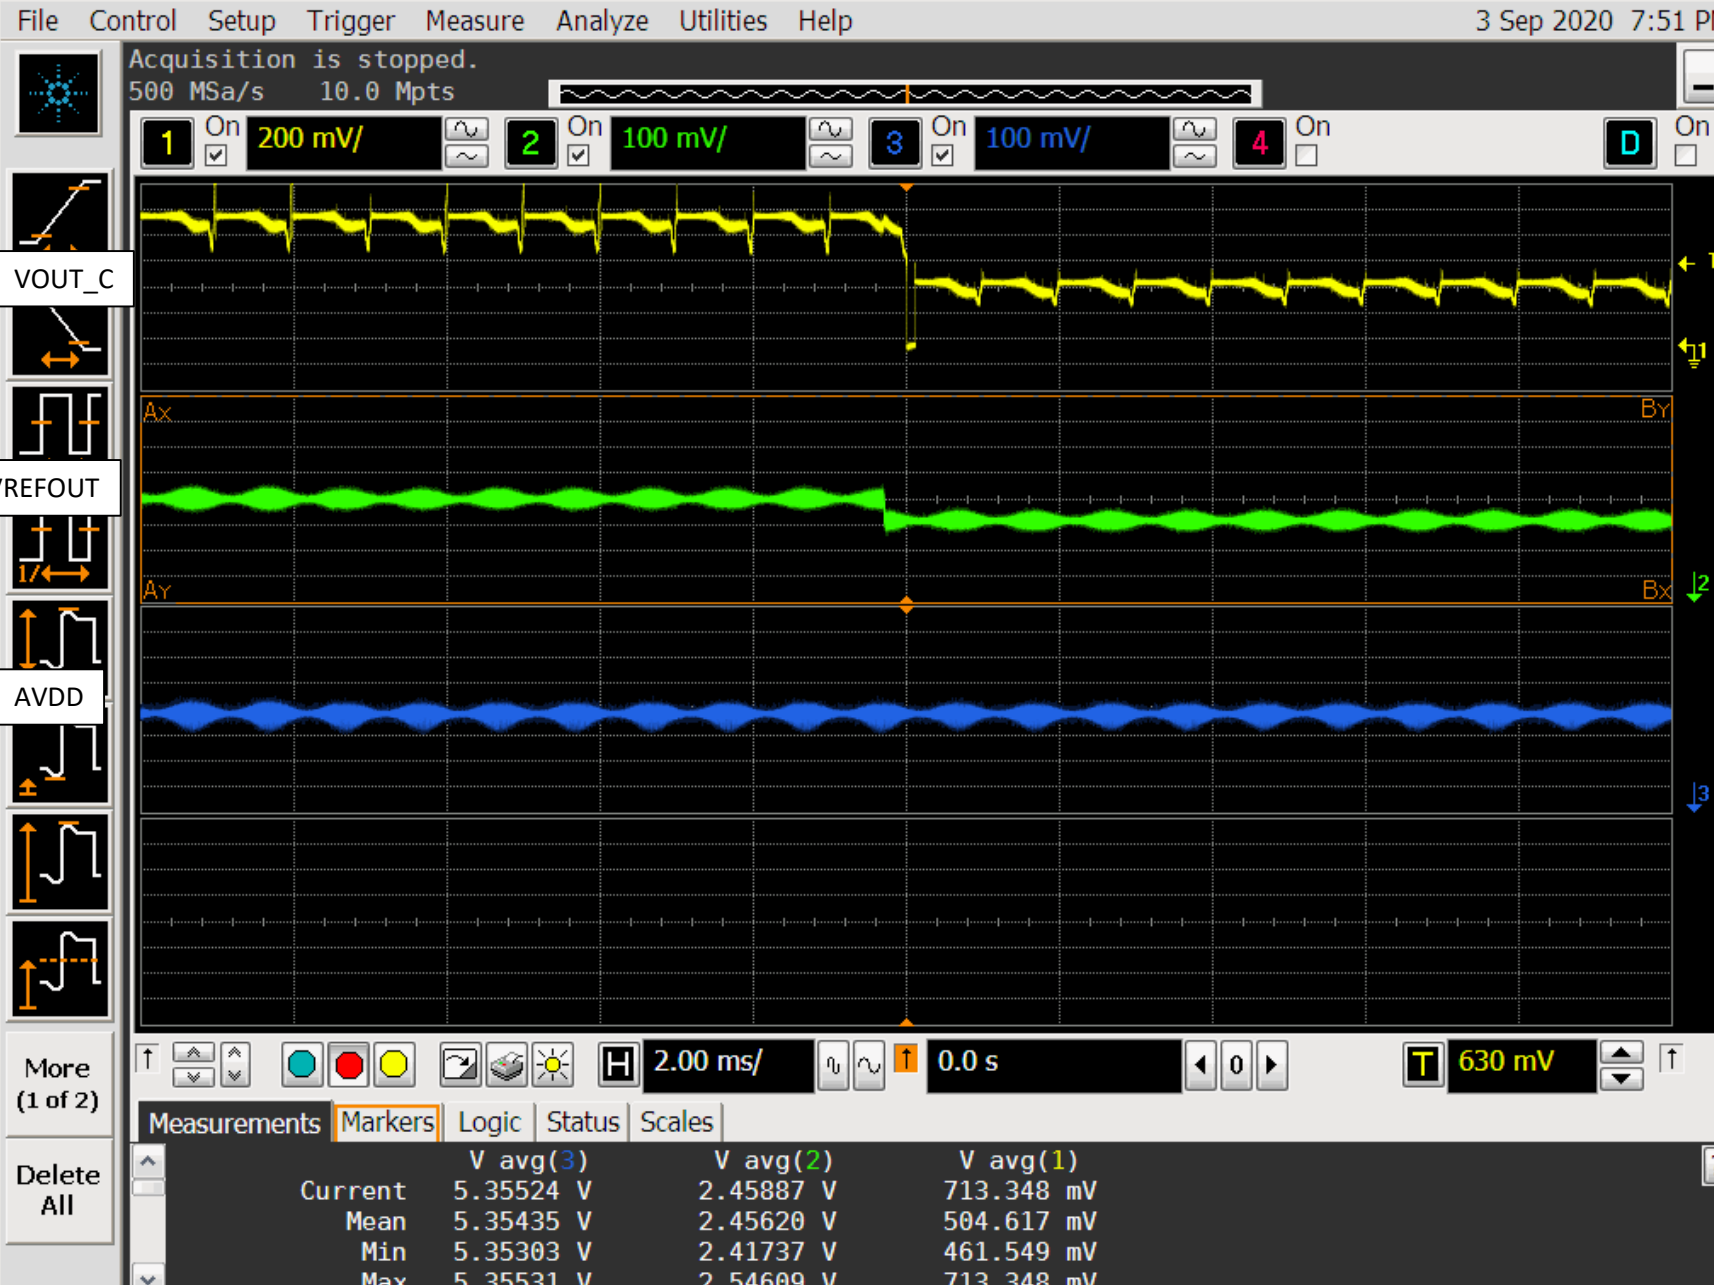
# Half voltage output during applying noise①

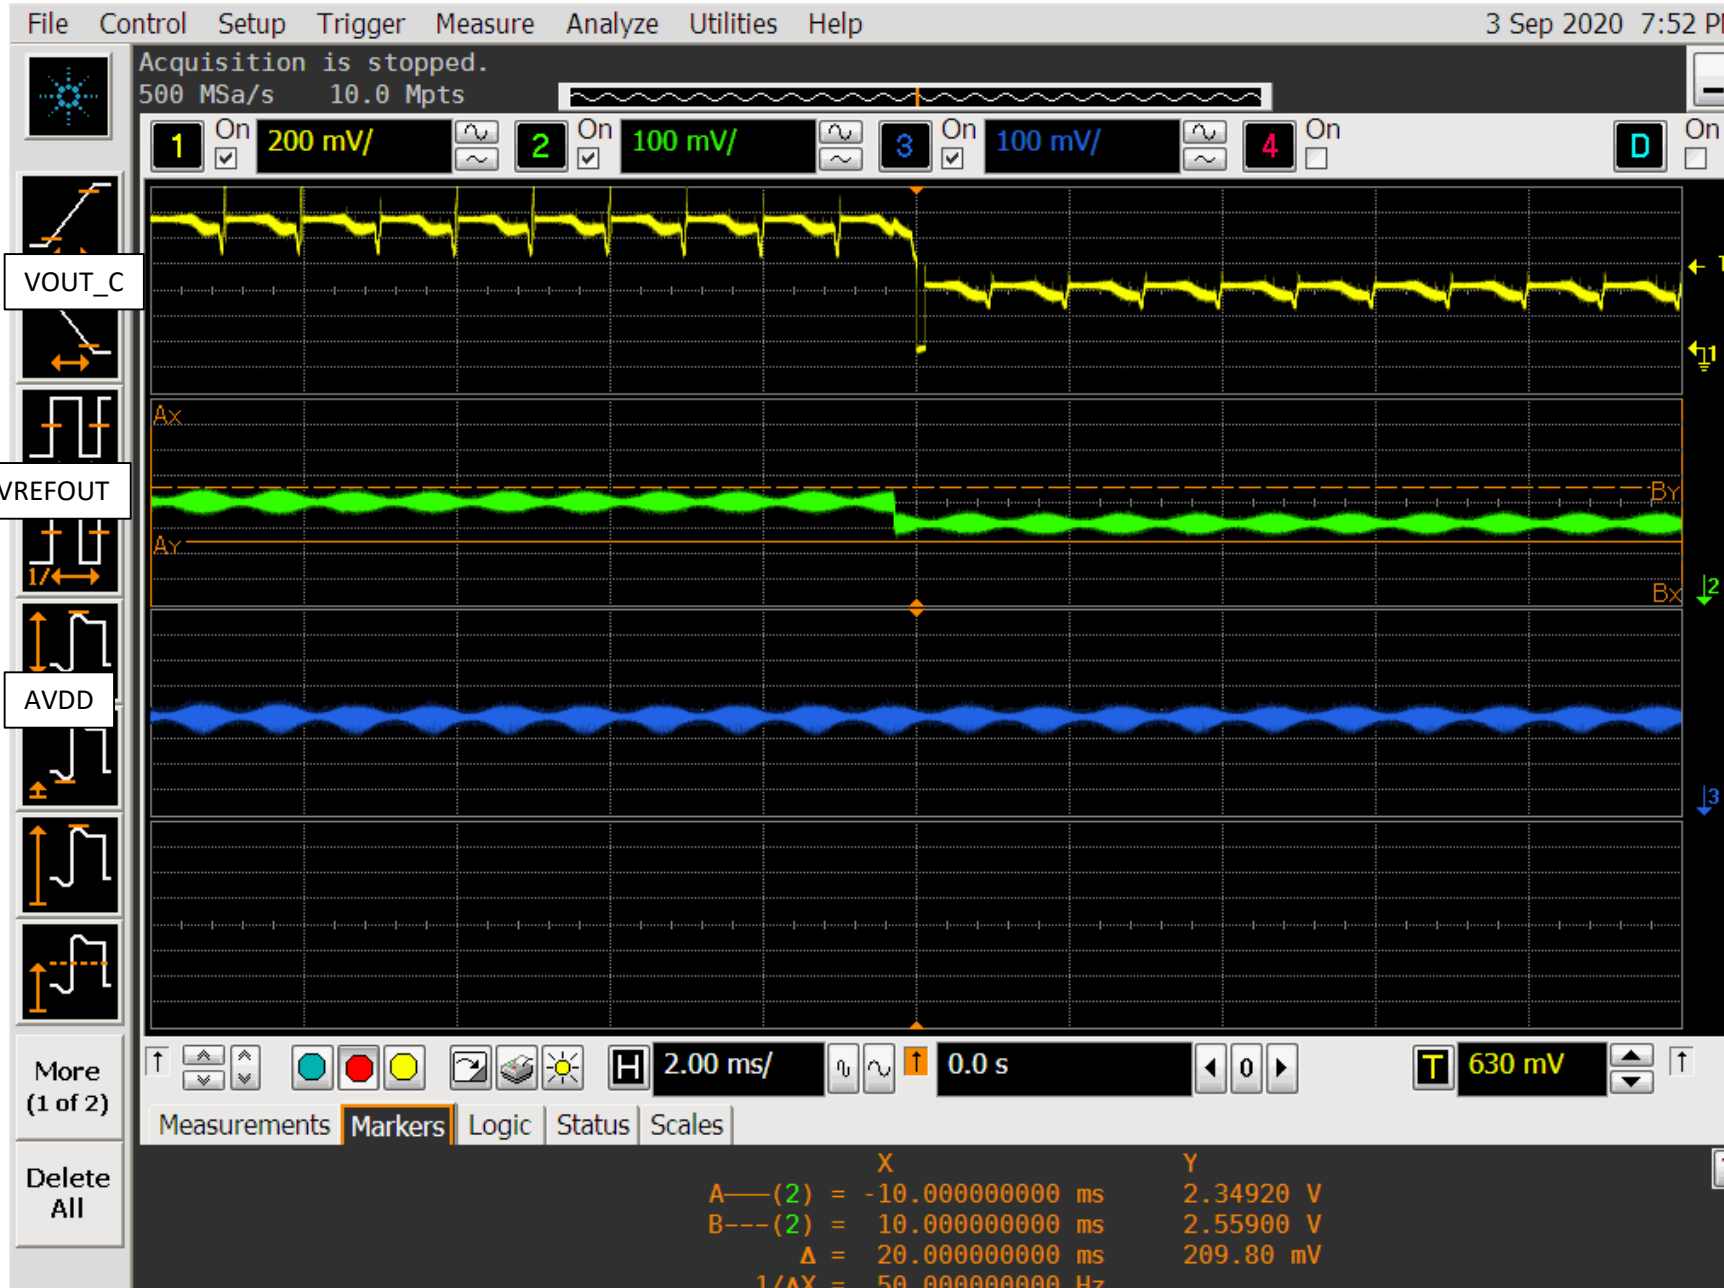
Half voltage output during applying noise②

⇒ Vref was dropping 209.8mV

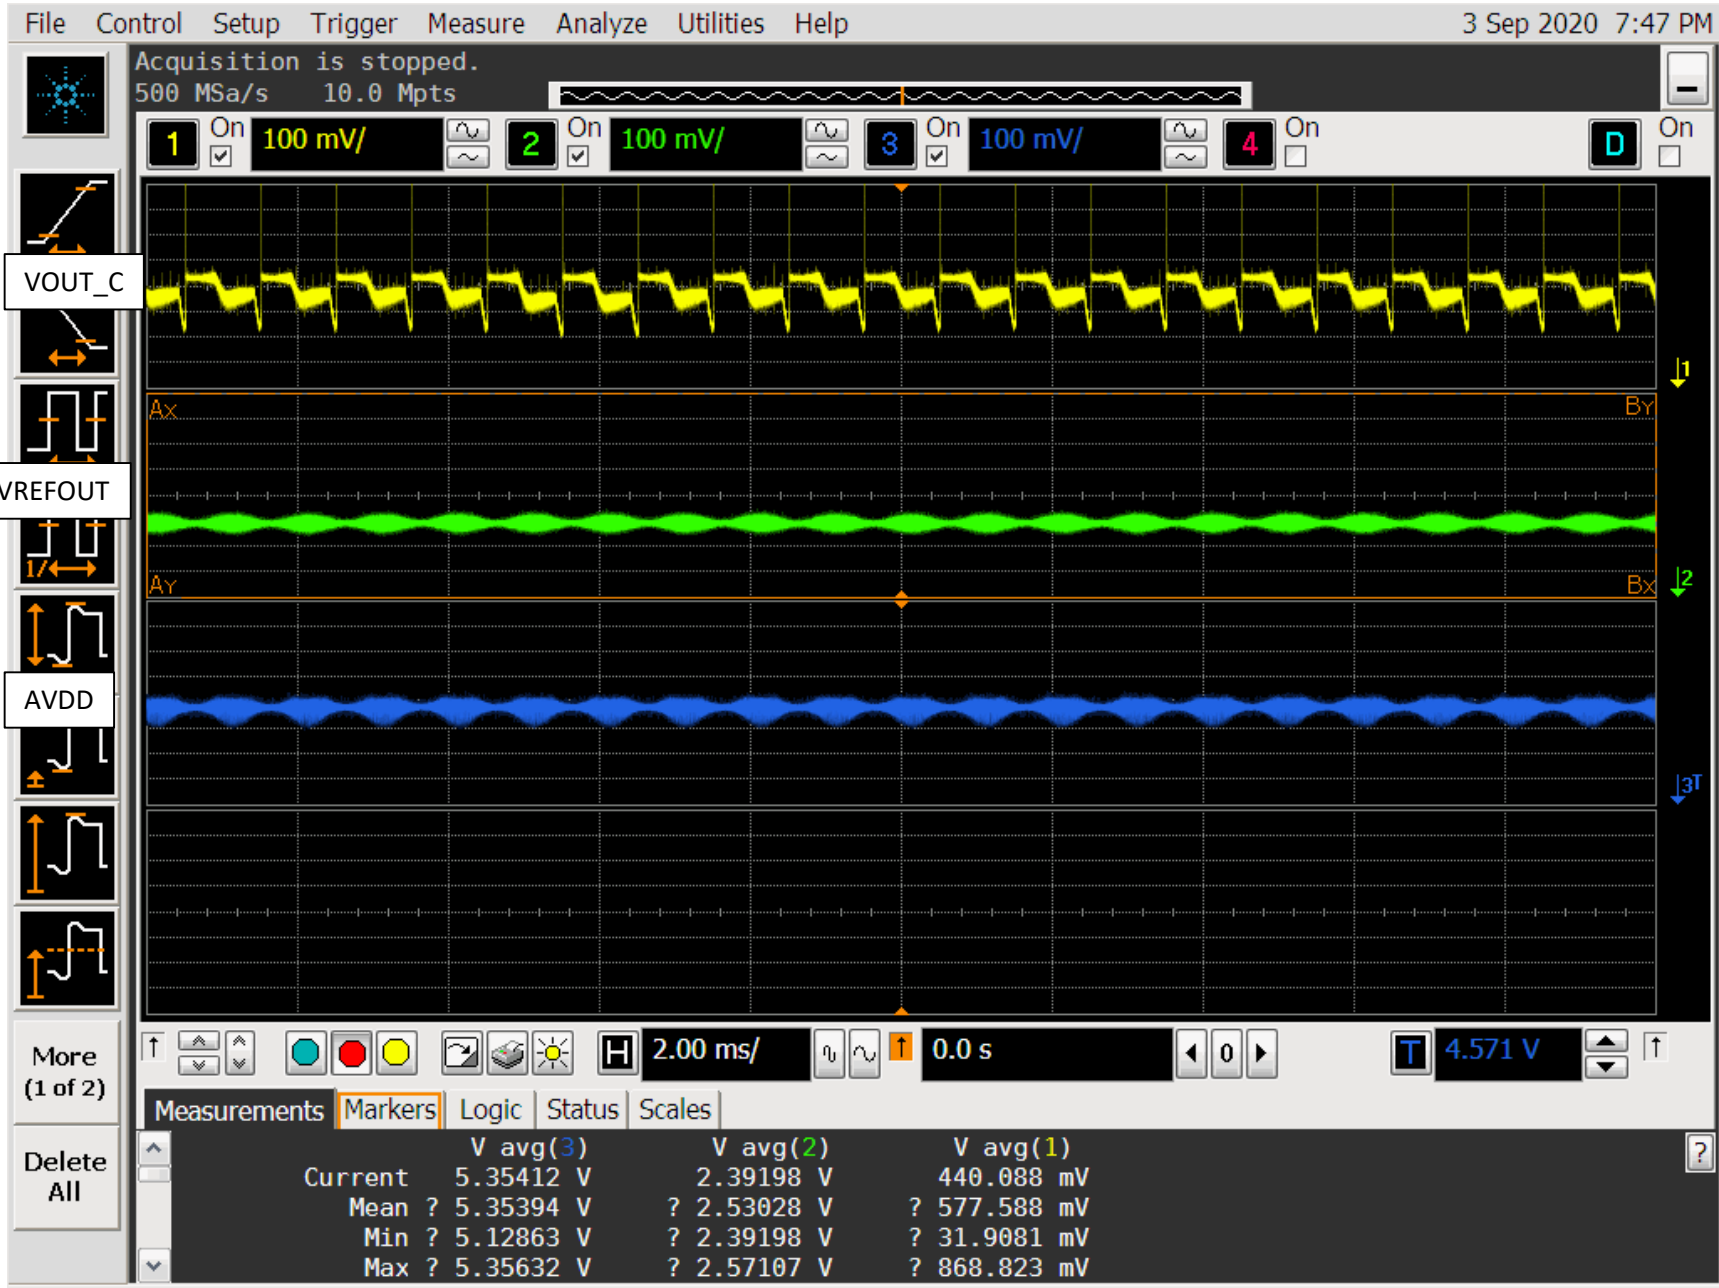
# After half output voltage during applying noise

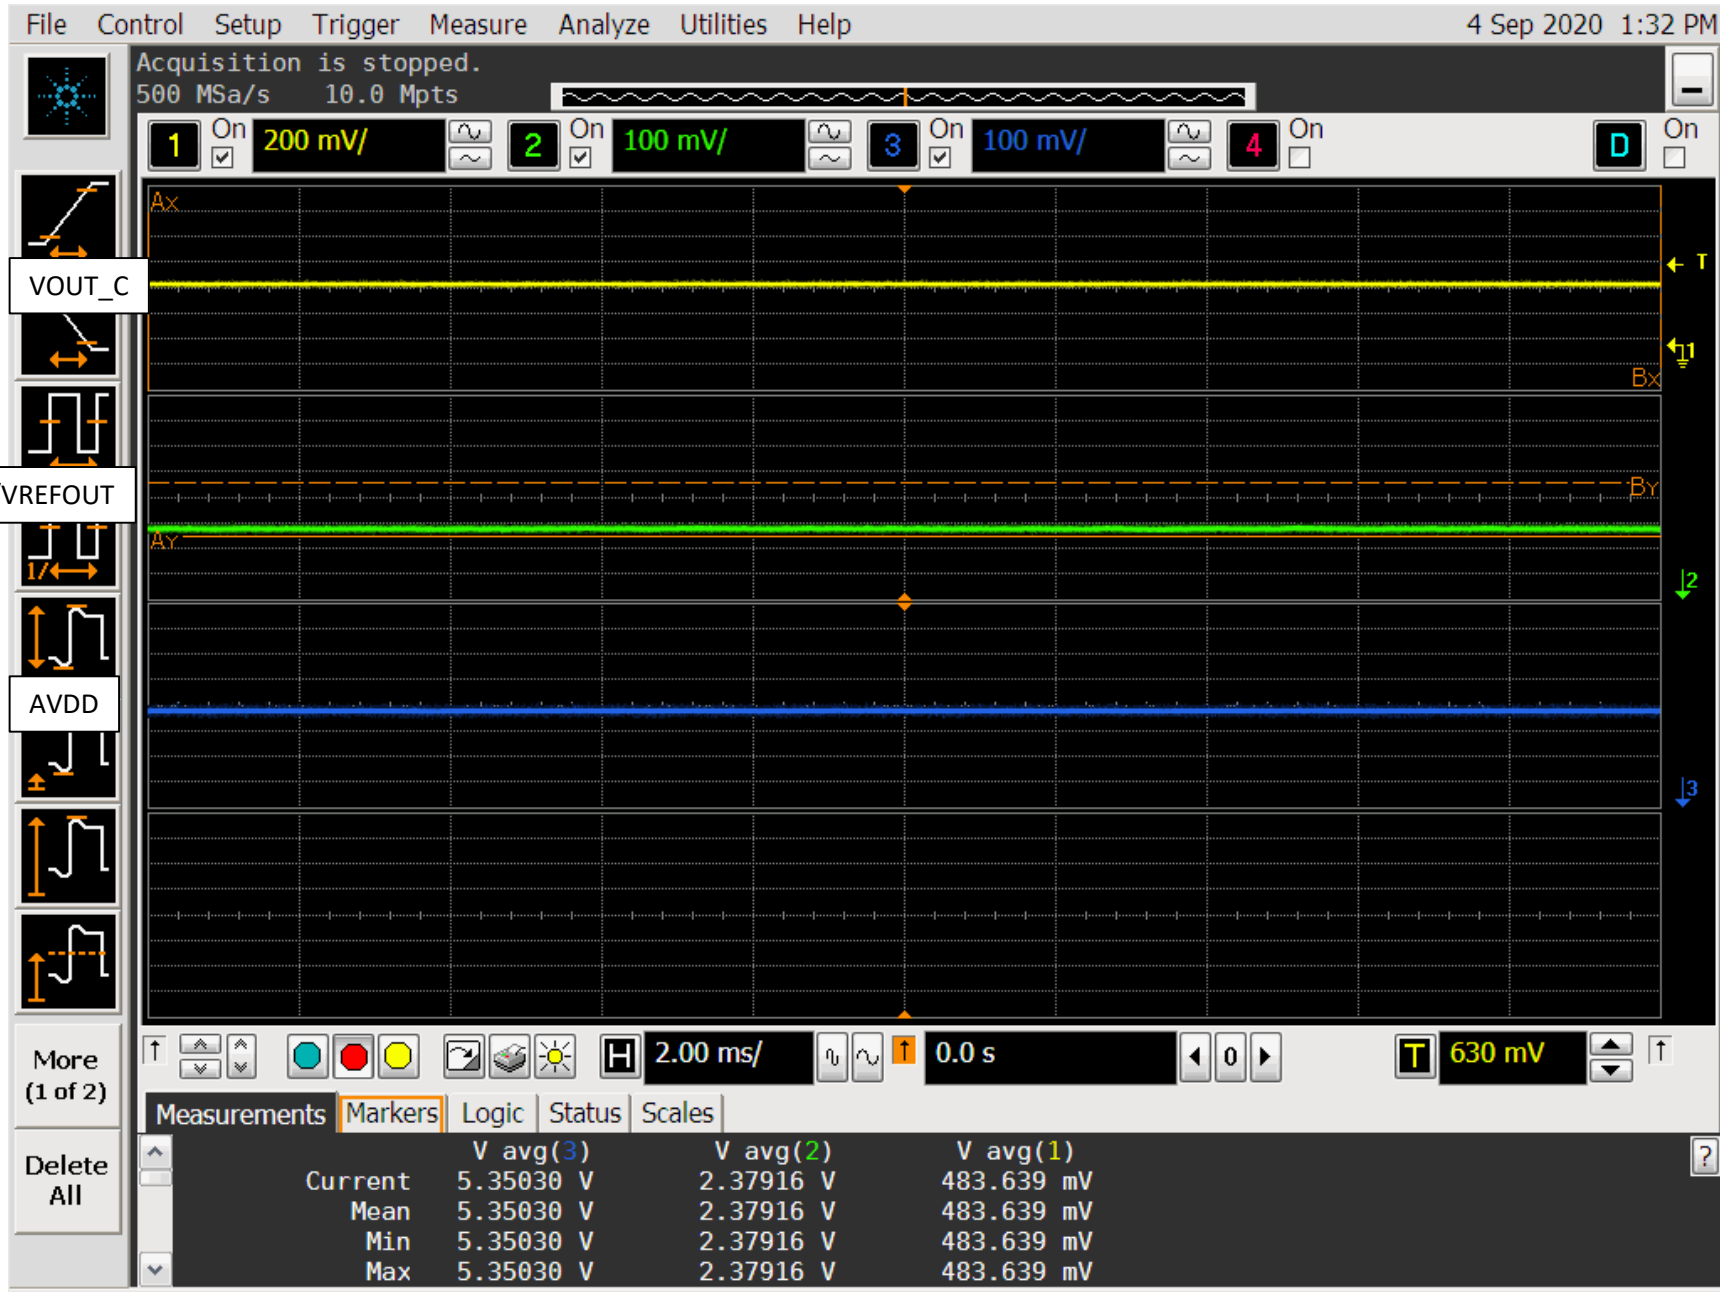
# After stopping applying Noise
